Inspection Report

Sample Report

Assure Home Inspection

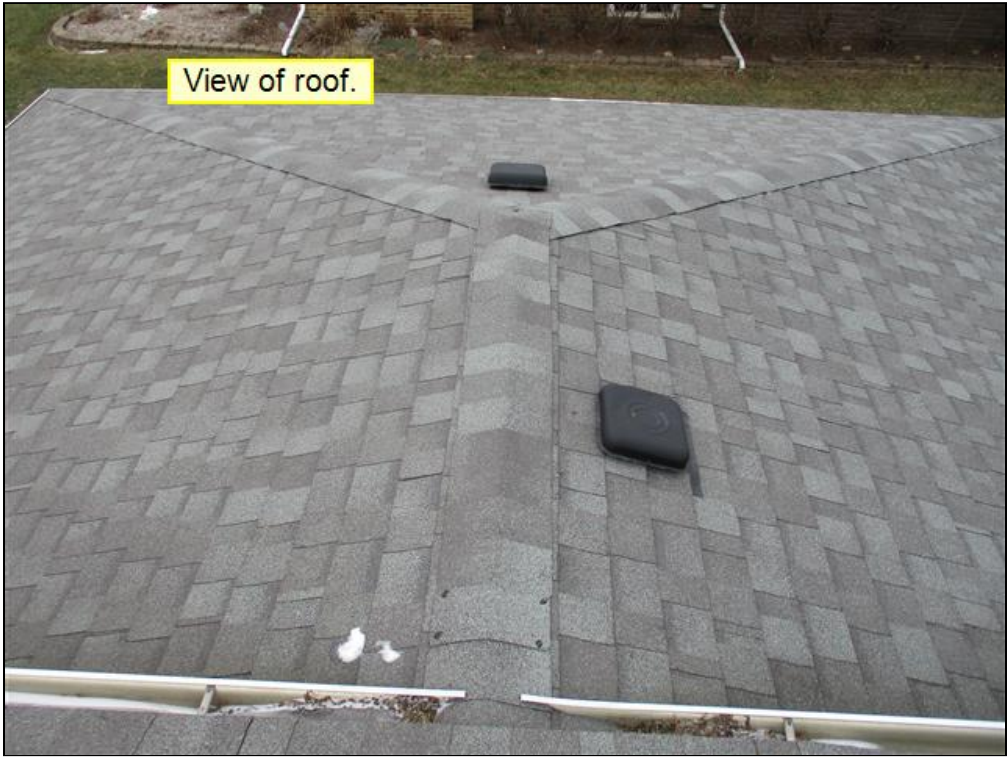
1.1 Item 1(Picture)

The detached shed roof was older, and had one missing shingle. Contact a roofing contractor to replace the missing shingle and any others that they find that need repair.

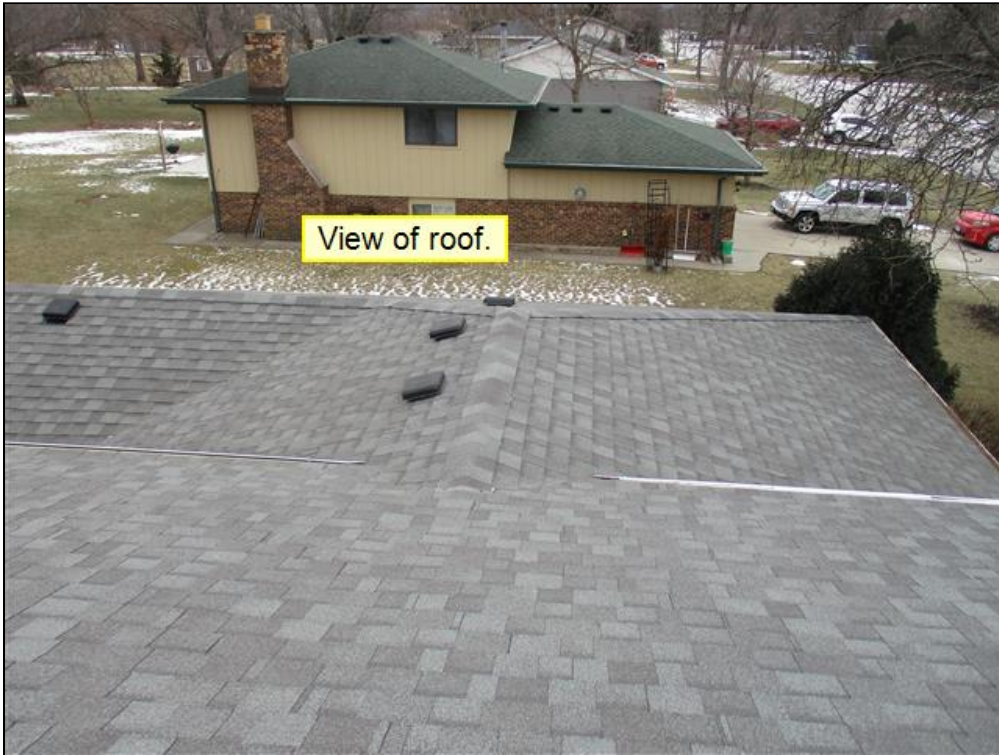
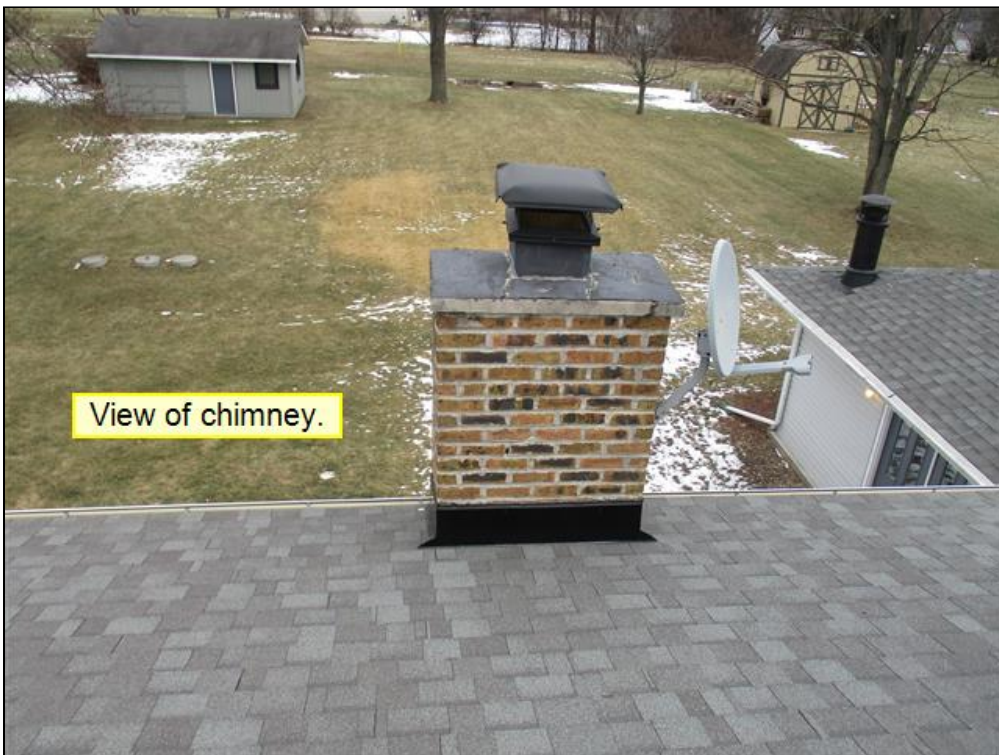
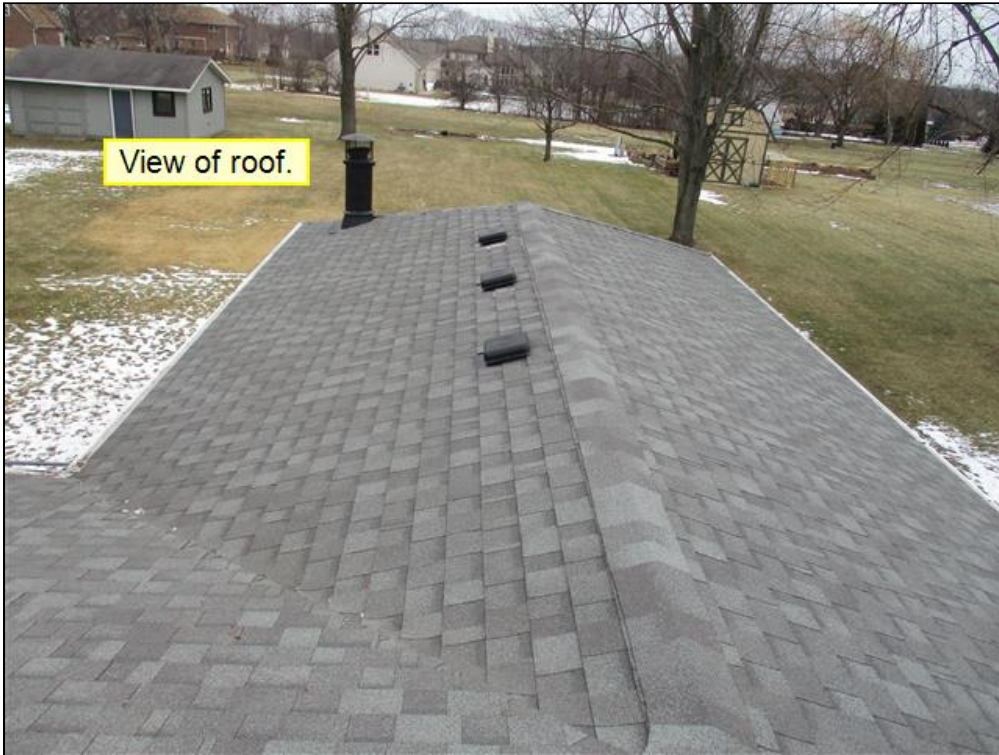
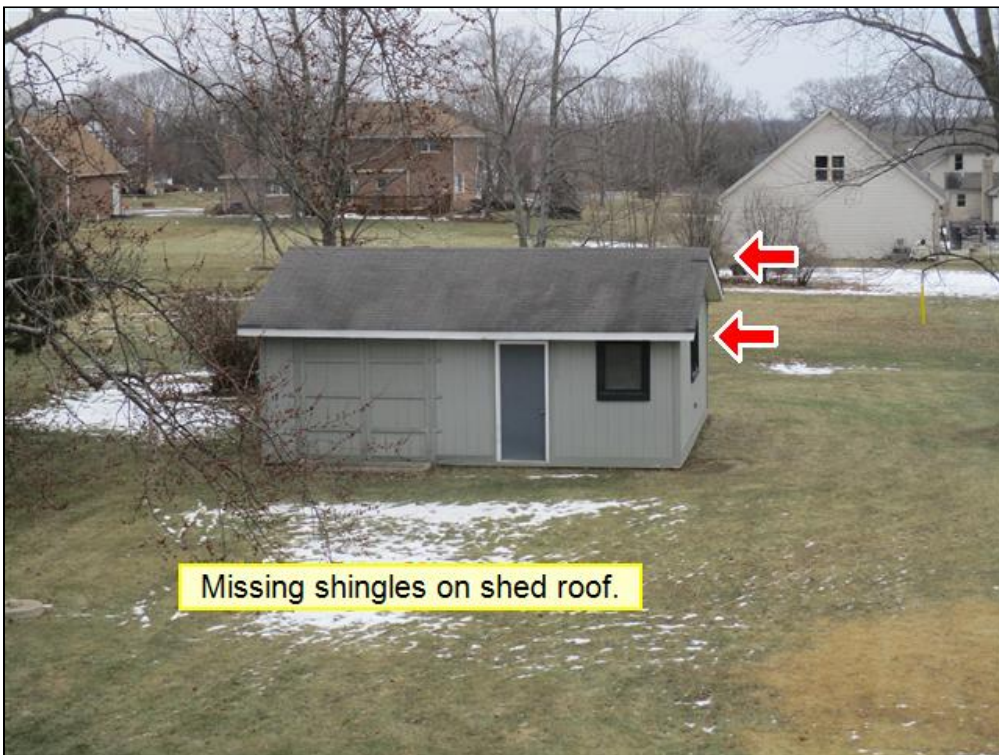
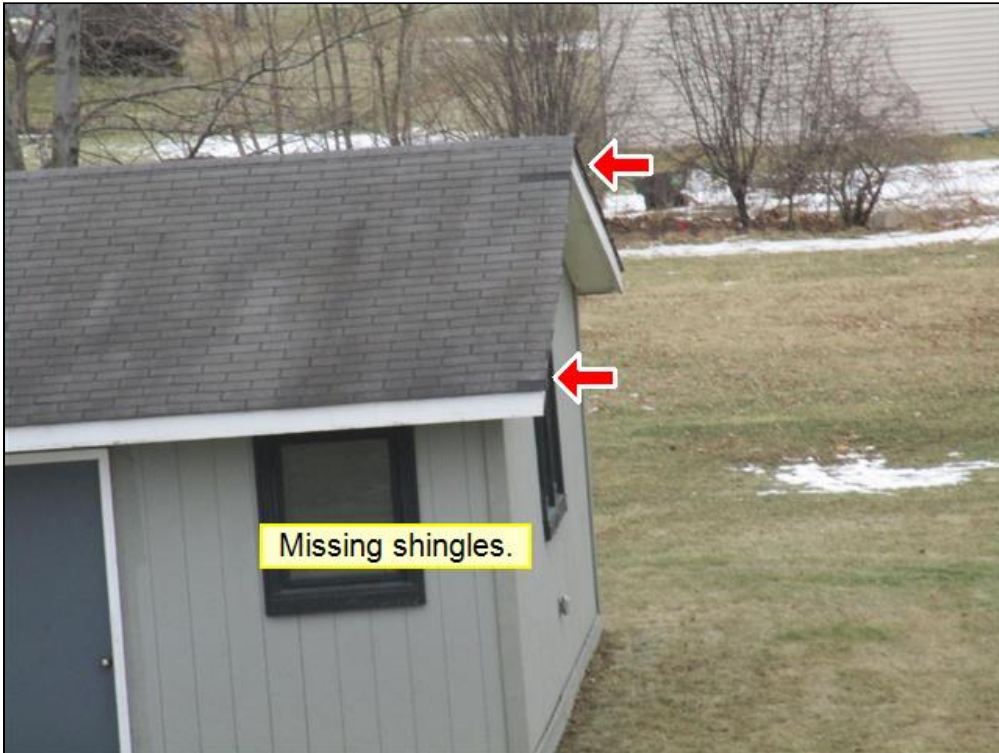
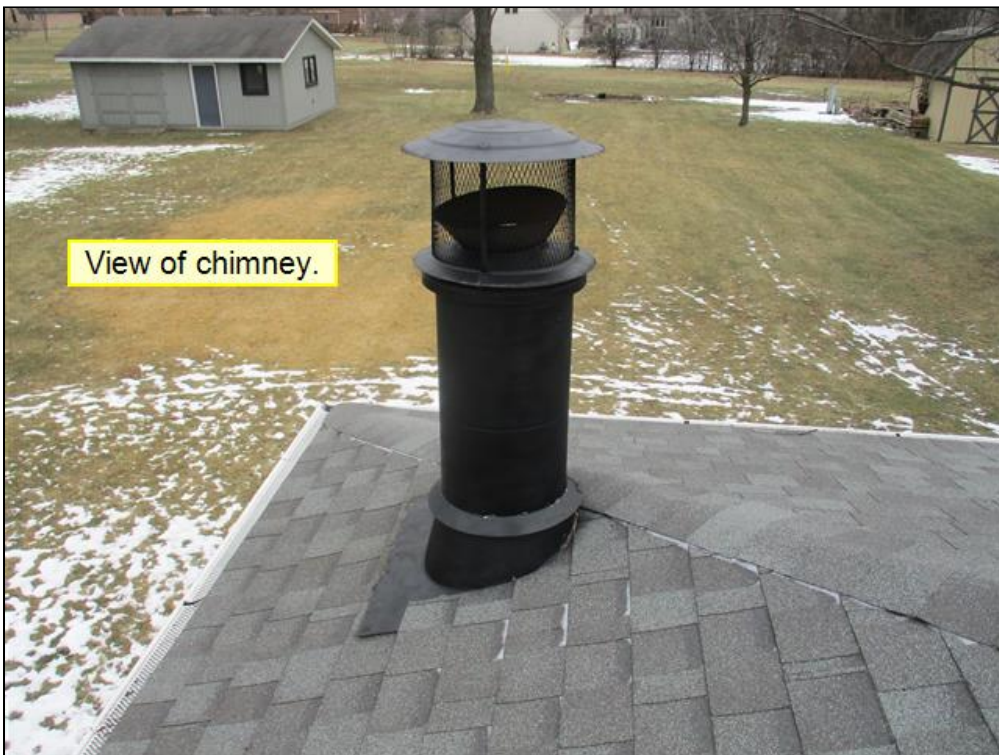
1.1 (1) The house roofing shingles were newer and in good condition.

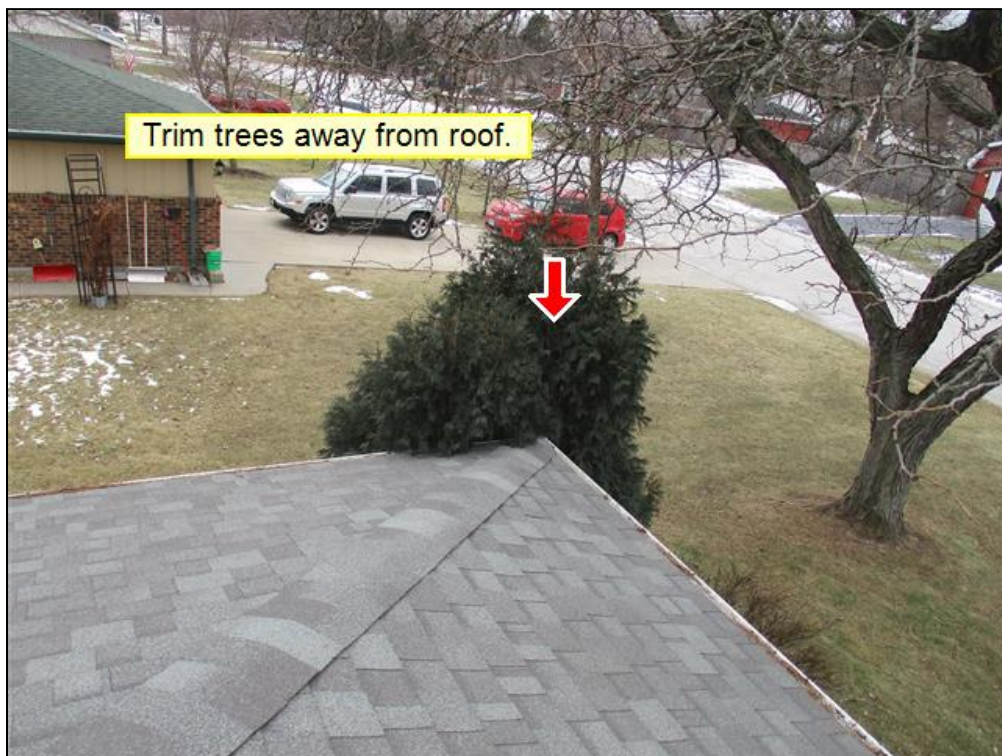
1.1 Item 8(Picture)

- 🏠 (2) There are trees in contact with the roof. This can cause damage to the roofing shingles and other components of the home. Contact a qualified person to trim tree branches away from the home.

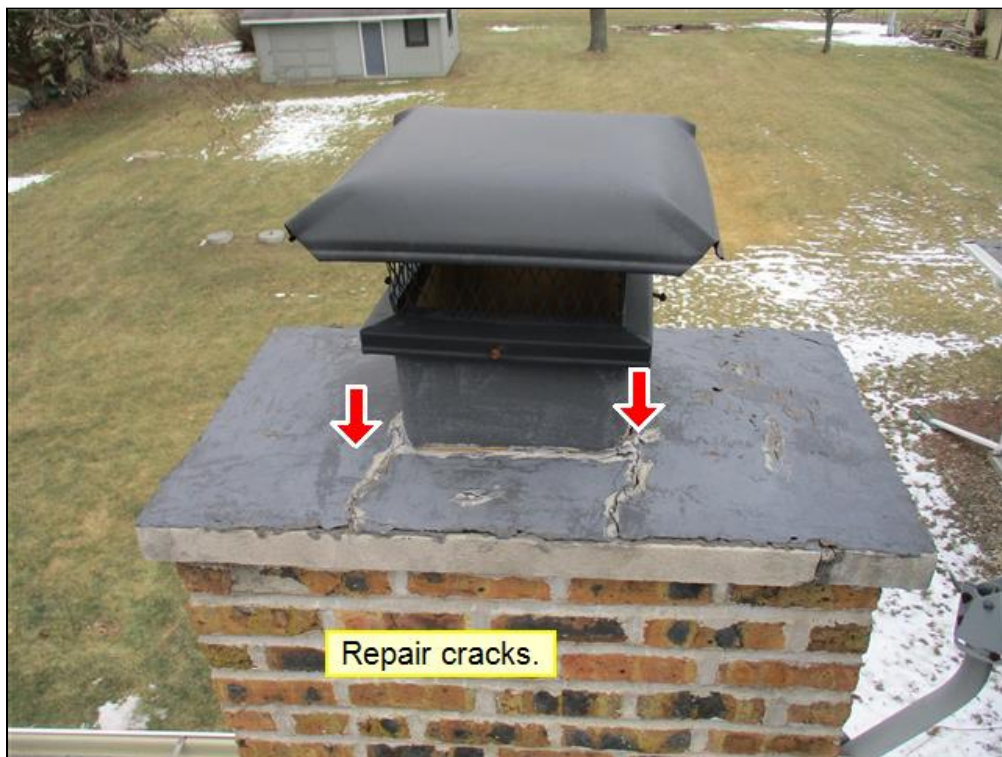
1.2 Item 1(Picture)

- 🏠 1.2 There are a few cracks in the brick chimney cap. I recommend caulking to prevent further damage.

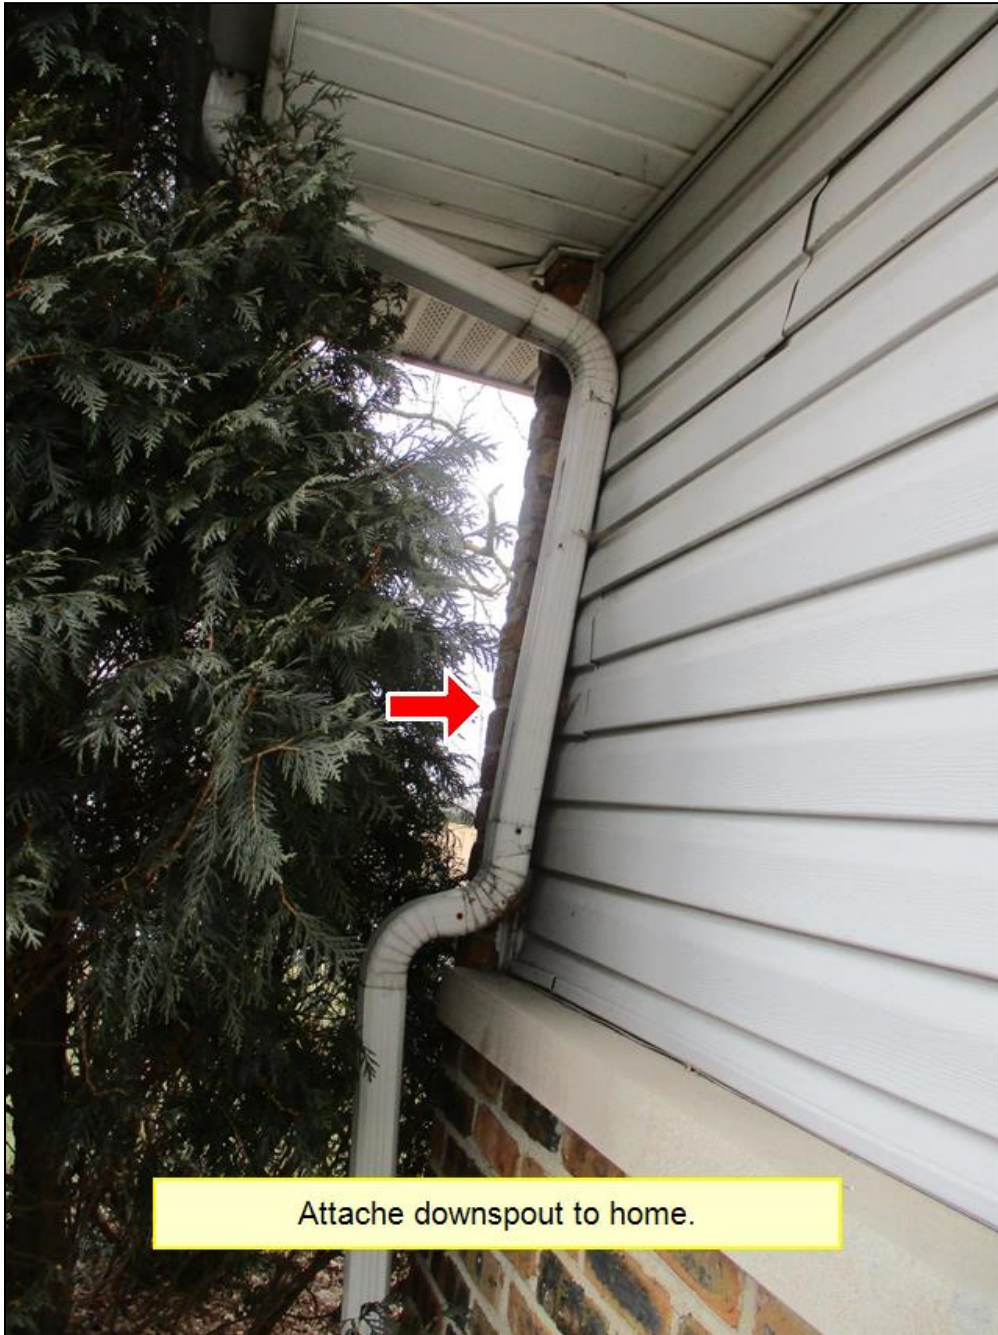
1.3 Item 1(Picture)

**1.3** (1) There was one downspout that was not properly attached to the home. If not properly attached, further damage may occur. Contact a qualified contractor to properly attach the downspout to the home.

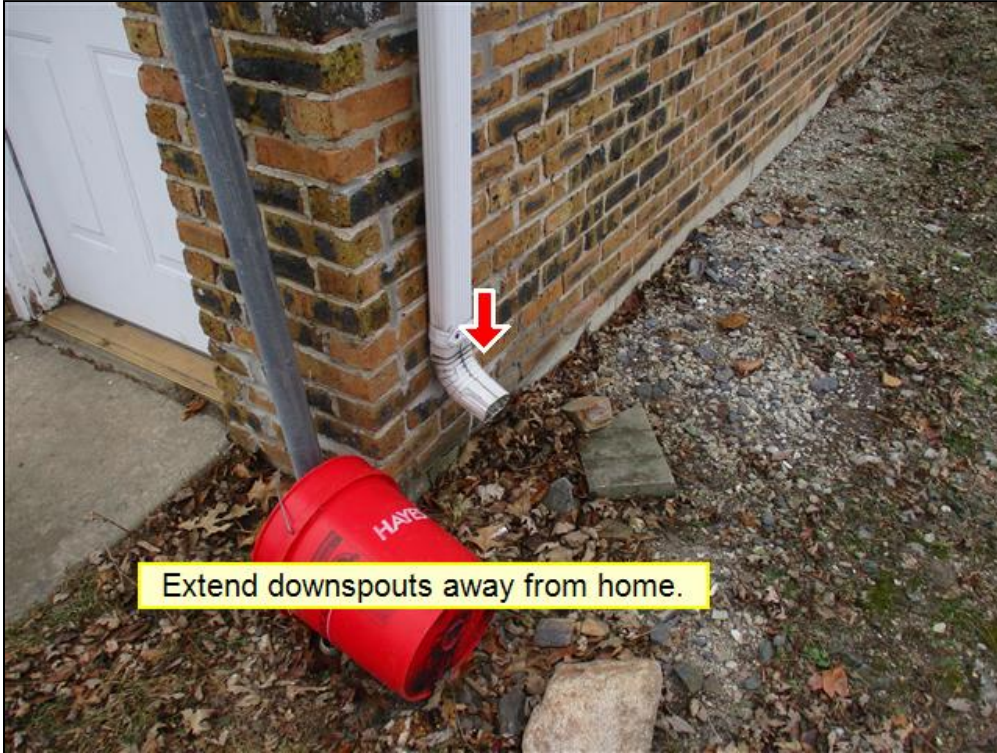
1.3 Item 2(Picture)

🏠 (2) The downspouts should be extended 6'-8' away from the home. This will prevent damage to the foundation, and water from entering the lower levels of the home. Contact a landscaping contractor to extend all downspouts away from home.

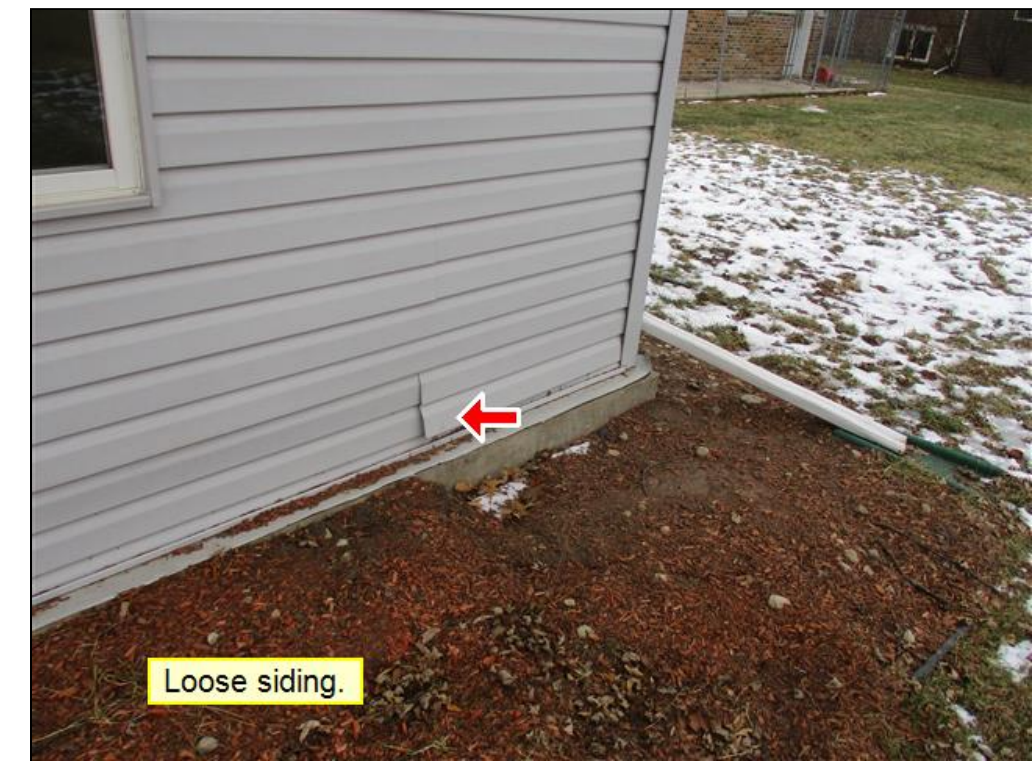
2.0 Item 1(Picture)

**2.0** There is a section of loose siding on the rear of the home. If not properly secured, further damage may occur. Contact a qualified contractor to properly secure the siding.

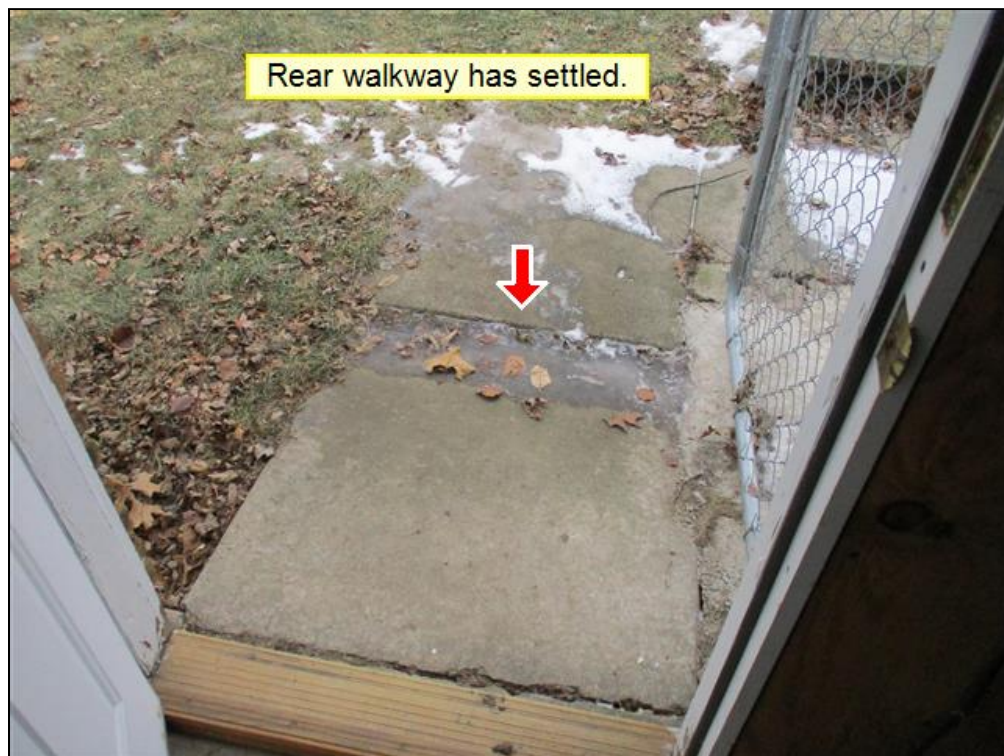
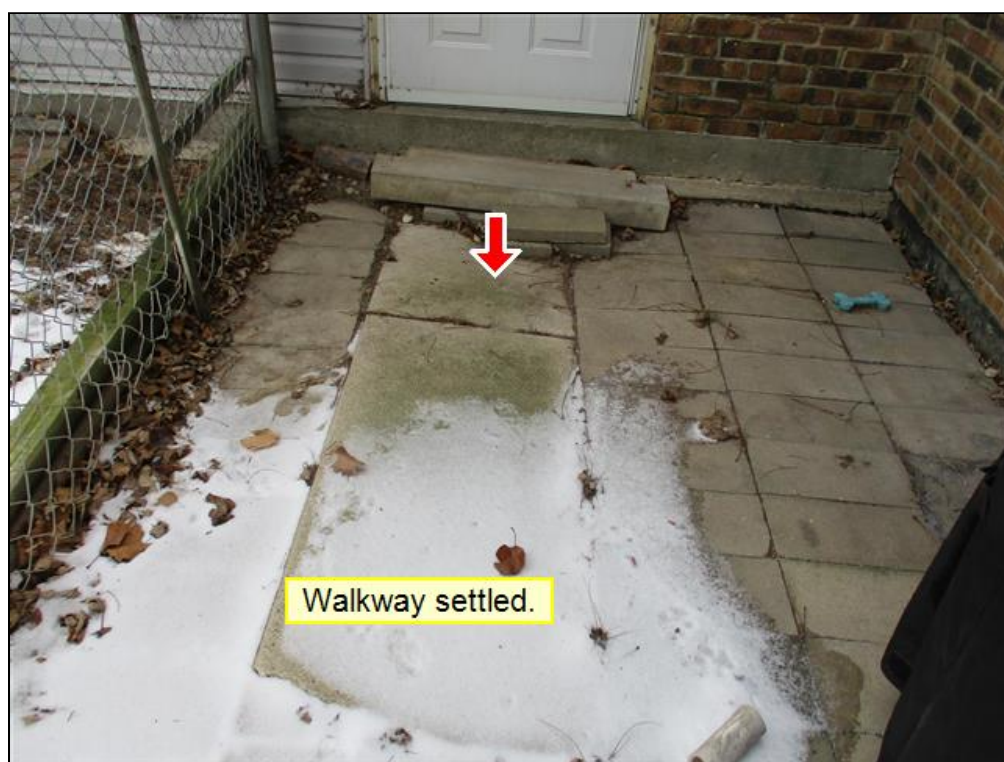
2.1 Item 1(Picture)

🏠 2.1 (1) There are sections of the rear walkway that have settled or lifted. This has caused a tripping hazard. If not repaired, injury to occupants may occur. Contact a concrete company to repair or replace the damaged sections of walkway.

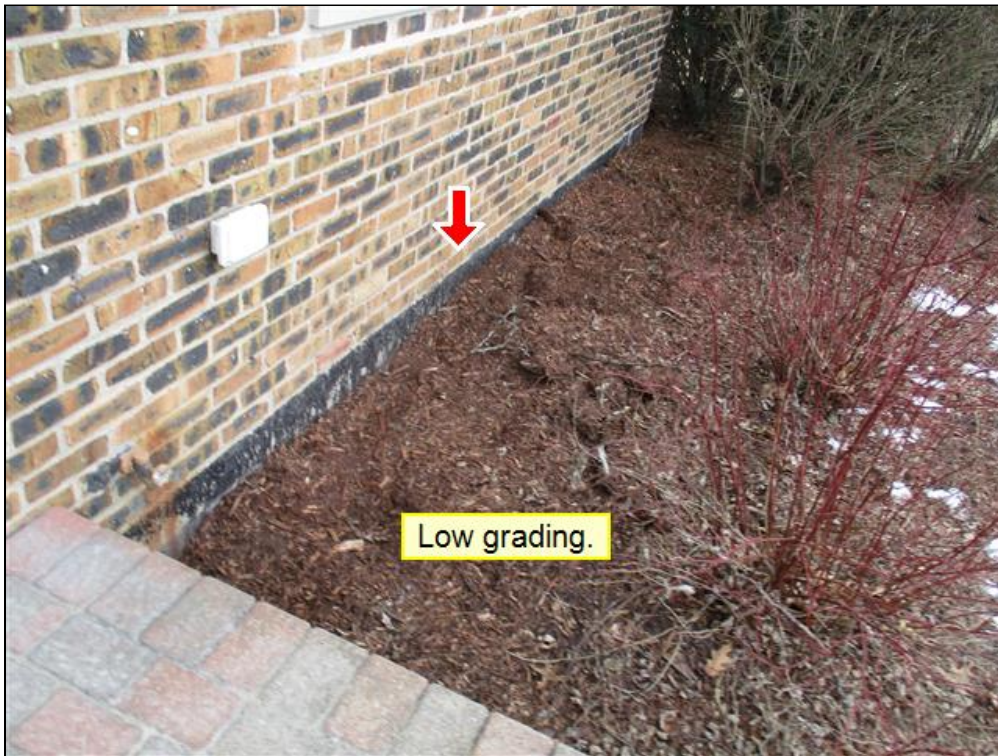
2.1 Item 3(Picture)

🏠 (2) The grading is low on the front and sides of the home. Low grading causes water to flow toward the home. The water can cause damage to the foundation or enter the crawl space. To correct the low grading, a landscaping company should be contacted to build up all low areas around the home.

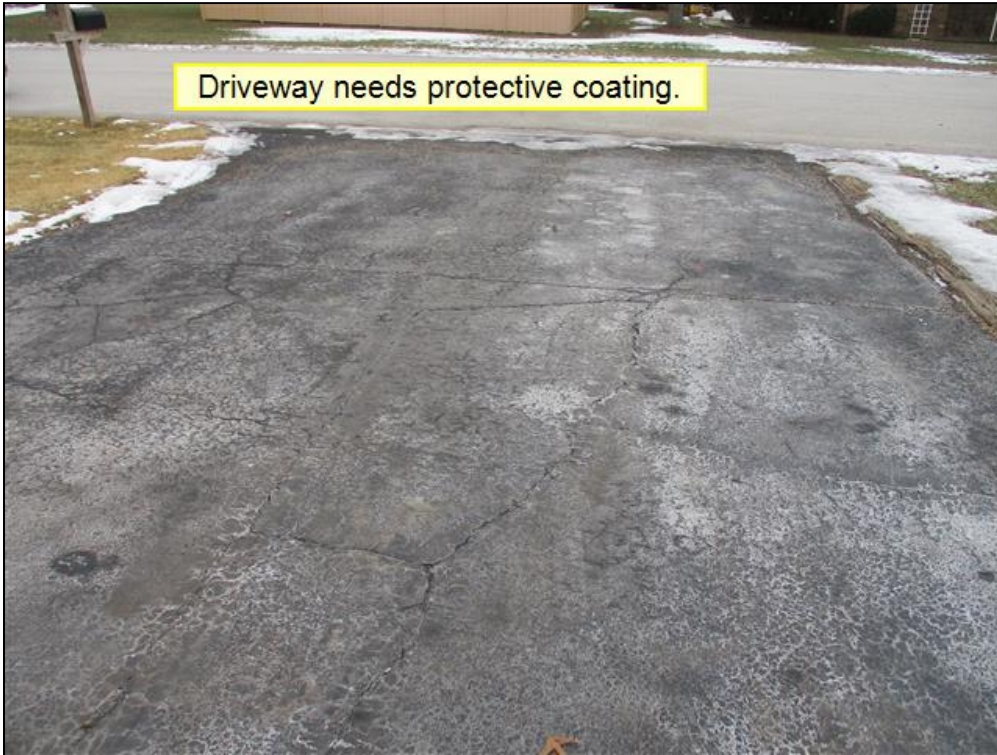
2.1 Item 4(Picture)

🏠 (3) The driveway is made of asphalt. Asphalt driveways should have a protective coating applied annually. I recommend applying a new protective coating to the driveway.

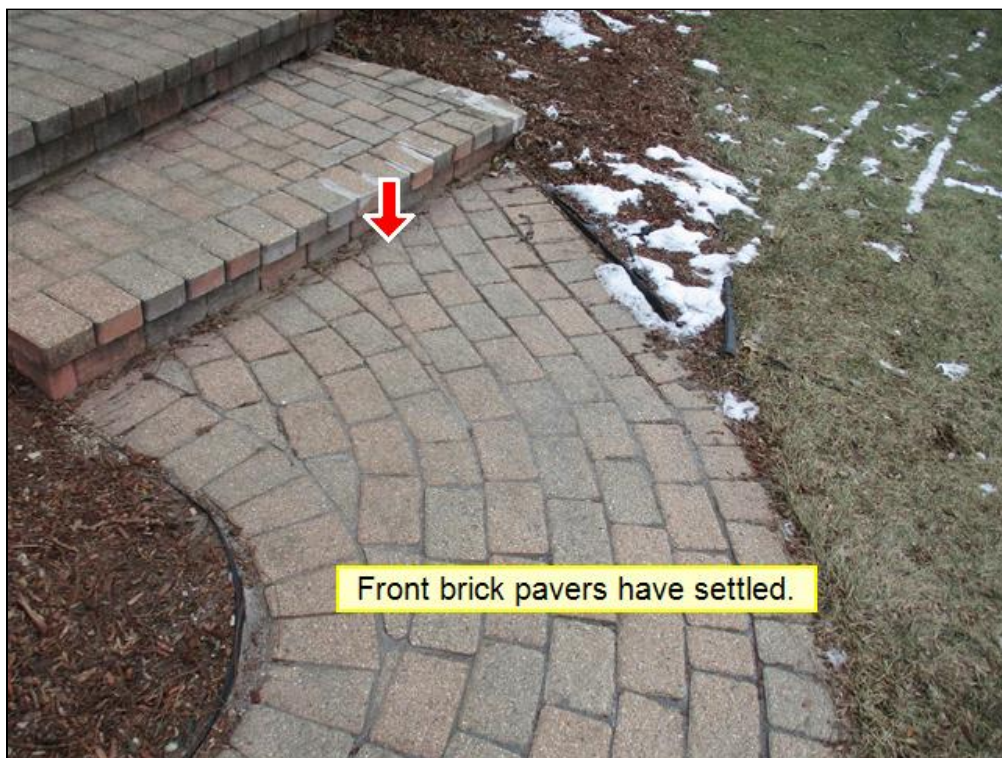
2.1 Item 5(Picture)

🏠 (4) The brick paver walkway needs repair. Brick pavers need periodic repair and maintenance to prevent damage. The algae must be removed from the joints, the brick power washed, new sand applied, and a new protective coating applied. Contact a landscaping company to perform this repair.

These pavers have also settled. They will need to be removed and reset.

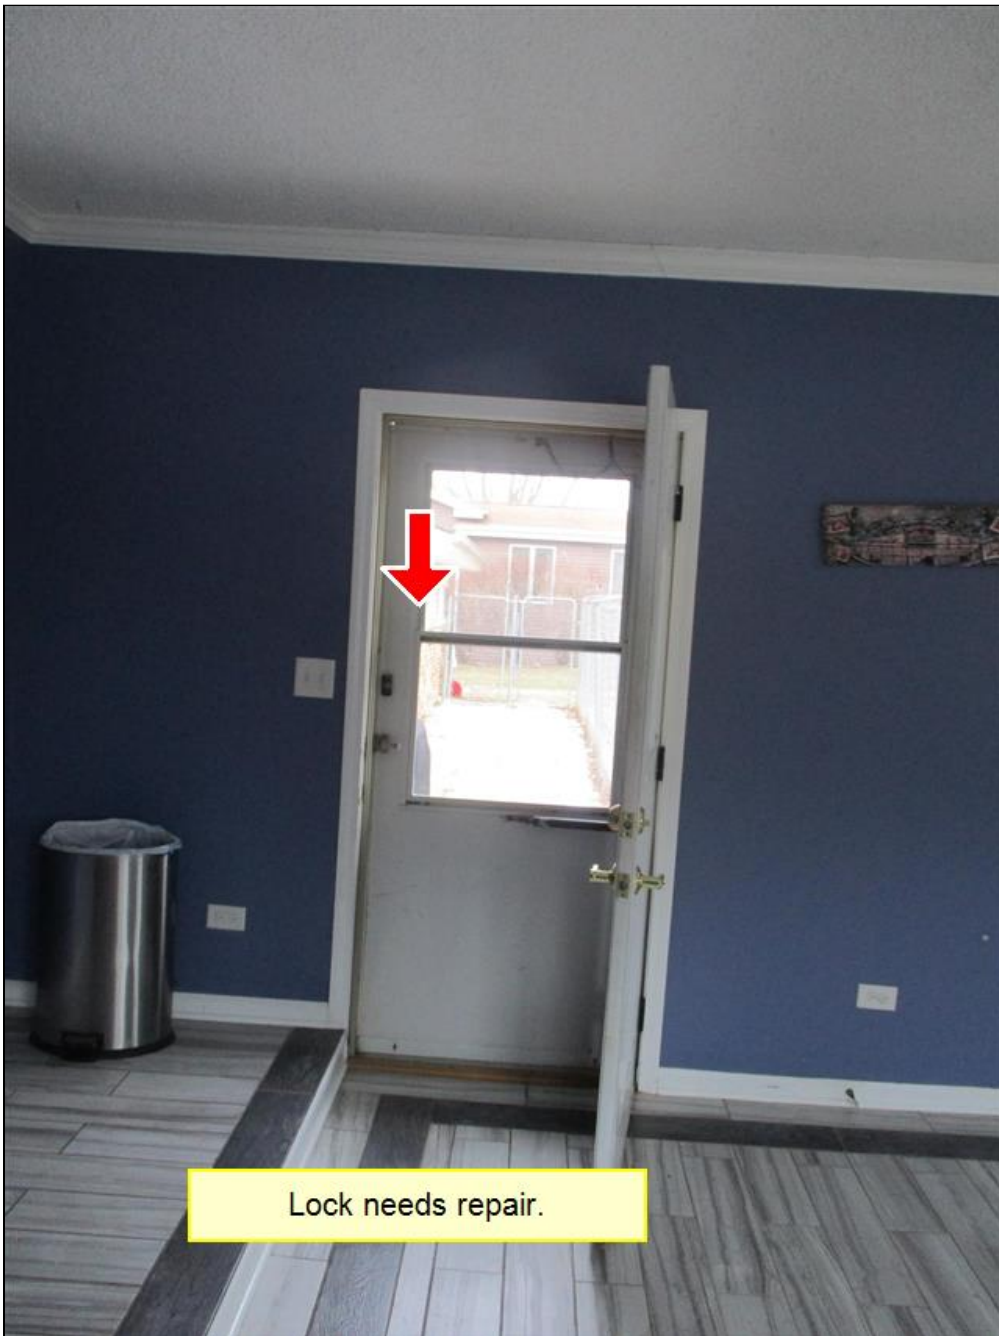
2.2 Item 1(Picture)

🏠 2.2 (1) The lock does not function on the rear storm door. Contact a qualified contractor to repair or replace the lock

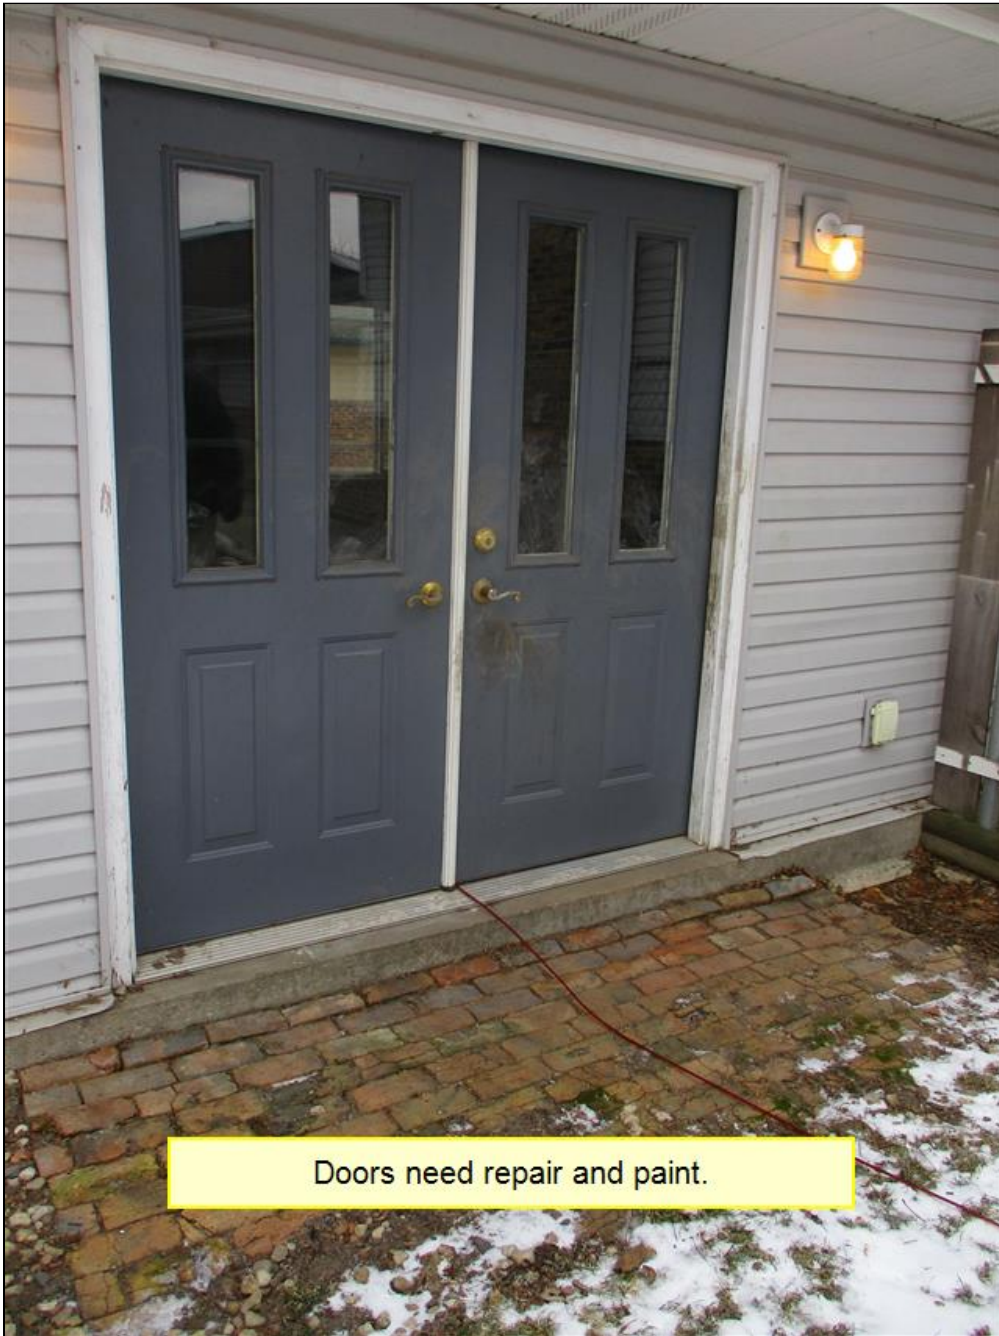
2.2 Item 2(Picture)

- 🏠 (2) The three seasons room double doors are severely worn. Contact a painting contractor to repair and paint.

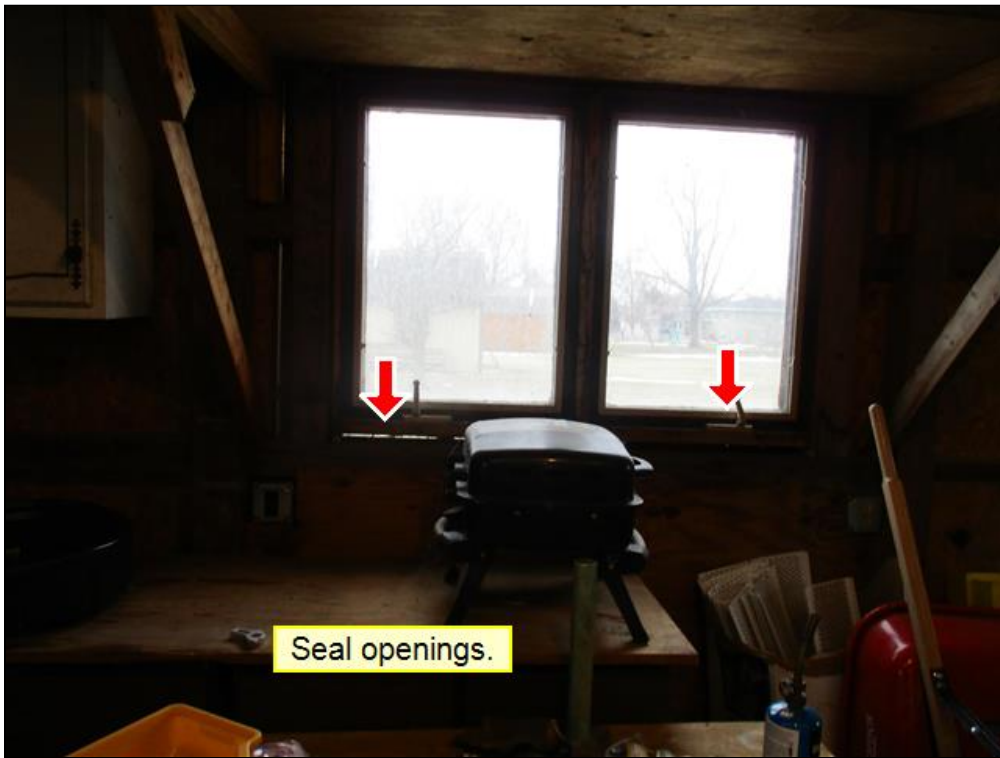
2.3 Item 1(Picture)

🏠 2.3 There are gaps under the shed windows. Contact a qualified contractor to seal all openings.
