Inspection Report

Sample Report

Assure Home Inspection

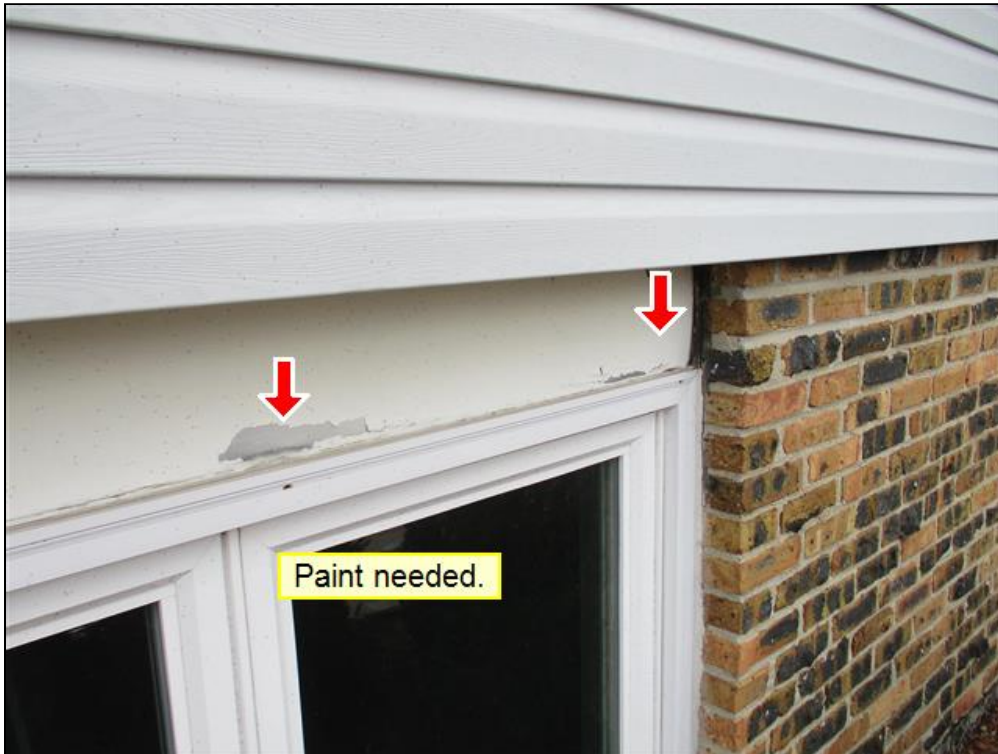
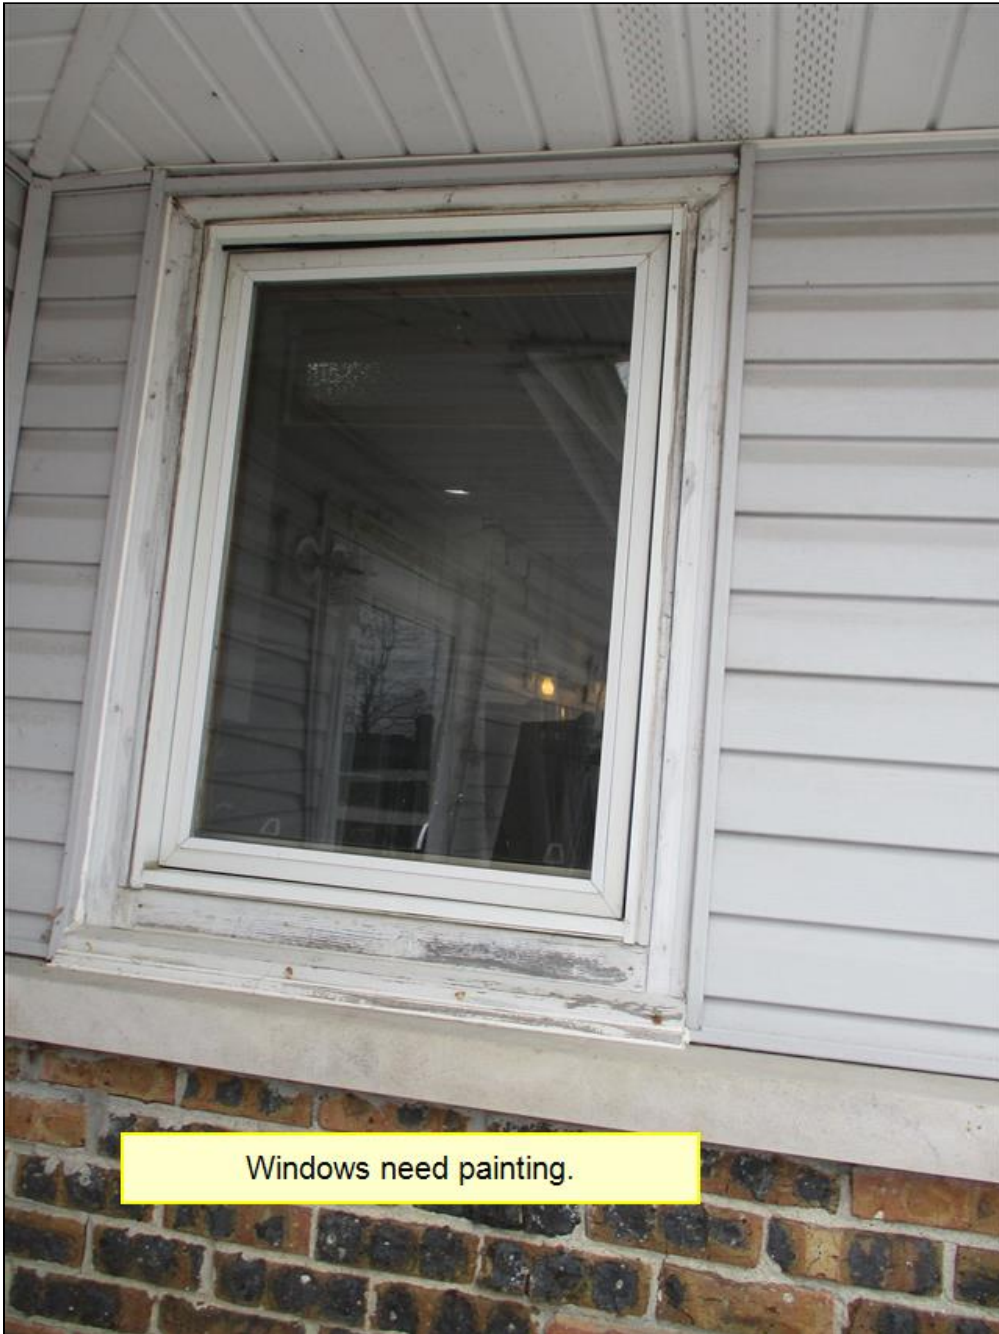
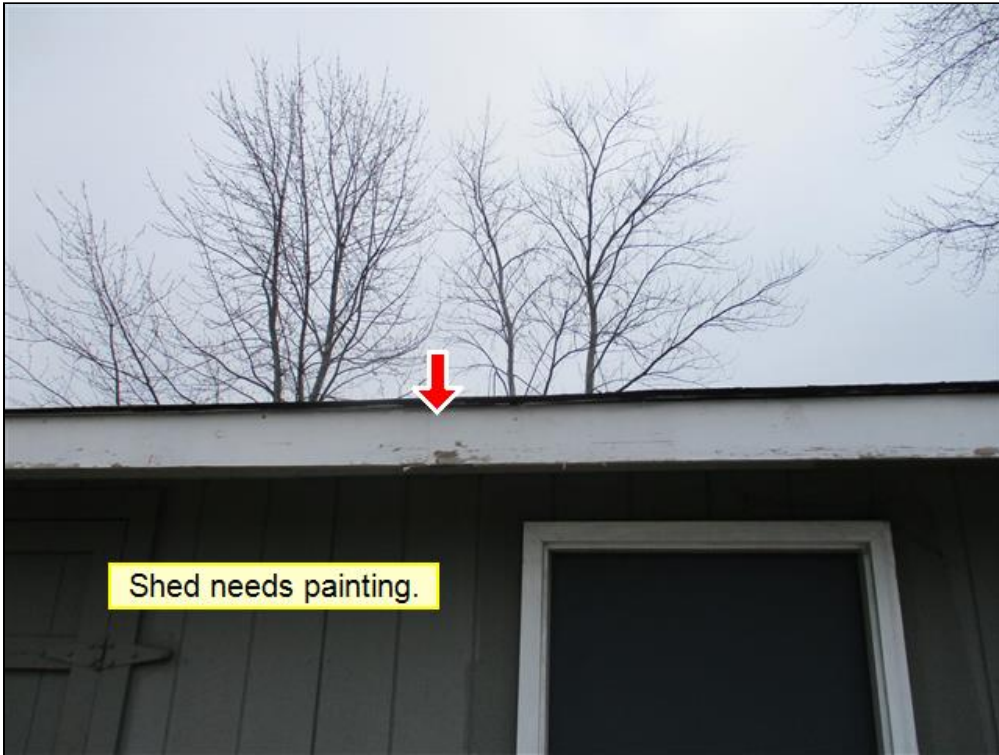
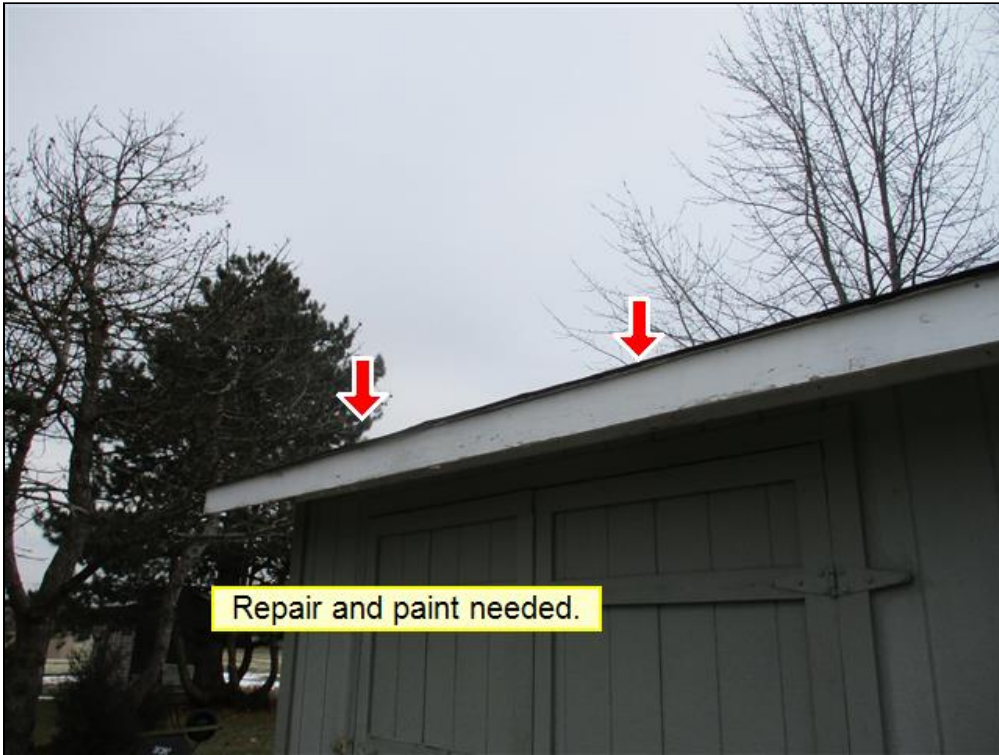
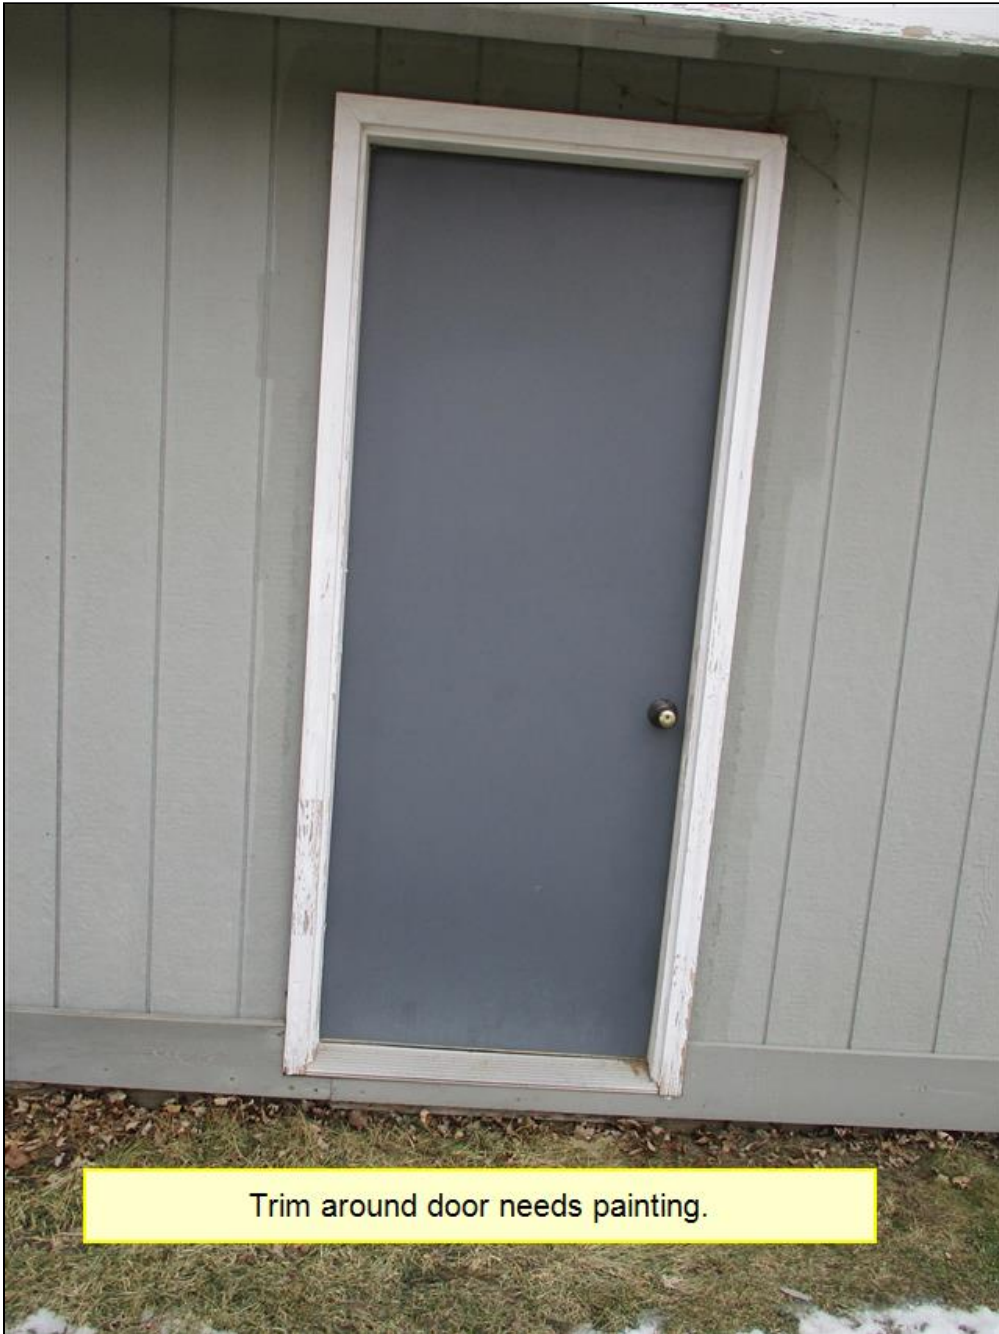
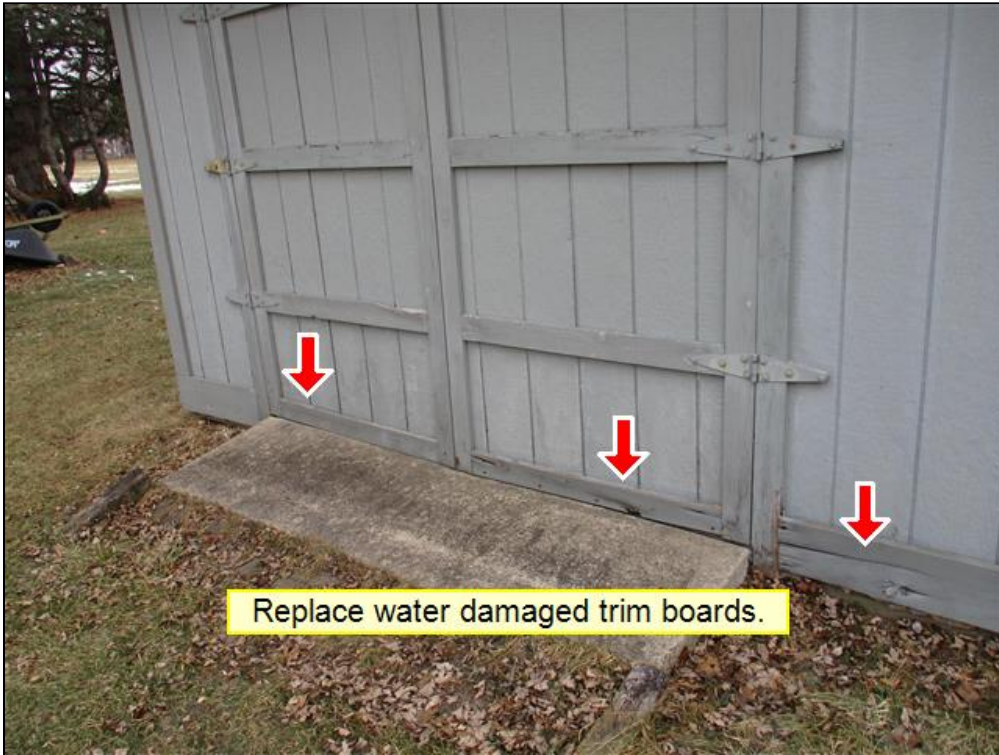
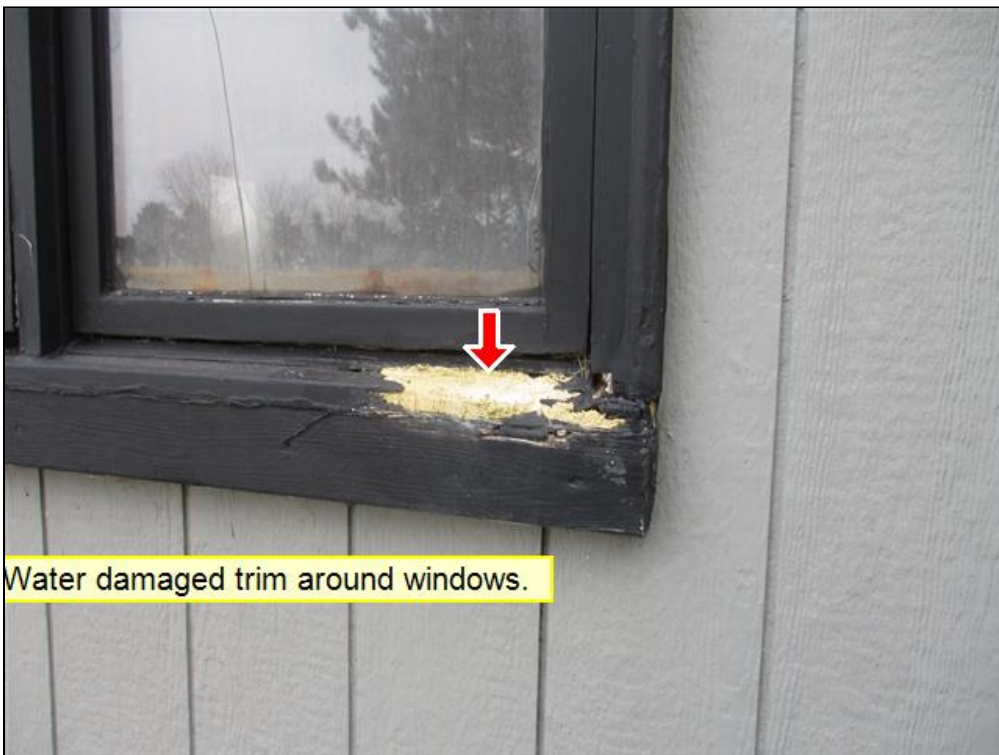
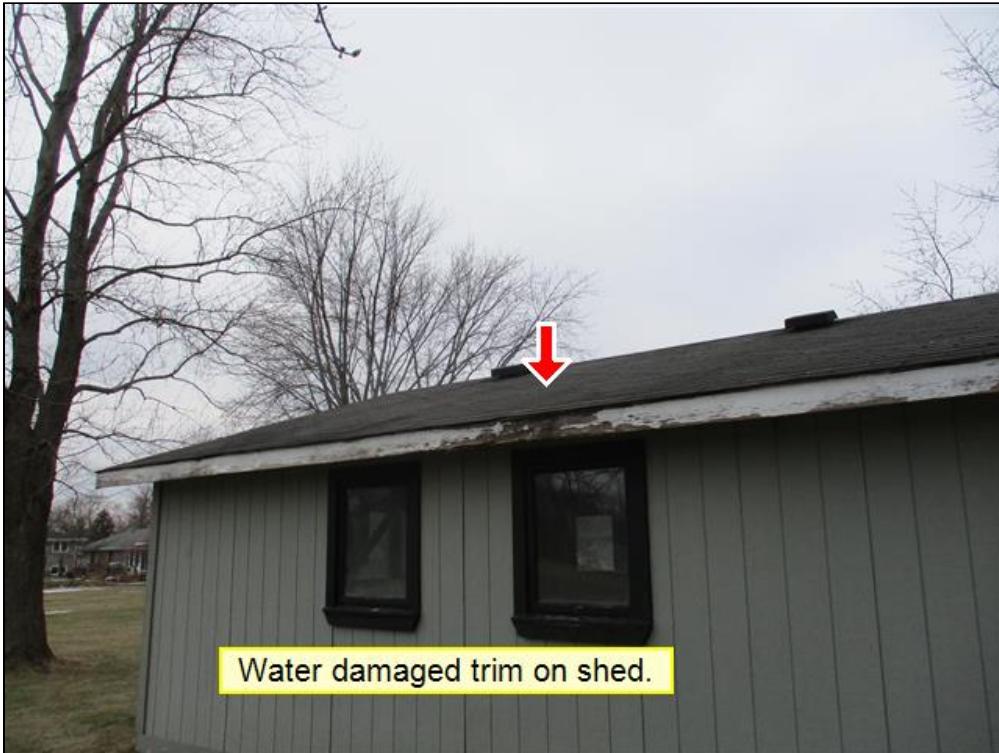
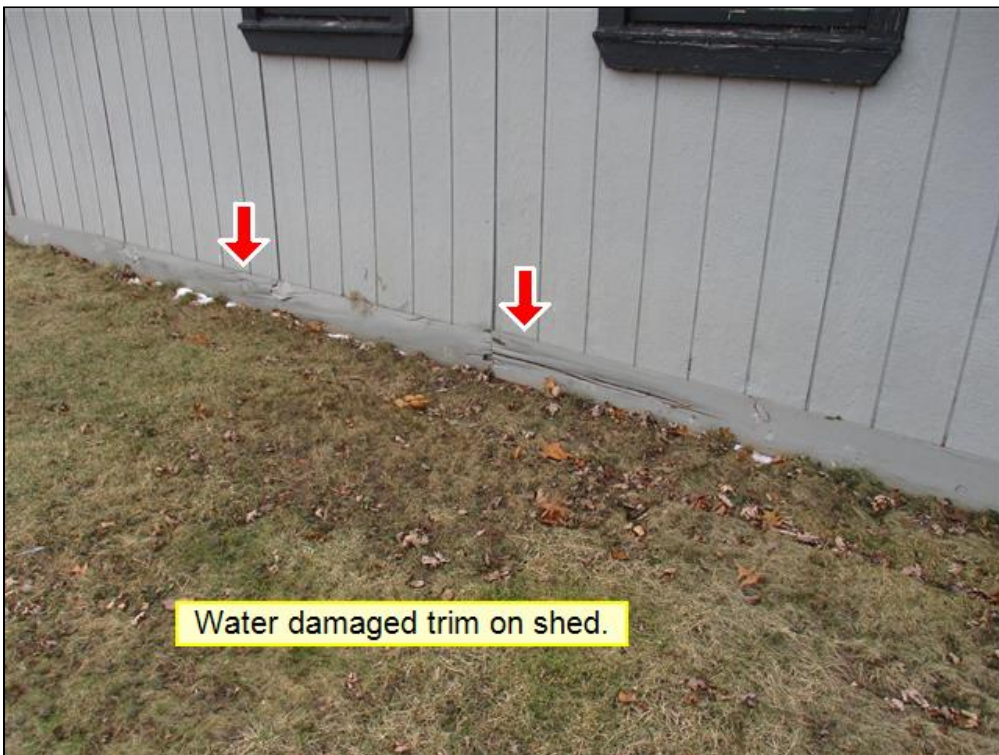
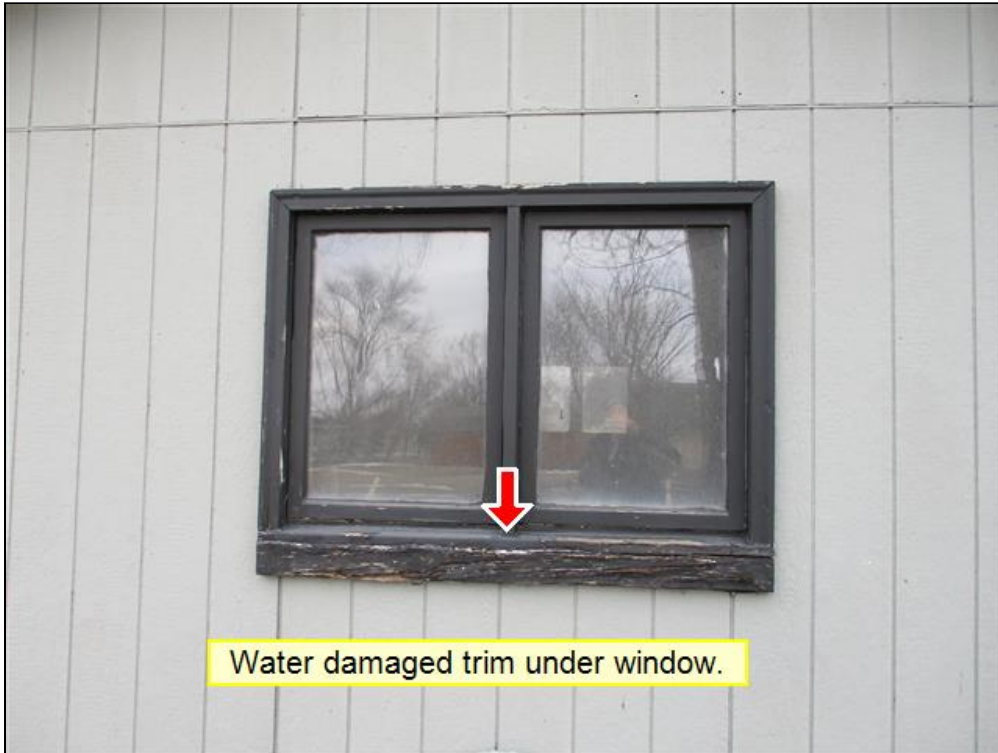
**2.5** There is peeling paint and water damaged trim, fascia, and soffits, on the exterior home and shed. If not repaired and painted, further damage will occur.

Contact a qualified contractor to repair, replace water damaged wood, and paint.

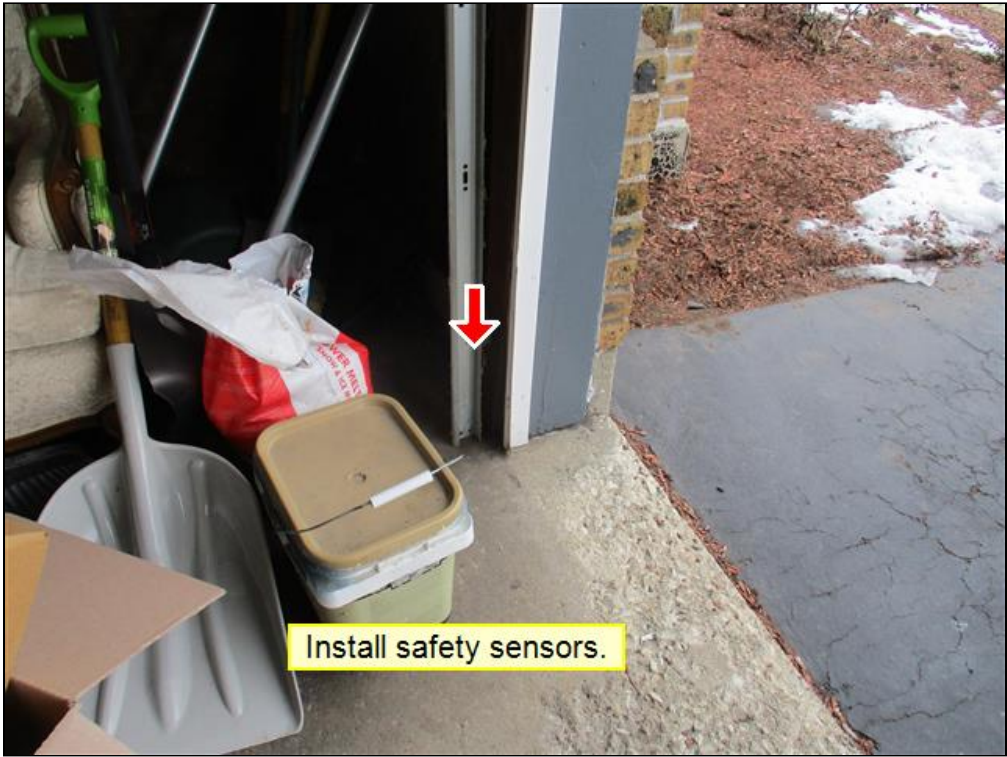
3.5 Item 1(Picture)

**3.5** The garage door opener is not equipped with safety sensors that prevent injury to occupants or animals. The sensors should be located on the lower portion of the garage door, and are designed to reverse the direction of the door if someone is beneath. This is a safety code enforced by municipalities. Contact a qualified person to install safety sensors on the garage door.

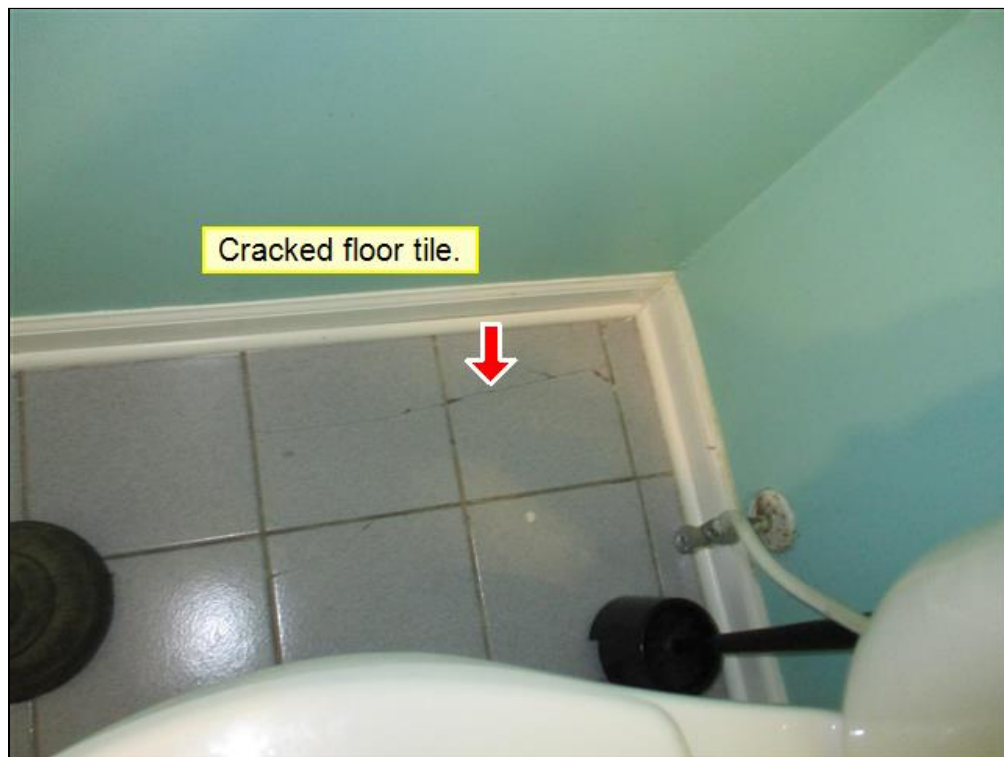
4.2 Item 1(Picture)

**4.2** There are several upper bathroom floor tiles that are cracked, and several kitchen floor tiles with holes. Contact a flooring contractor to replace all damaged floor tile.

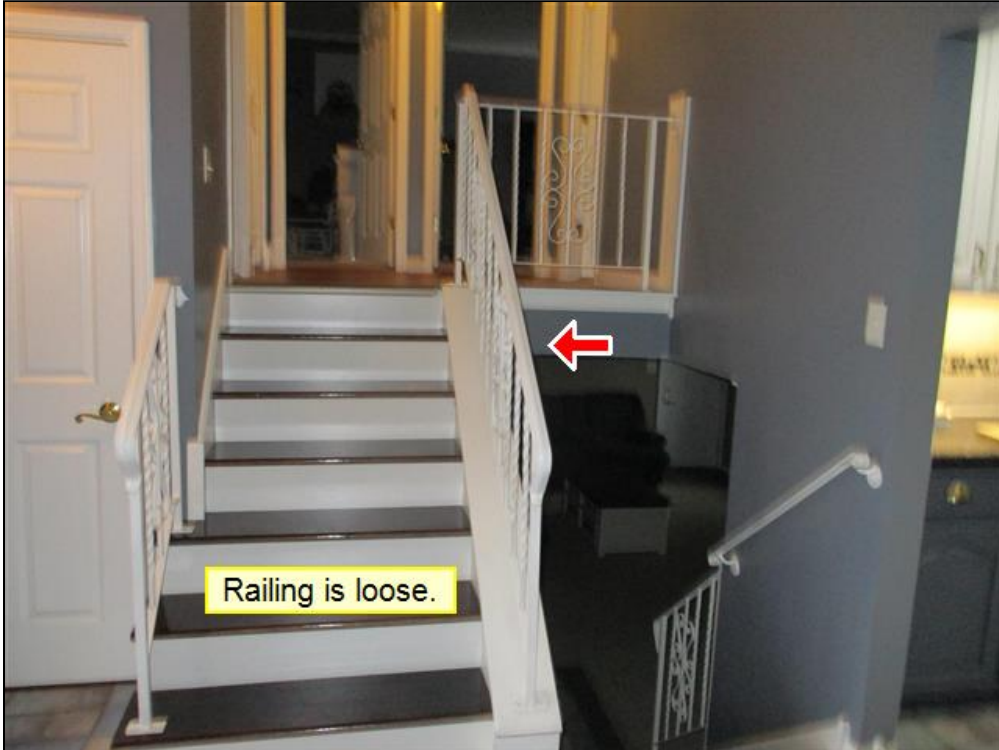
4.3 Item 1(Picture)

**4.3** The upper level hand railing is slightly loose. If not properly secured, further damage will occur. Contact a qualified contractor to properly secure the railing.

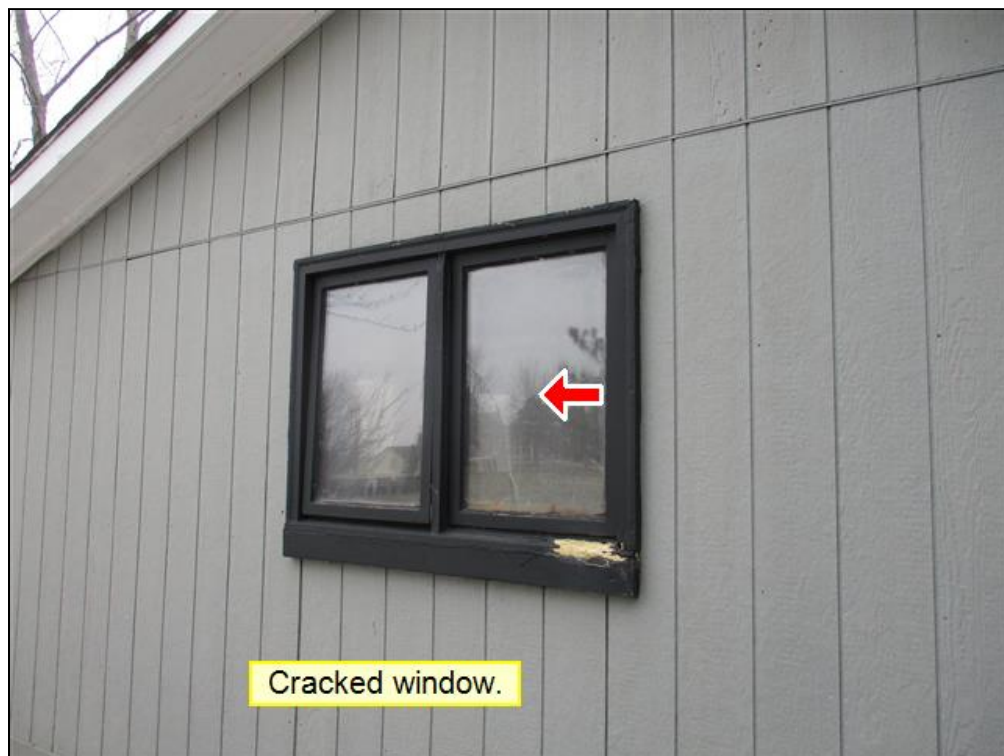
4.4 Item 1(Picture)

4.4 There were two cracked windows on the shed. Cracked windows are a safety hazard because of the potential for injuries from the cracked glass. Contact a glass replacement company to replace the cracked windows.

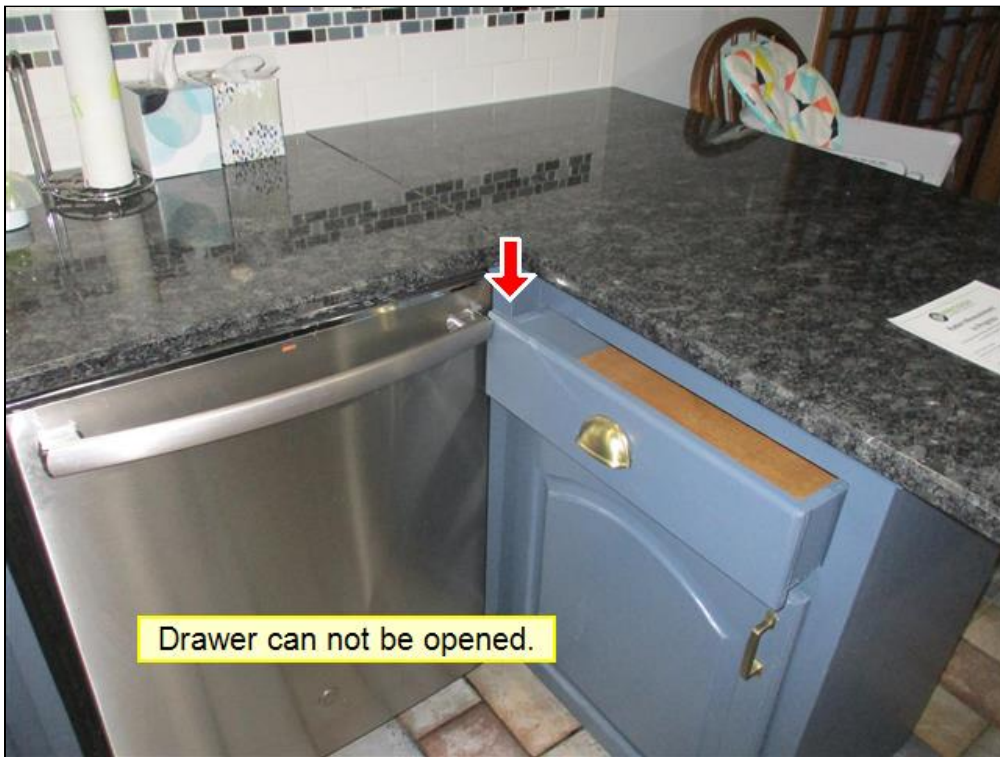
4.5 Item 1(Picture)

**4.5** There is one kitchen cabinet drawer that does not open. The drawer contacts the dishwasher upper handle. To correct this issue, the dishwasher may need to be replaced with one that has a recessed handle.

Contact a qualified contractor to make repairs needed so door can be utilized.

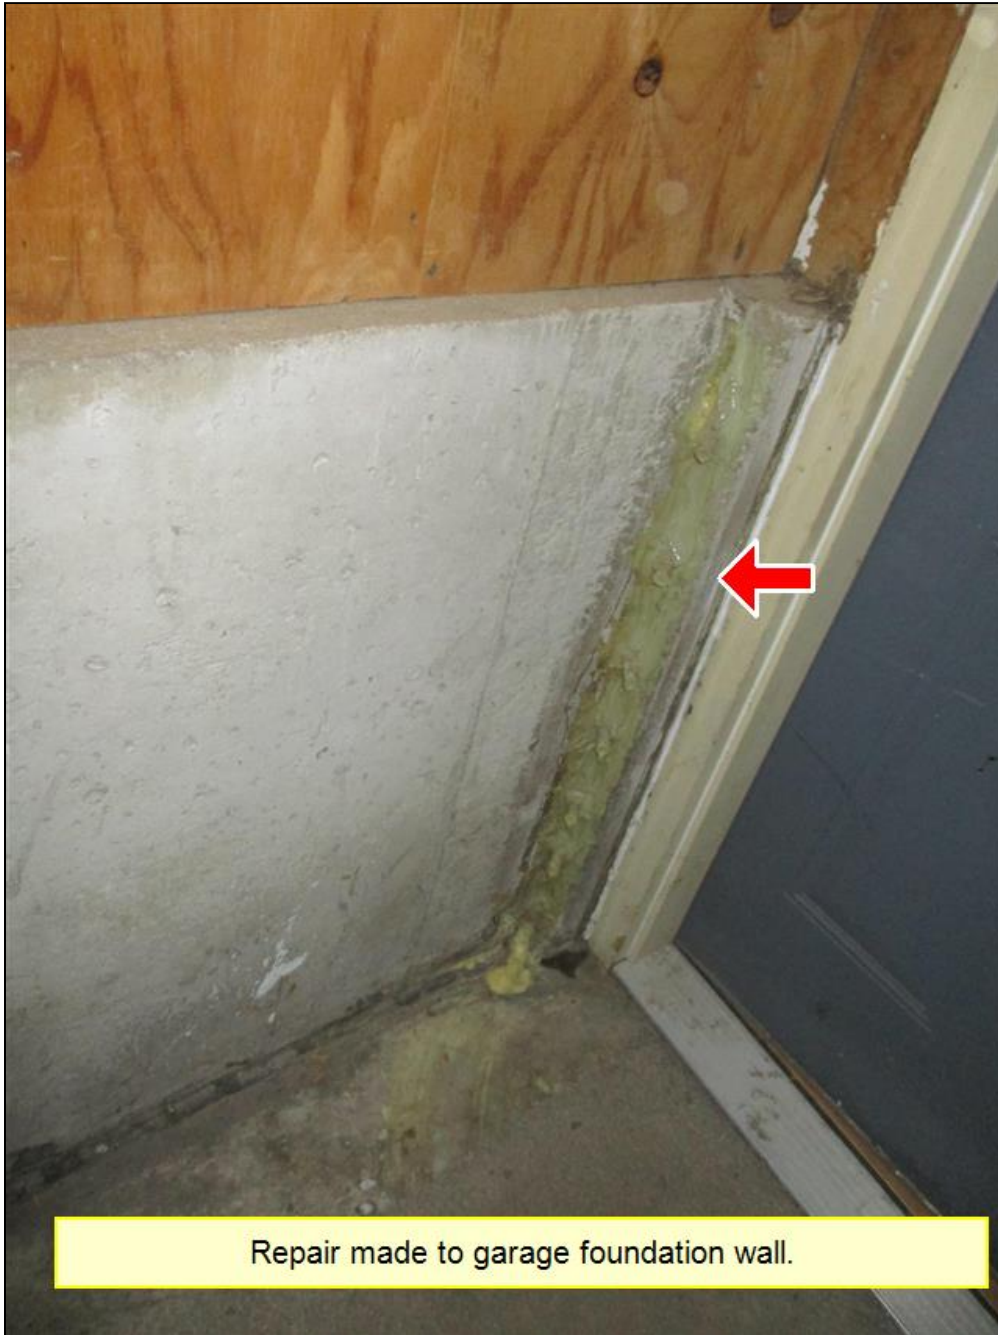
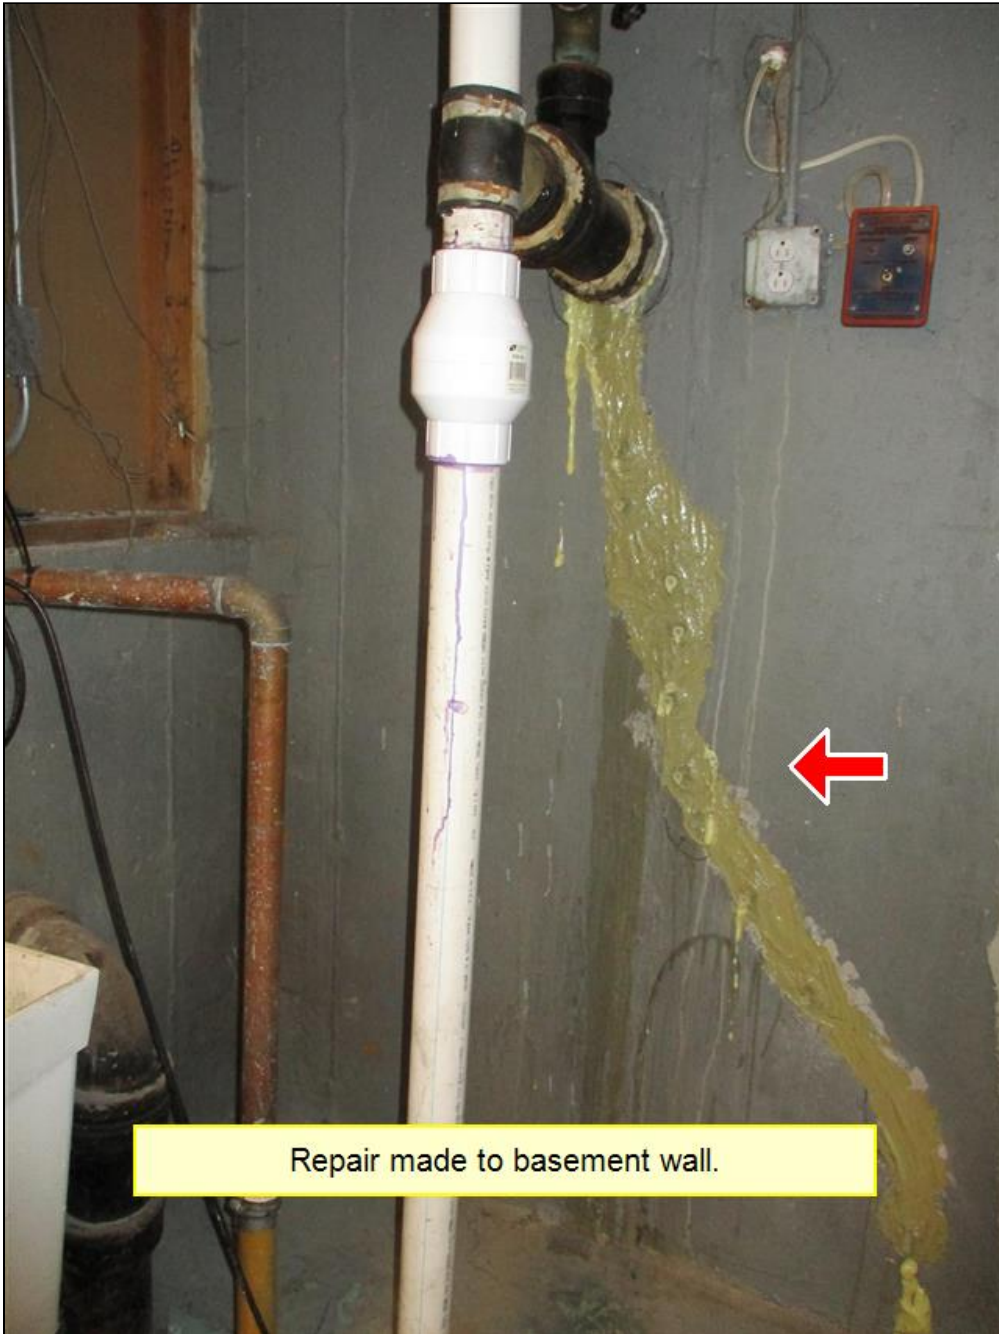
5.0 Item 1(Picture)

5.0 (1) There were repairs made on the basement concrete walls. These repairs are common and not a problem, but I recommend asking owner for any warranties that may be transferable.

Repair made to garage foundation wall.

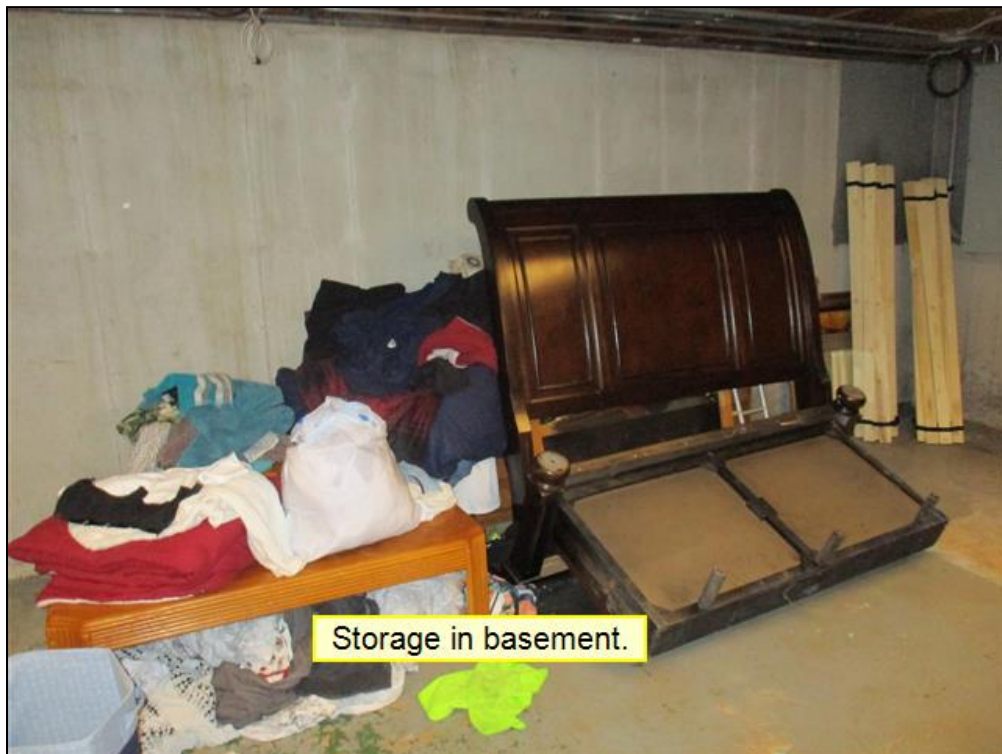
5.0 Item 3(Picture)

(2) There was a lot of storage in the basement. This makes it impossible for me to view all walls, floors, etc. I recommend checking the basement when you do your final walk through inspection.

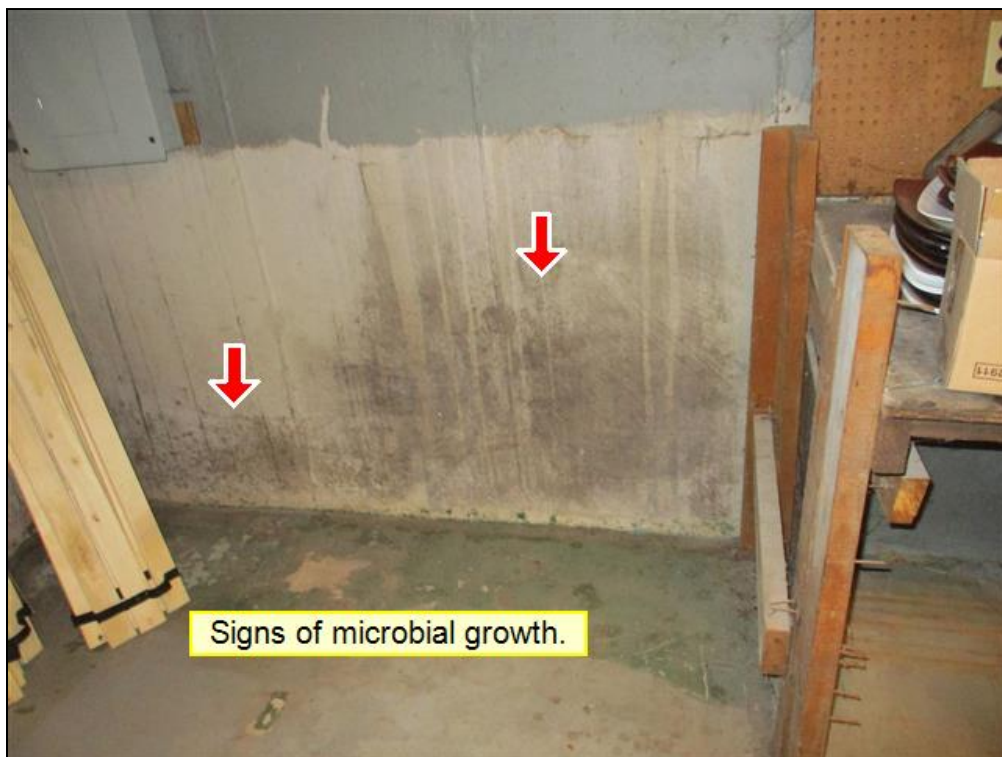
5.0 Item 4(Picture)

🏠 (3) There are strong signs of microbial growth on concrete walls in the basement. The microbial growth developed because of the damp atmosphere in the basement. Contact a mold professional to test or remove the growth.

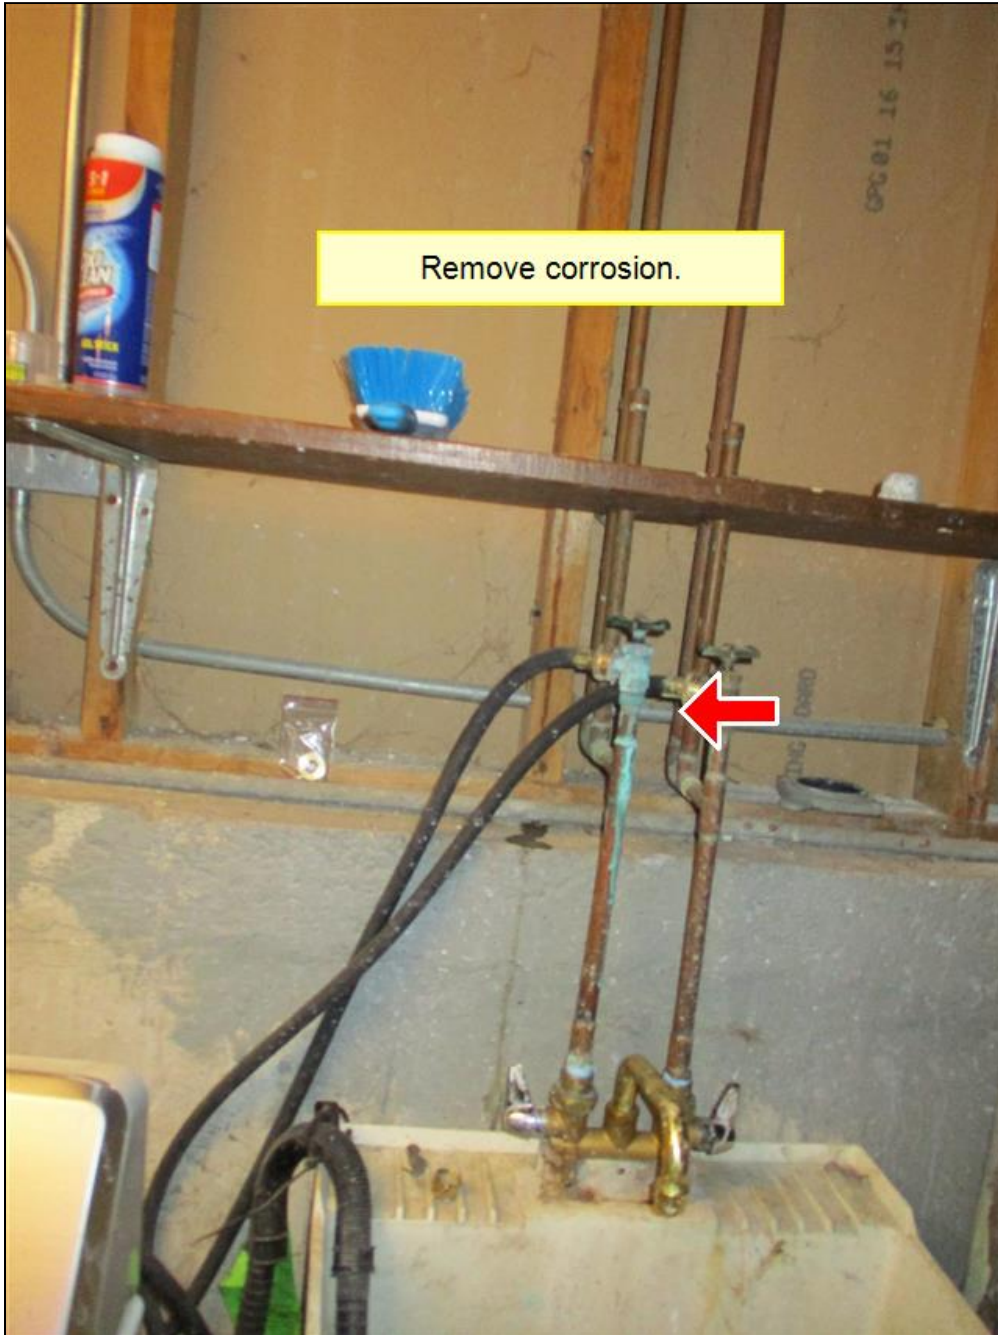
6.0 Item 1(Picture)

**6.0** (1) There are sections of the water piping that are corroded. If the corrosion is not removed, leaking may develop. Remove all corrosion from water piping. This can be done with a wire brush or emery cloth.

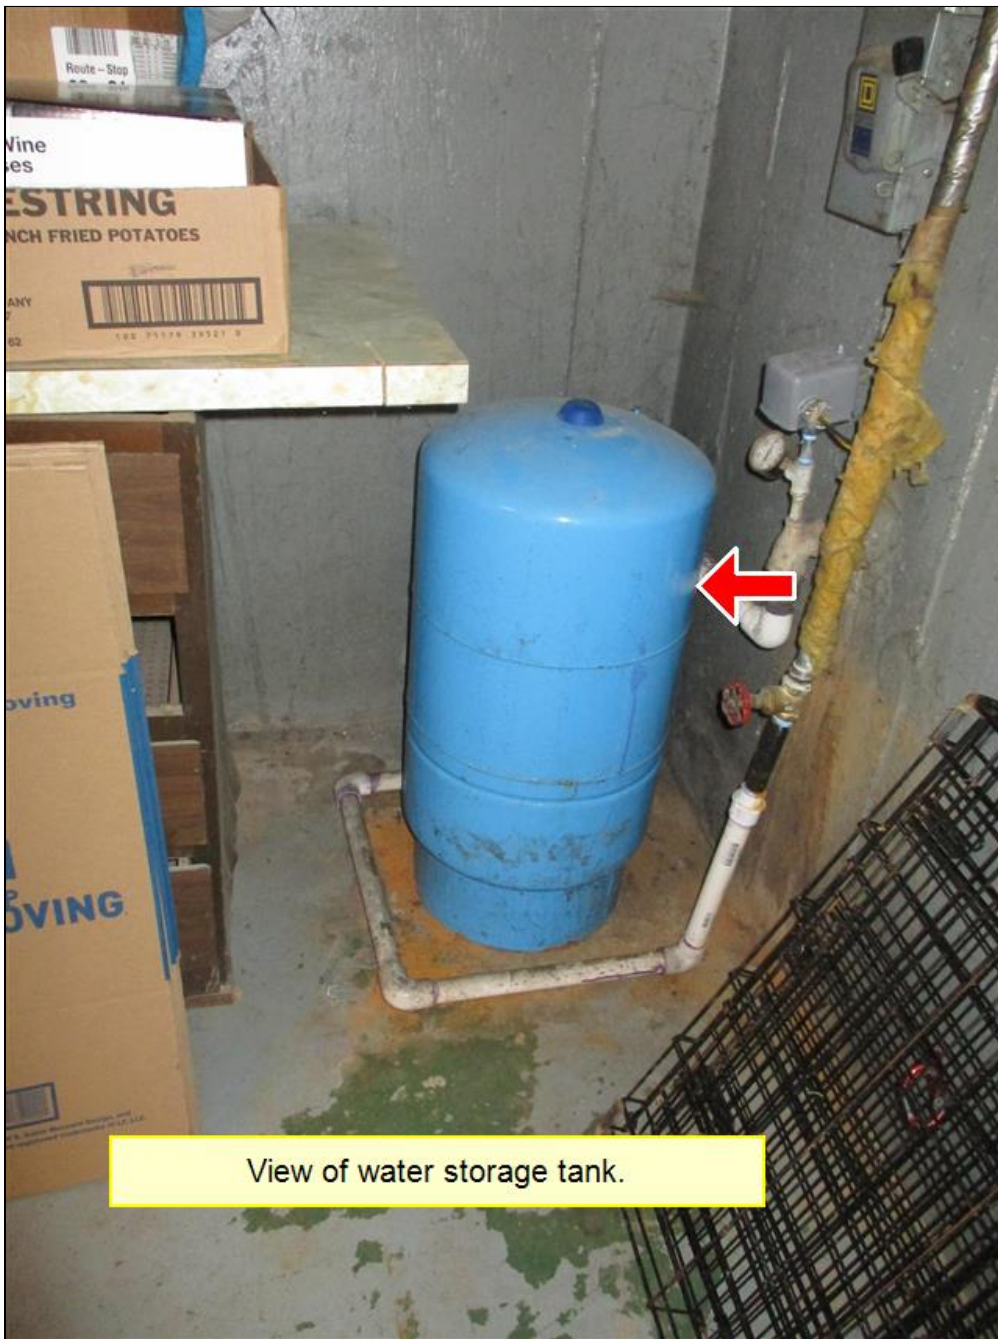
6.0 Item 3(Picture)

(2) The home is equipped with a private well and waste disposal system. It is necessary to have the well and waste system inspected for proper operation. Normally this cost is incurred by the seller. If seller is not paying for the inspection, I highly recommend having the systems inspected. Contact a well and septic inspection company to properly check condition of well and waste disposal system.

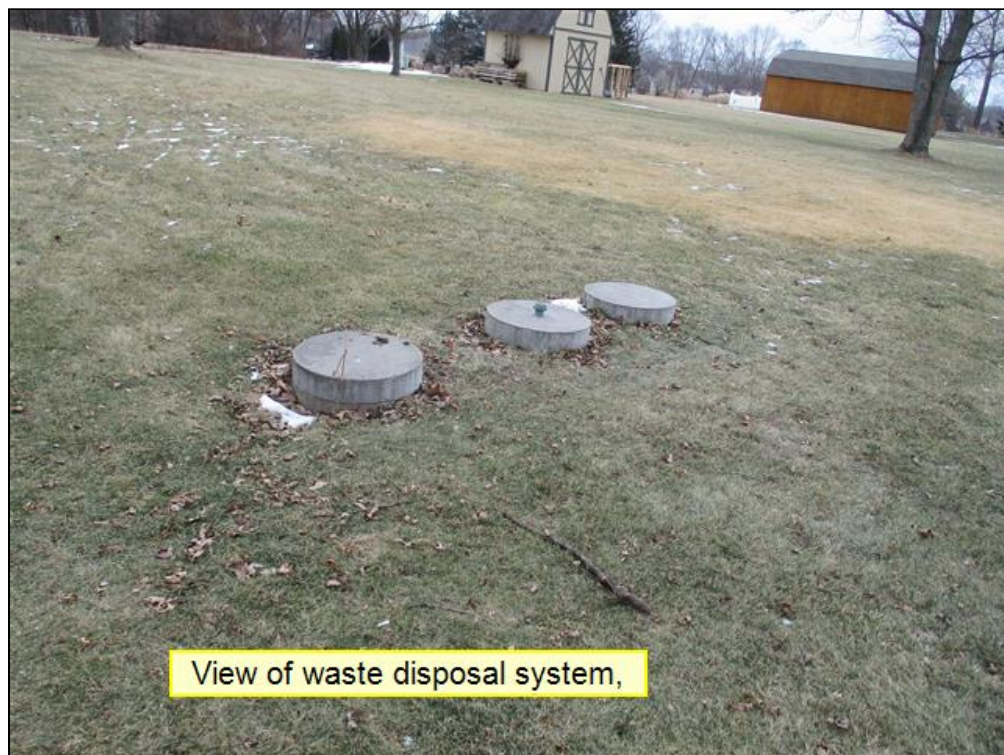
6.0 Item 4(Picture)

View of waste disposal system,

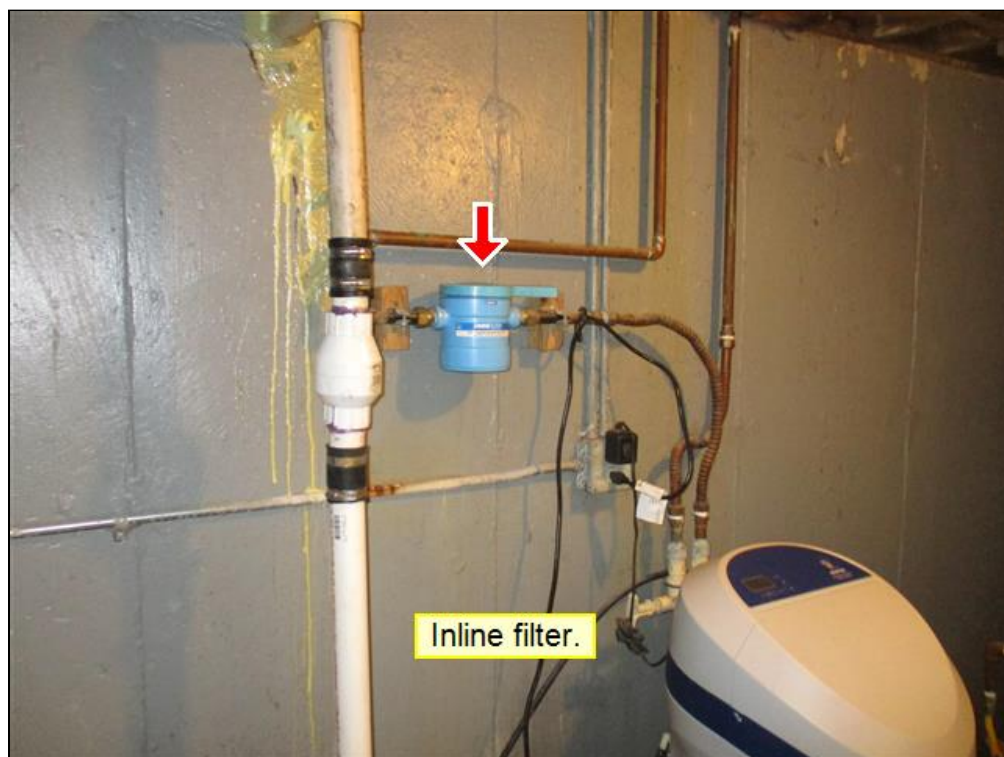
(3) The home is equipped with an in-line water filter. The filter is designed to remove particulate matter from the water. The filter will need to be changed periodically. If not changed, the water pressure will decrease in the home. I recommend asking the home owner how to operate and change filter.

Inline filter.

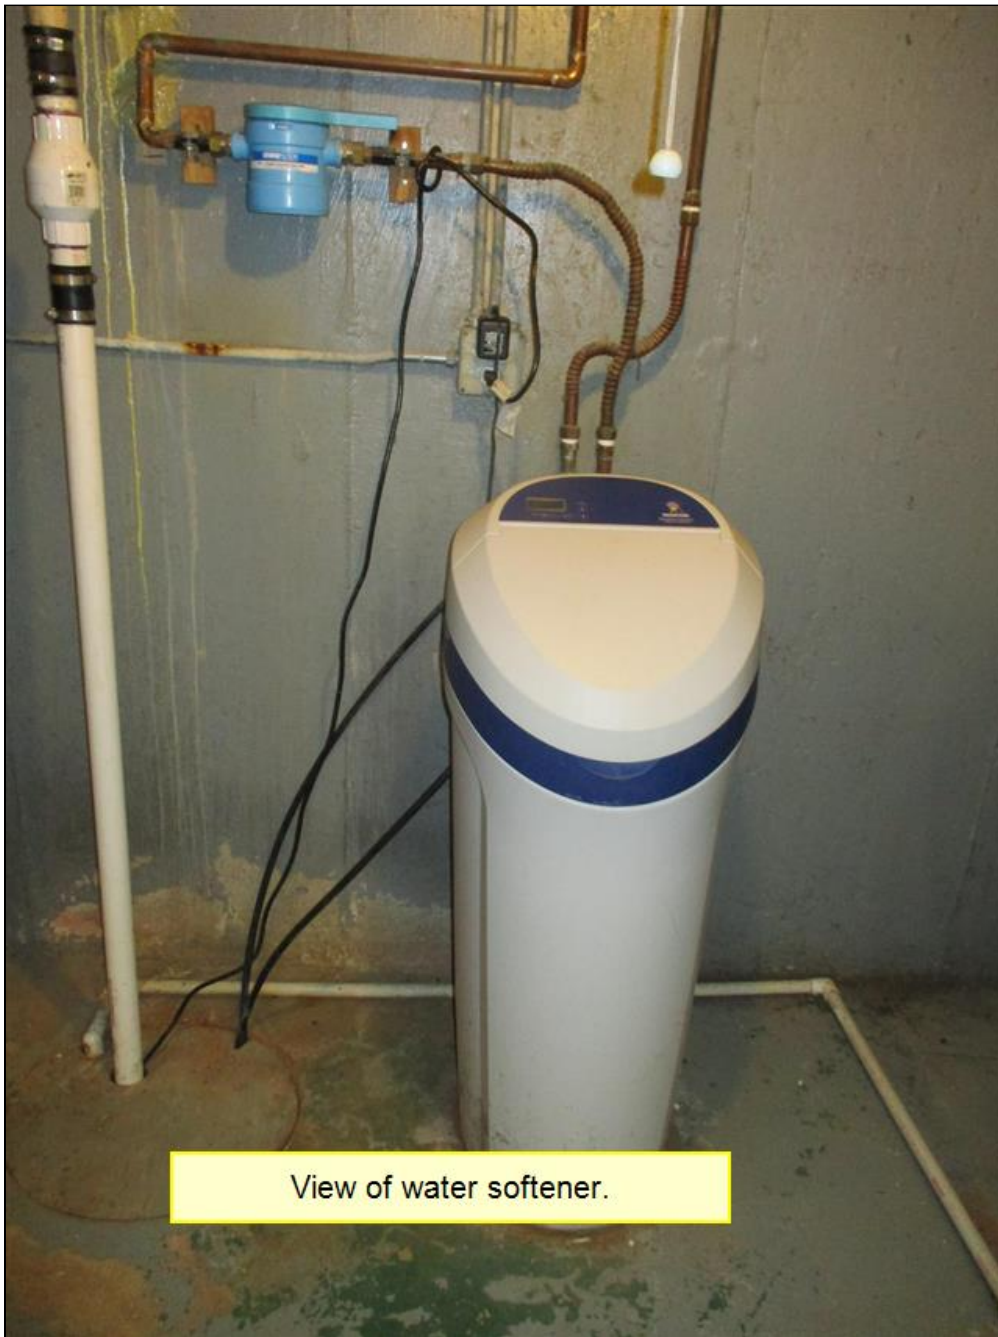
6.0 Item 6(Picture)

(4) The home is equipped with a water softener. The softener will need maintenance and salt added regularly. I recommend asking the current home owner to show you how to operate and maintain this equipment.

It is beyond the scope of a home inspection to test the operation of the softener. You will need to contract a water treatment company if you want to have it tested.
