Inspection Report

Sample Report

Assure Home Inspection

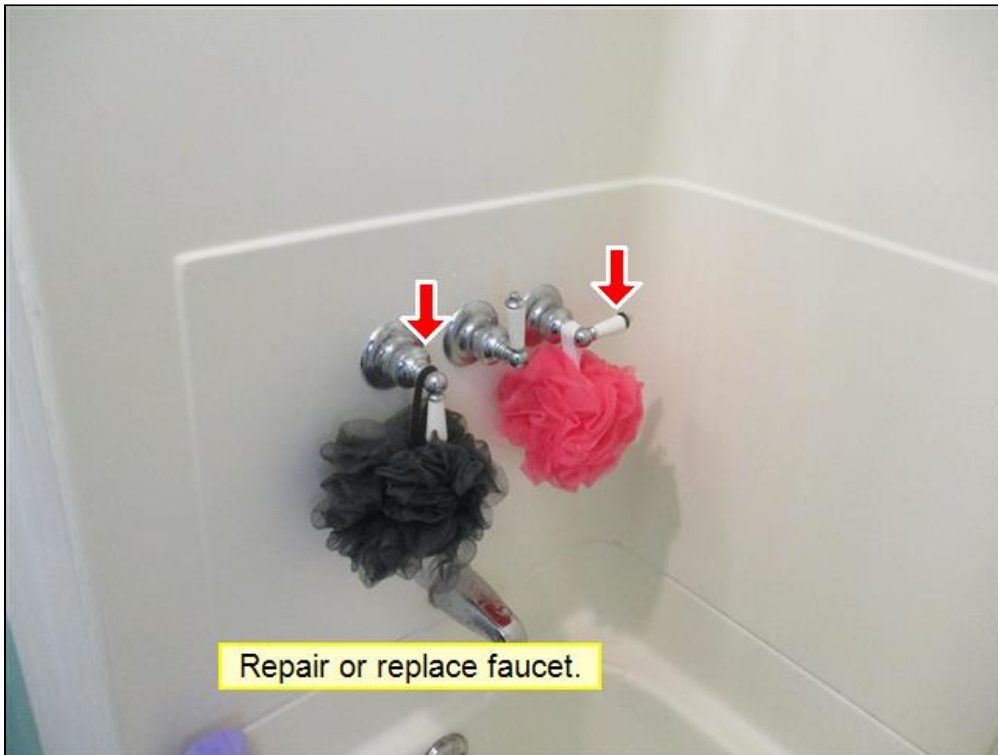
6.0 Item 7(Picture)

(5) The upper bathroom shower faucet is not properly installed. One of the faucet handles turns off when in the horizontal position and the other shuts the water off in the vertical position.

Contact a plumbing contractor to further evaluate and make repairs needed for proper operation.

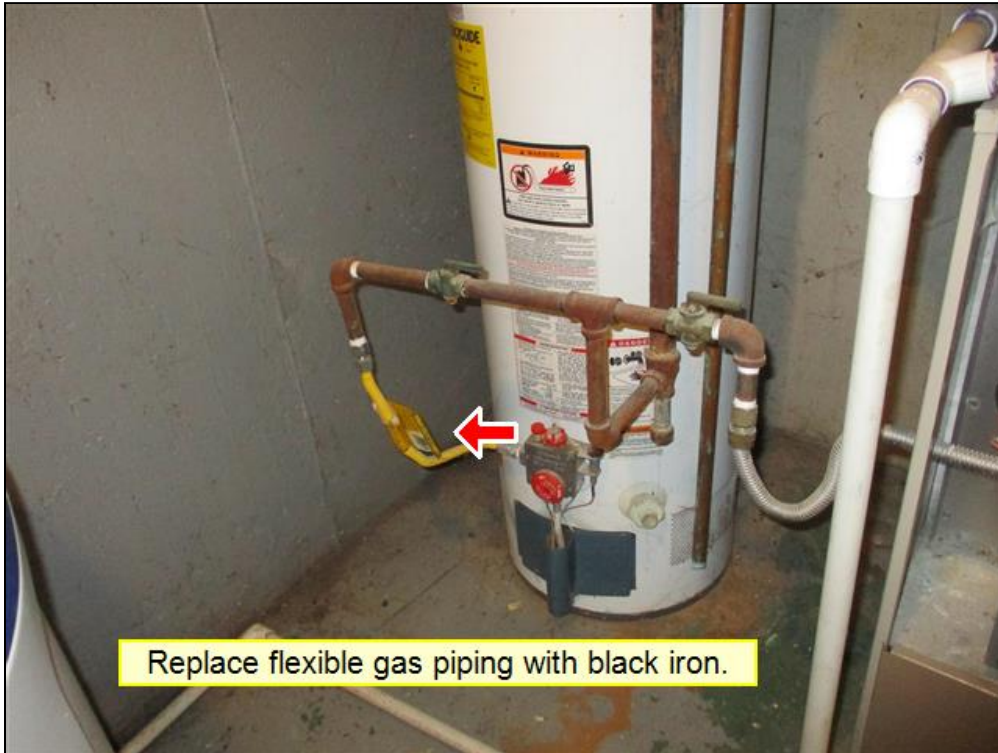
6.2 Item 1(Picture)

🏠 (3) The water heater gas piping is connected with flexible tubing. Modern standards require all gas piping to be made of black iron piping. This is a safety issue that must be corrected. Contact a plumbing contractor to install black iron piping.

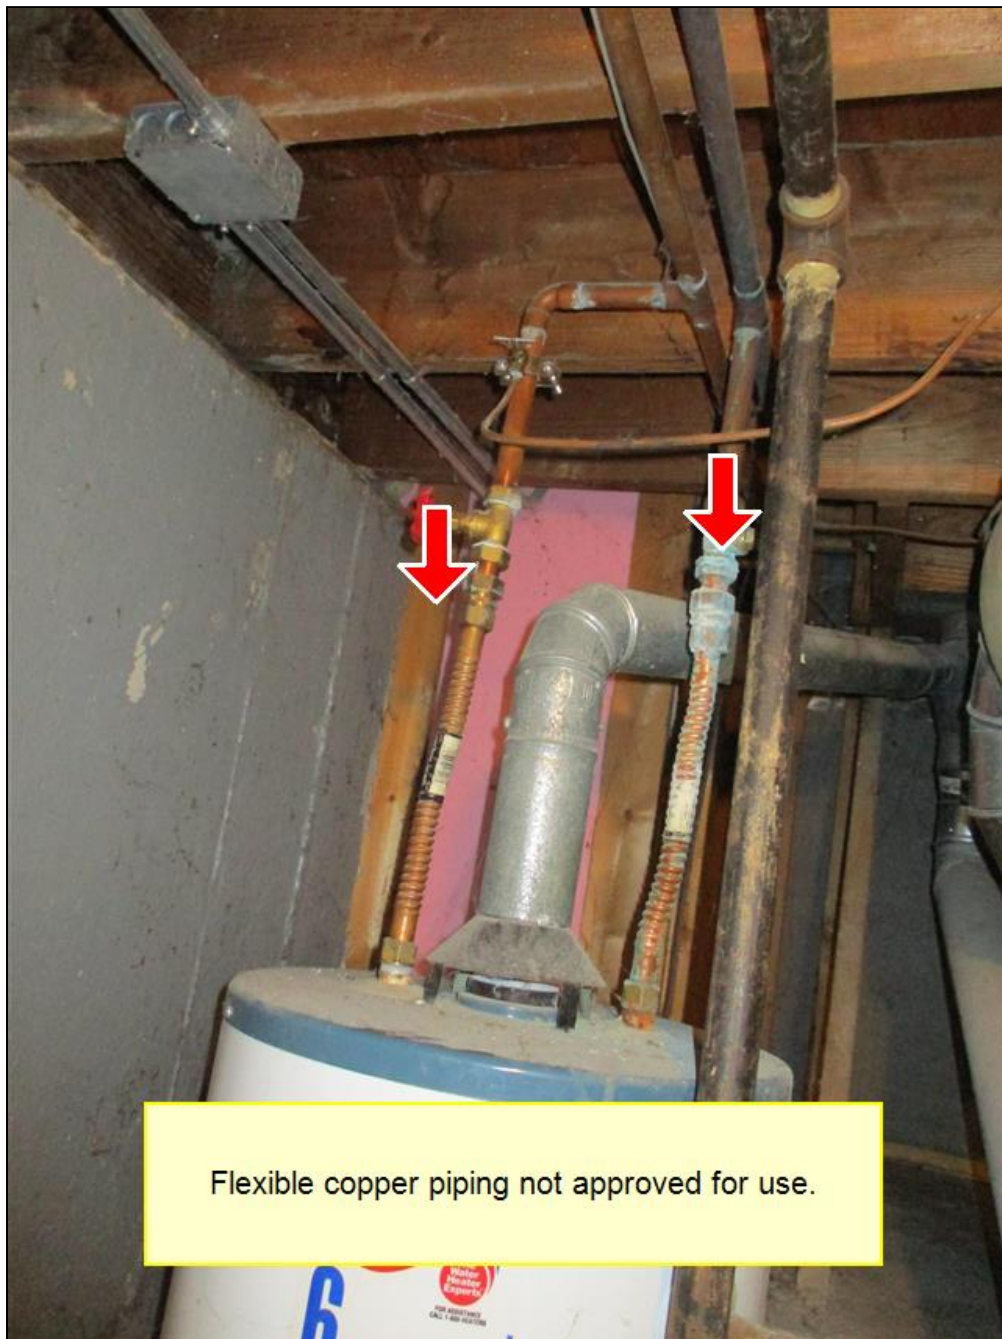
6.2 Item 2(Picture)

- 🏠 (4) The water heater water piping is connected with flexible copper tubing. Modern plumbing code, and local municipal codes, do not allow this material. Contact a qualified person to connect the water heater with hard copper piping.

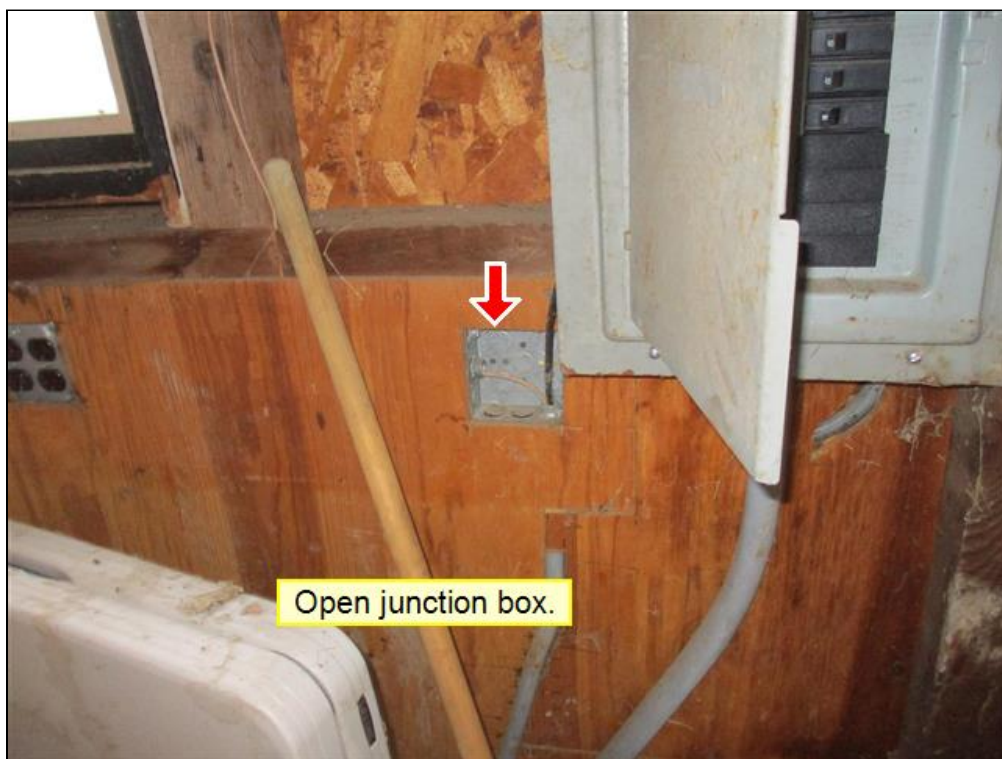
7.1 Item 1(Picture)

7.1 There was one open junction box in the shed. Open junction boxes are a safety hazard because the internal wires are exposed to the occupants. This can also cause an FHA, or other inspections, to fail. Install covers on all open junction boxes around home.

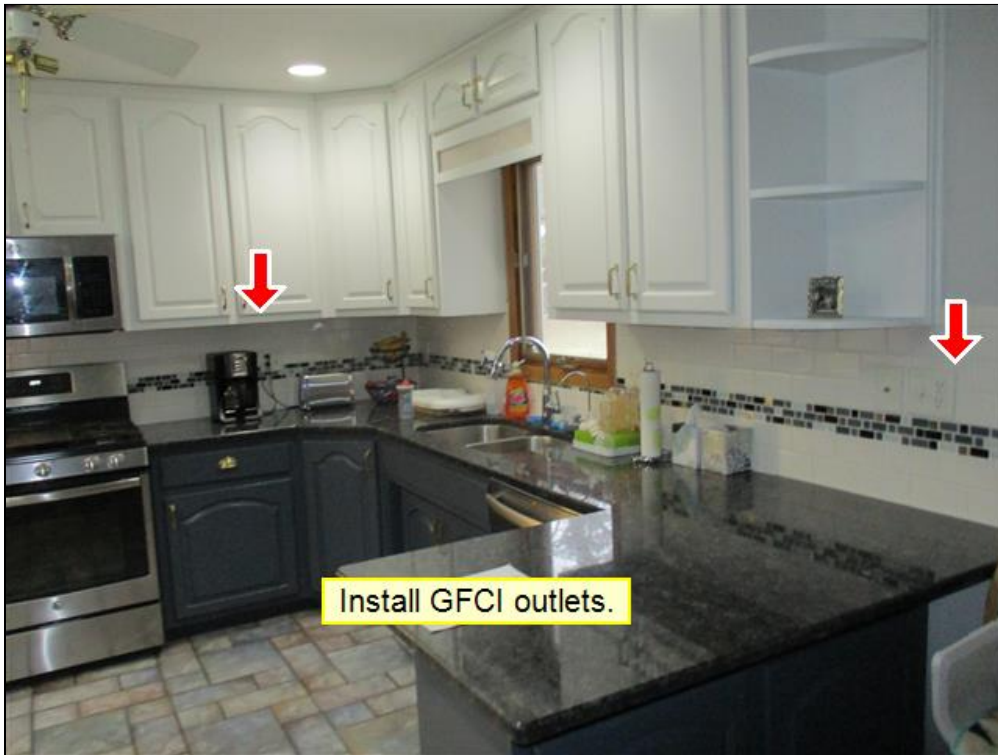
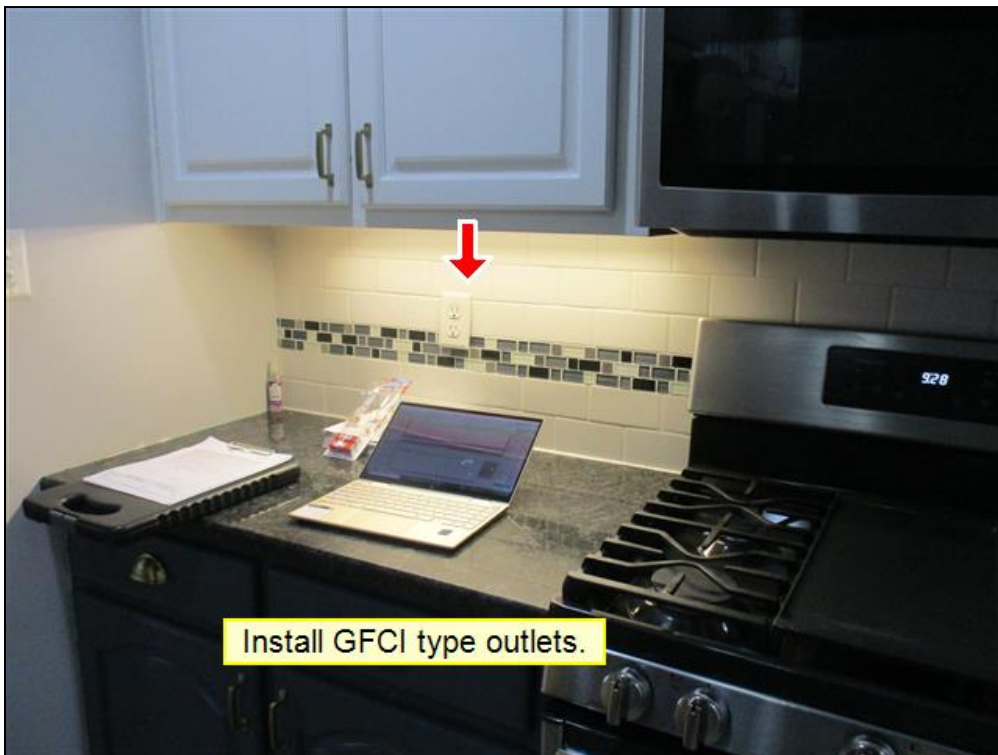
7.2 (1) The kitchen electrical outlets are not GFCI (ground fault circuit interrupted) protected. GFCI type electrical outlets protect the family against electrical hazards. When this home was built, it was not required to have GFCI electrical outlets in the kitchen. Modern standards now require GFCI outlets above the counters in the kitchen. Install GFCI type outlets above the counters in the kitchen.

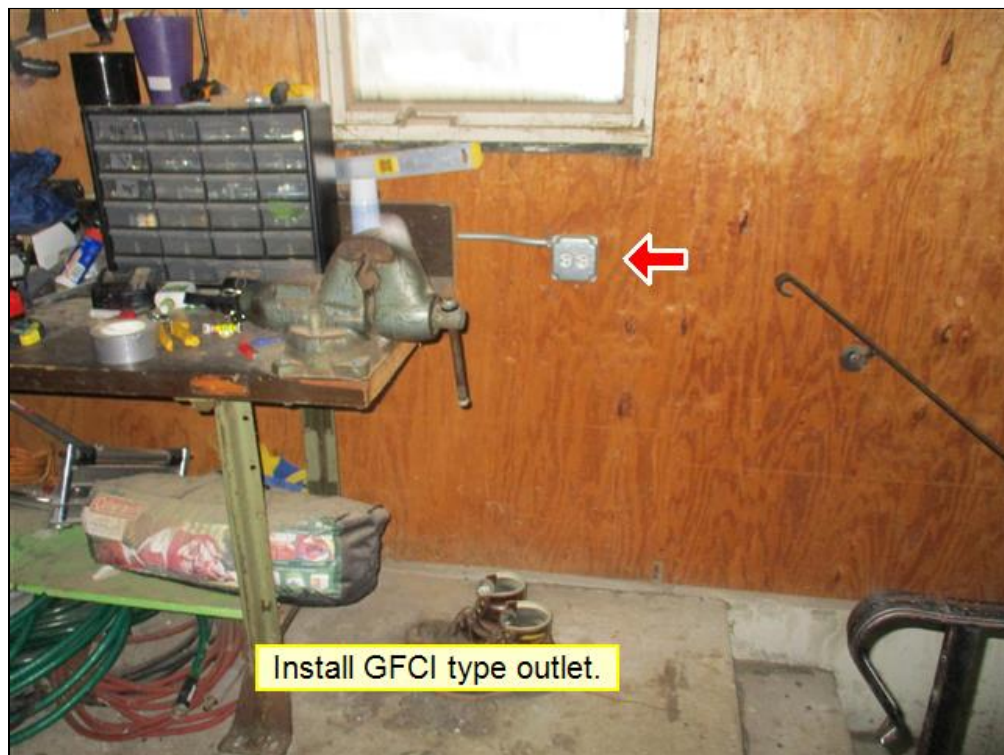
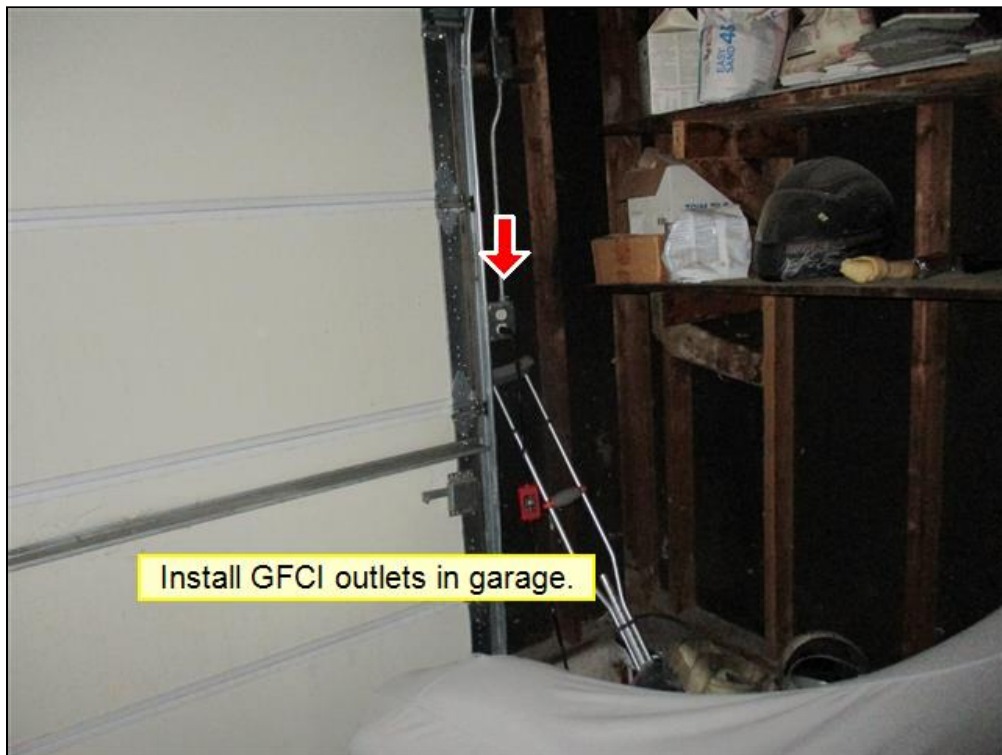
7.2 Item 3(Picture)

(2) There were three garage electrical outlets are not GFCI (ground fault circuit interrupted) protected. GFCI type electrical outlets protect the family against electrical hazards. When this home was built, it was not required to have GFCI electrical outlets in the garage. Modern standards not require GFCI outlets in the garage. I recommend updating electrical outlets in garage to GFCI type outlets.

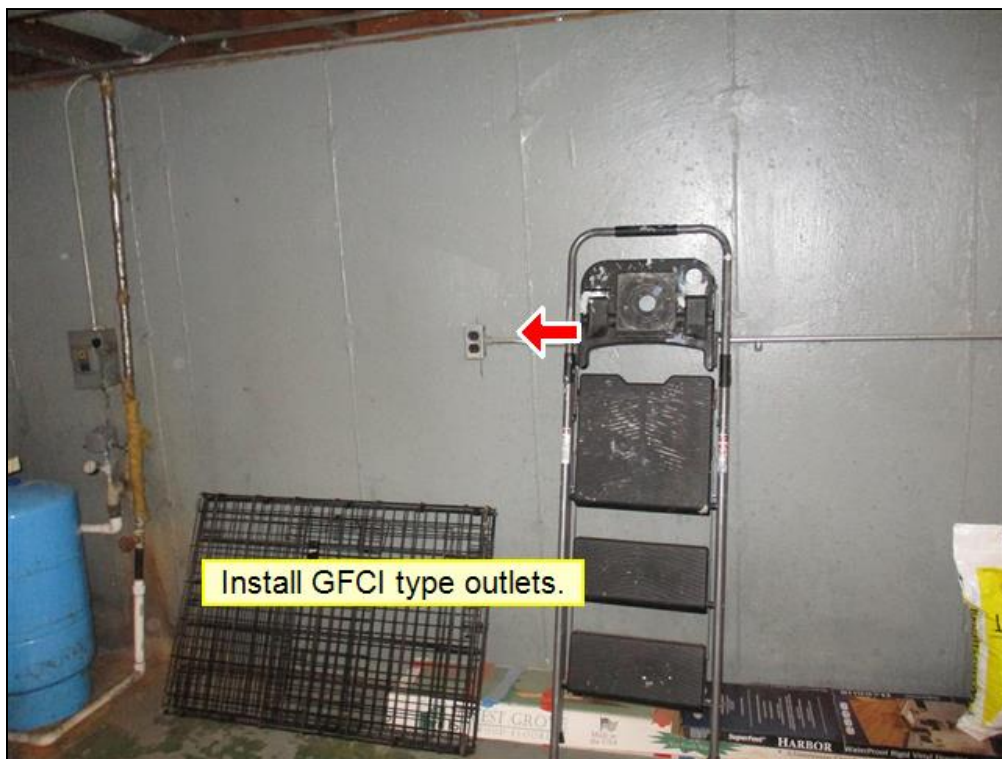
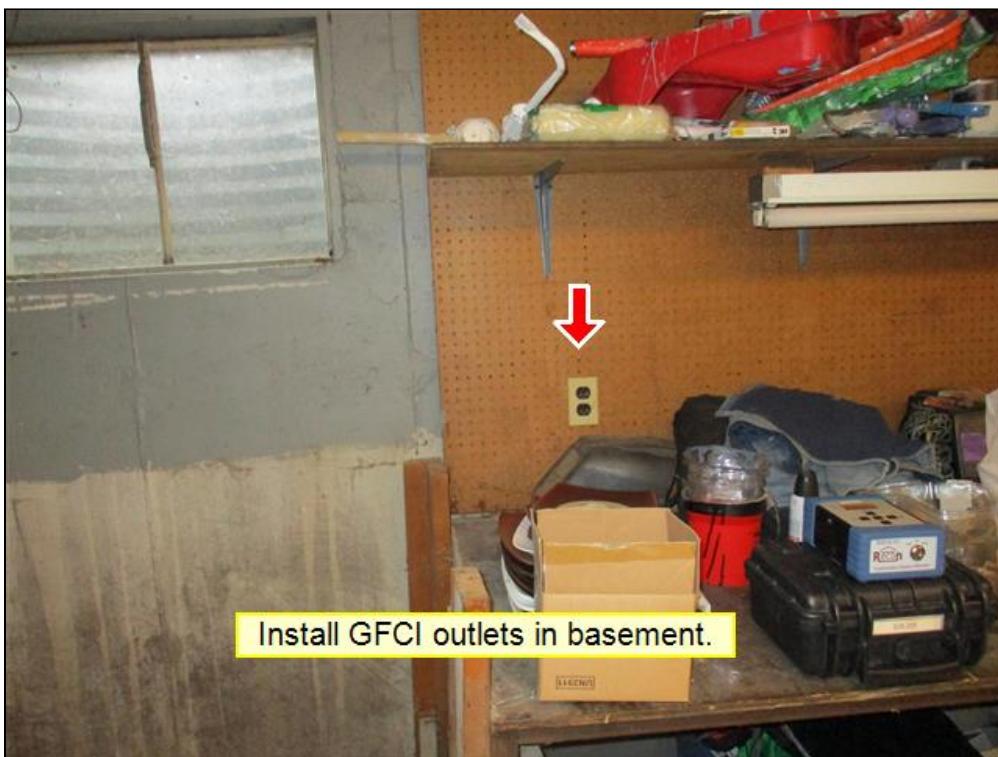
7.2 Item 6(Picture)

📍 (3) The basement electrical outlets are not GFCI (ground fault circuit interrupted) protected. GFCI type electrical outlets protect the family against electrical hazards. When this home was built, it was not required to have GFCI electrical outlets in the basement. Modern standards not require GFCI outlets in unfinished basements. I recommend updating electrical outlets in garage to GFCI type outlets.

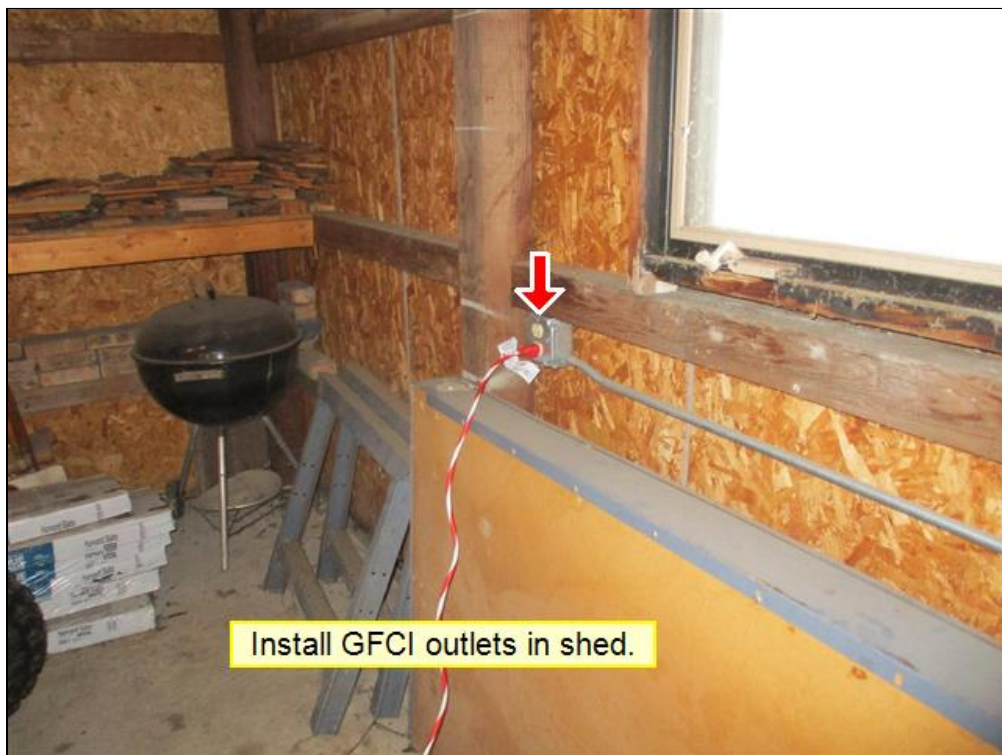
7.2 Item 9(Picture)

(4) Most of the shed electrical outlets are not GFCI (ground fault circuit interrupted) protected. GFCI type electrical outlets protect the family against electrical hazards. When this home was built, it was not required to have GFCI electrical outlets. Modern standards not require GFCI outlets in garages and sheds. I recommend updating electrical outlets in shed to GFCI type outlets.

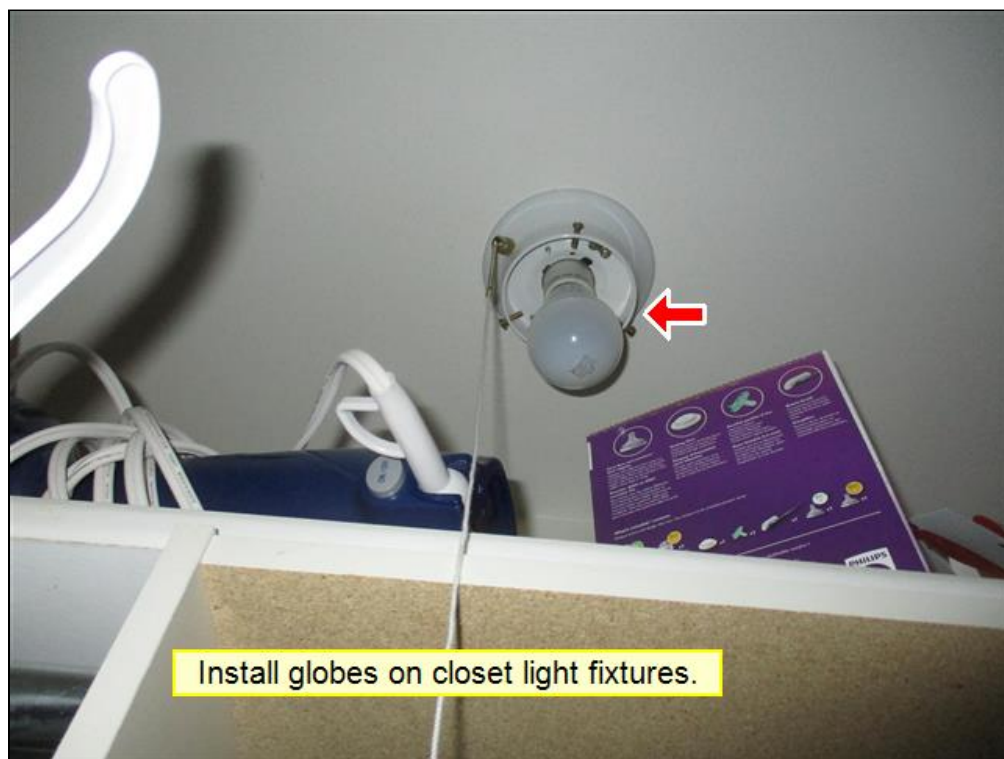
7.3 Item 1(Picture)

**7.3** (1) Modern fire safety standards require the closet light bulbs to be covered by a protective globe. This globe prevents contact between the hot light bulbs and clothing. When this home was built these type light fixtures were not used. I recommend installing globe type light fixtures in all closets to protect the occupants from fire hazards.

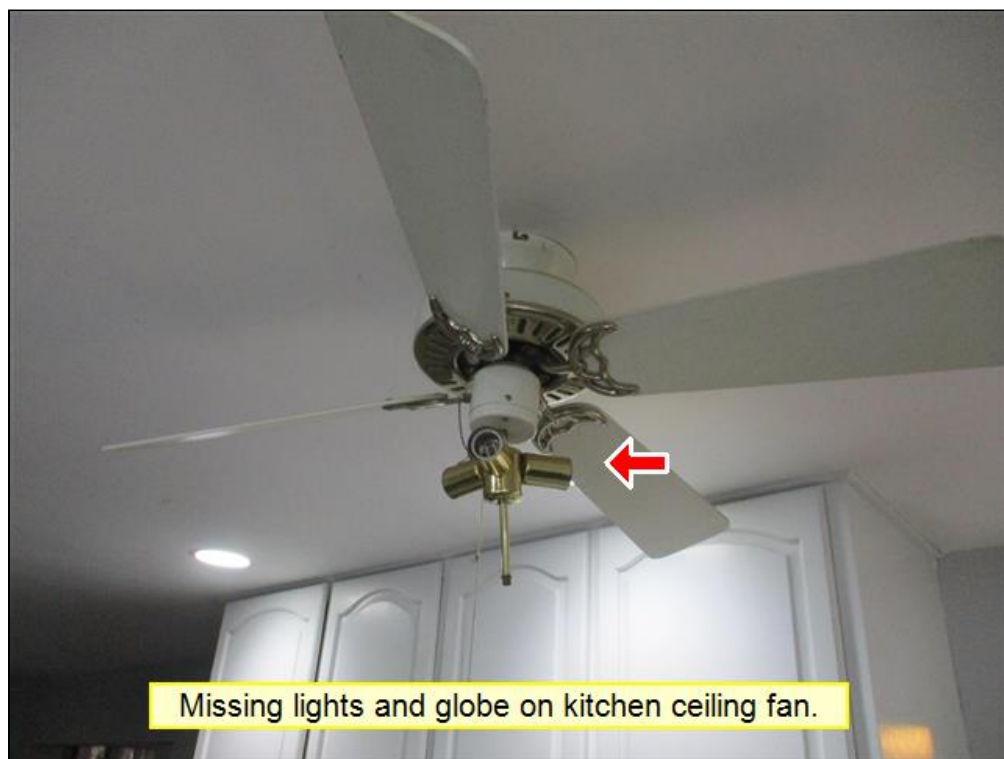
(2) There were several light fixtures that did not function. The problem may be as simple as burnt out light bulbs, or the fixture may not function. I recommend asking the home owner to replace all light bulbs and ensure all light fixtures function. You can then check them when you do your final walk through.

Missing lights and globe on kitchen ceiling fan.

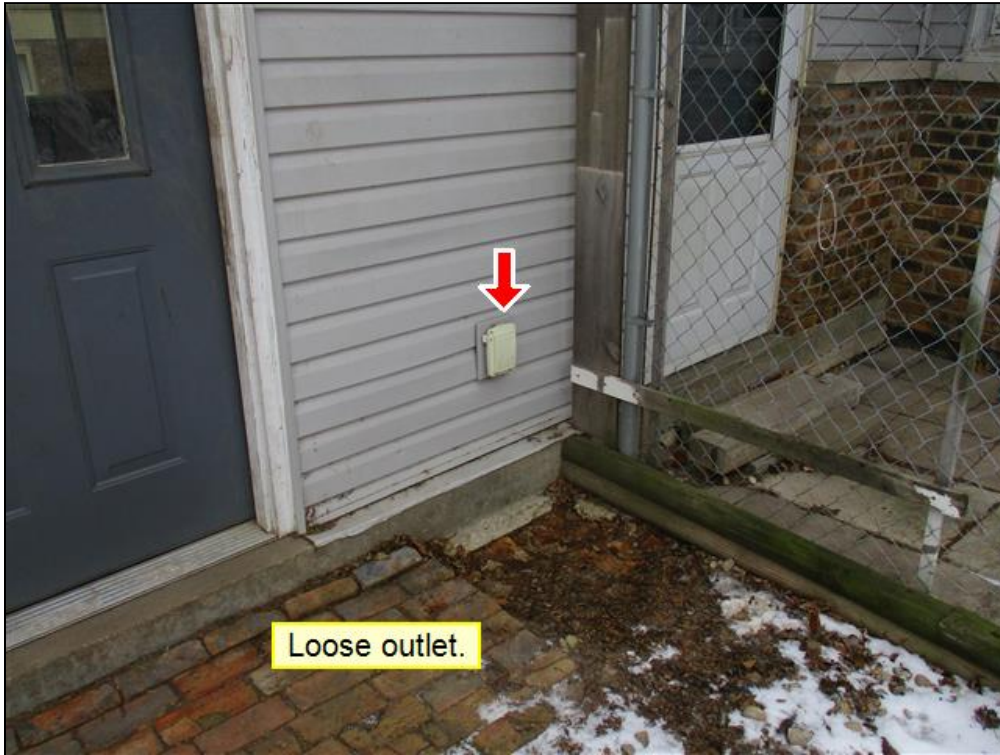
7.3 Item 8(Picture)

(4) There was one exterior rear electrical outlet that was loose. A loose outlet can cause arcing which can cause damage to the electrical outlet or even fire. Contact a qualified person to properly secure the outlets. See pictures for locations.

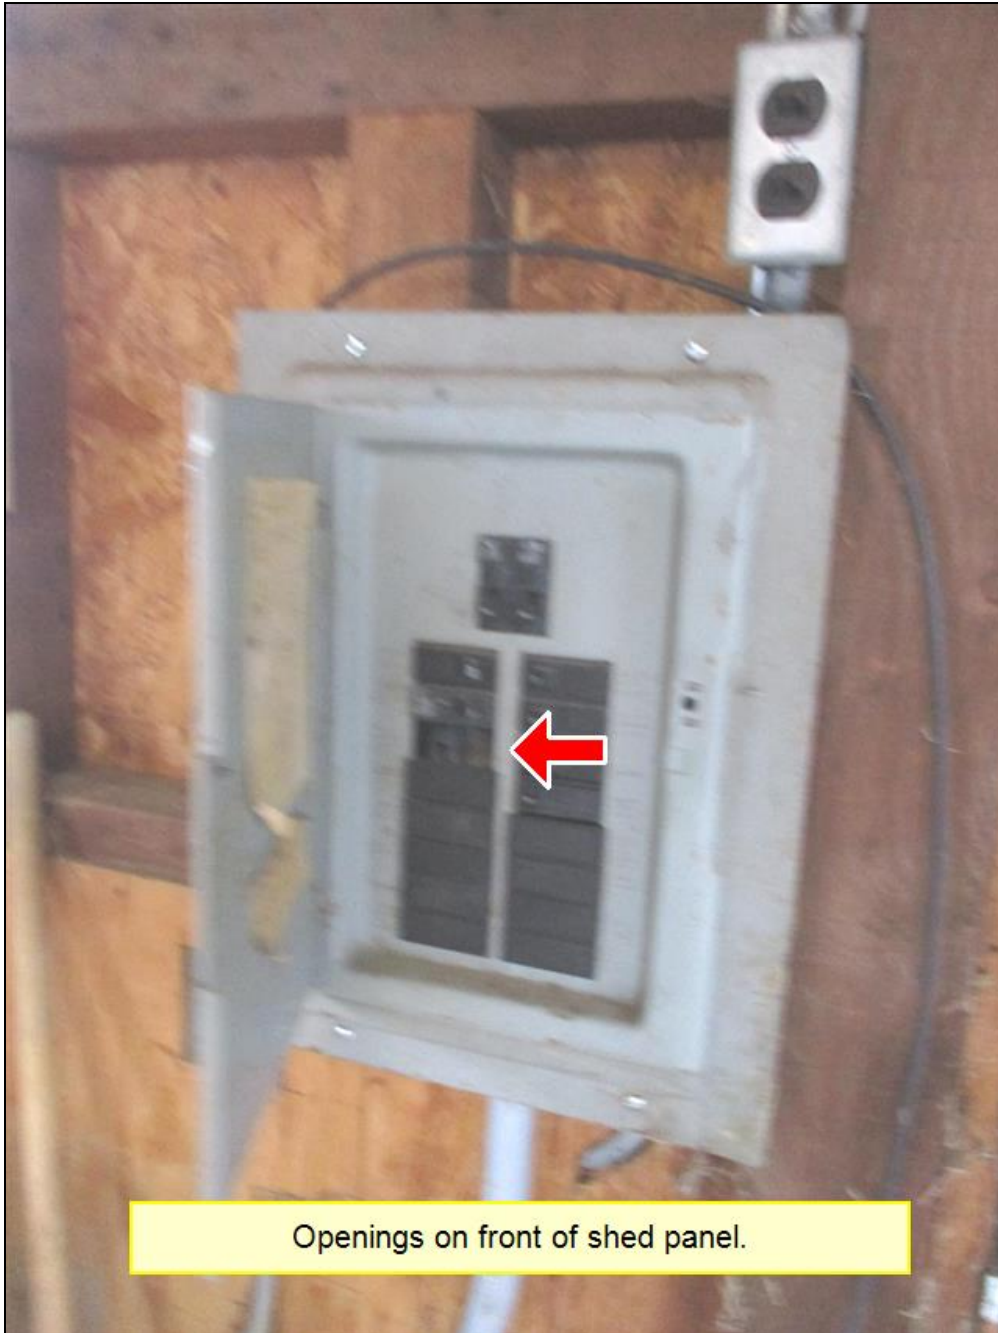
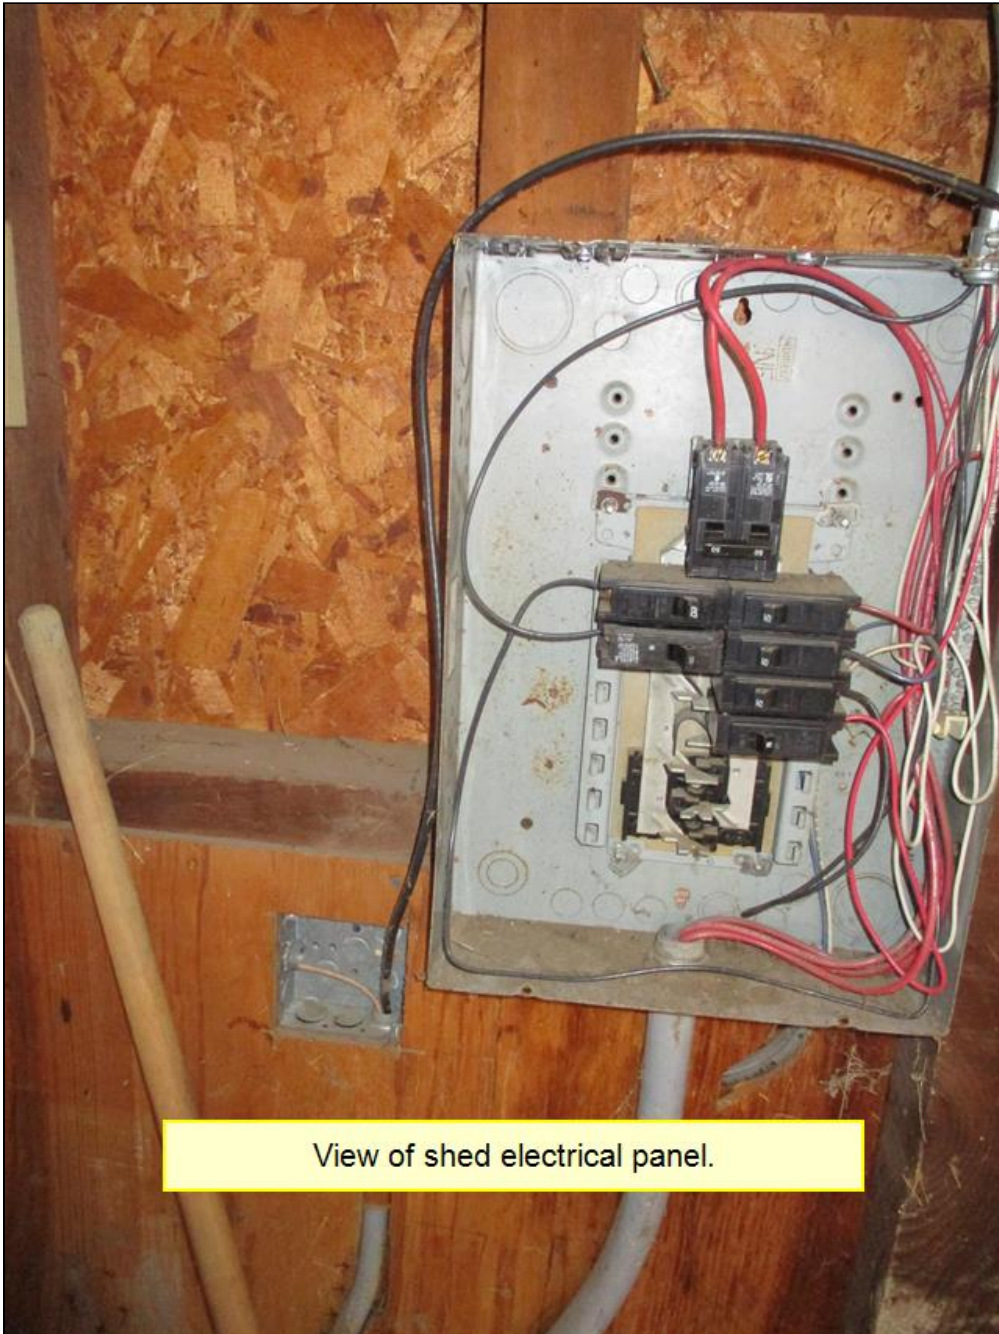
7.4 Item 1(Picture)

**7.4** (1) There is an opening on the front of the detached shed electrical panel. Openings in the electrical panel are a safety hazard because the internal components are exposed to the occupants. If not corrected, injury could occur. This can be corrected by inserting a breaker, or inserting a cover plate. Both items can be purchased at any hardware store. Any type electrical work should be done by a qualified person.

The main electrical panel is located in the basement, there is a sub-panel in the garage, and one in the detached shed.

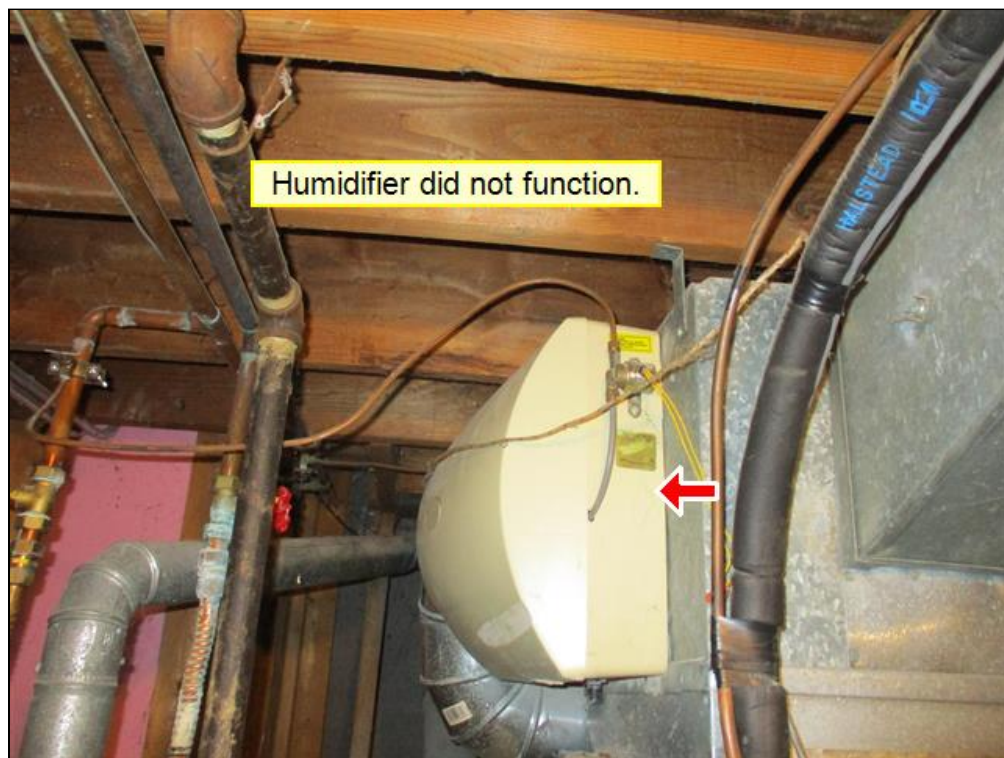
8.2 Item 1(Picture)

There are two humidifiers that do not function.

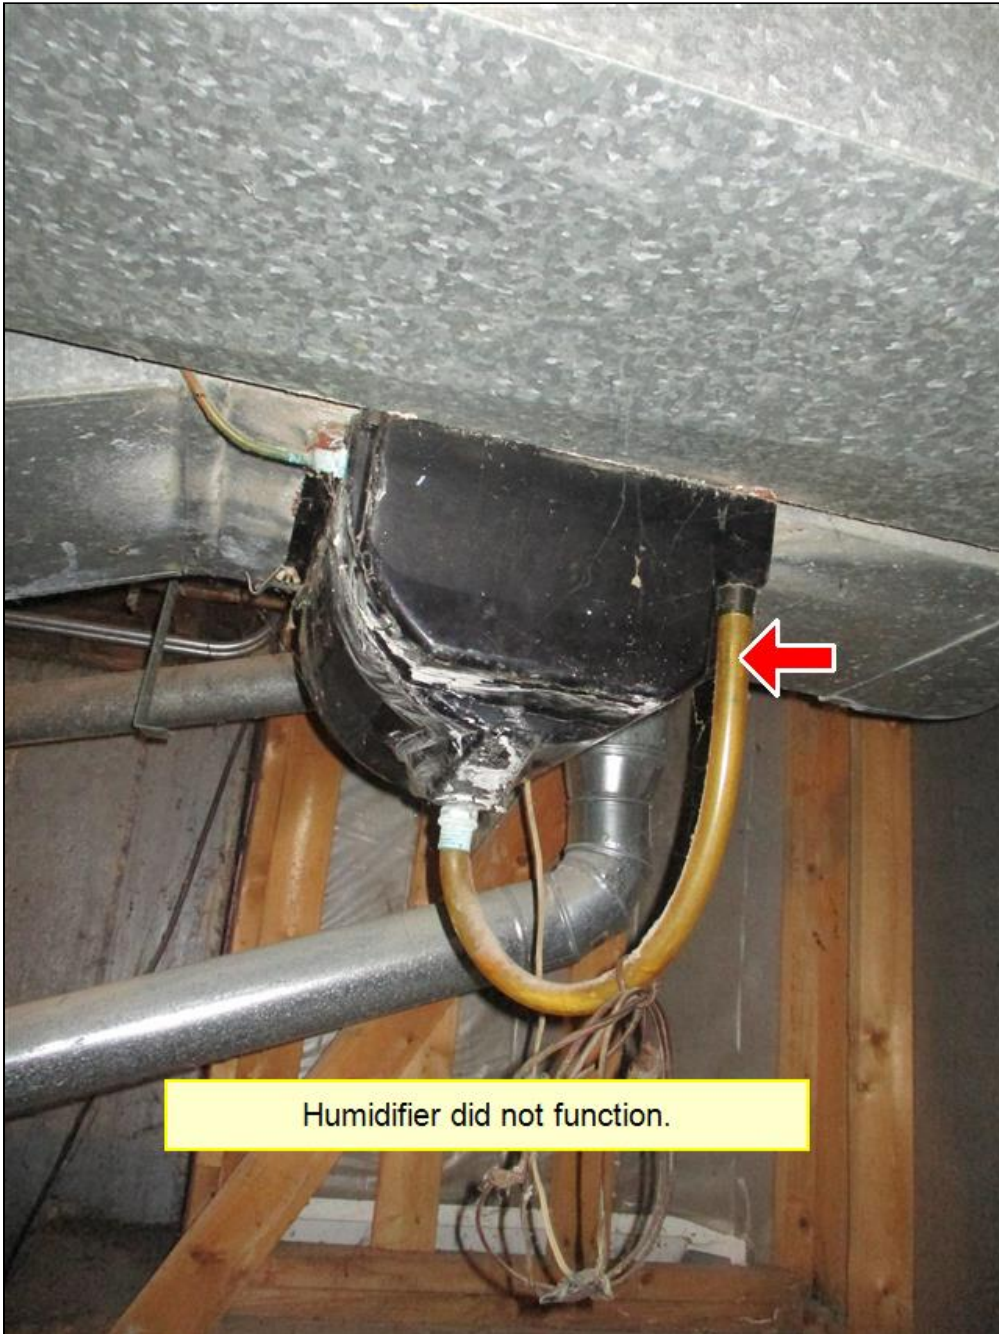
8.2 Item 2(Picture)

**8.2** The humidifier was not working during the home inspection. Humidifiers are important to prevent wood flooring and trim from drying out and separating. They also have health benefits for occupants. I recommend contacting a heating contractor to repair humidifier in home.

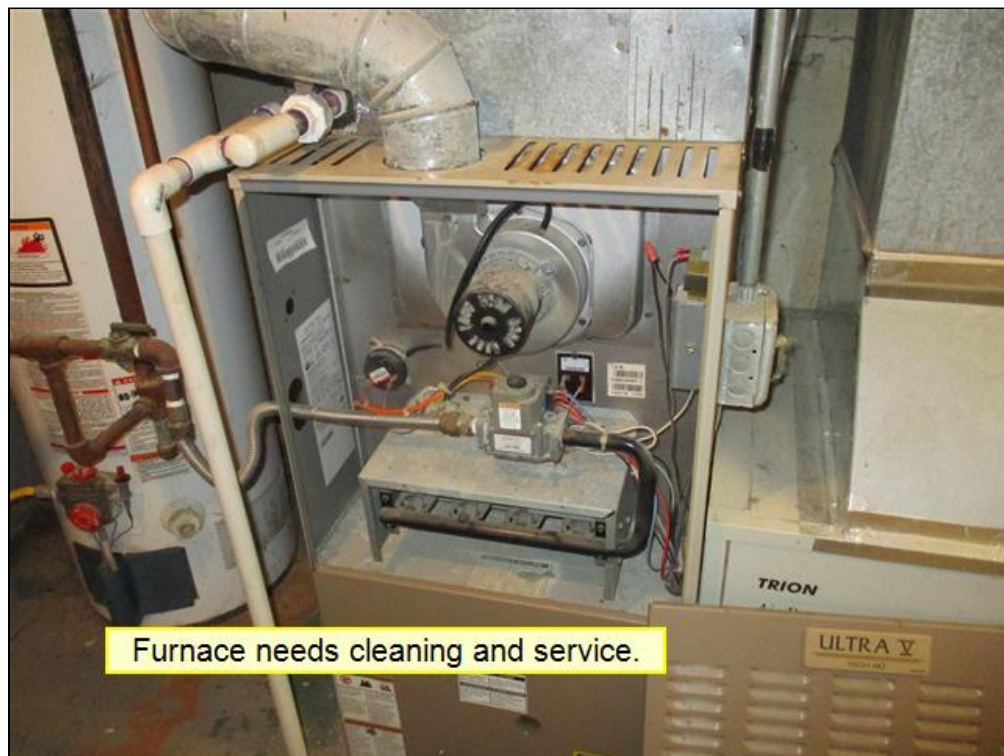
8.4 Item 1(Picture)

(2) The furnace operated as intended, but it is very dusty and dirty. Dust and dirt can lead to premature failure of the furnace. I recommend having the furnace cleaned by a HVAC contractor.

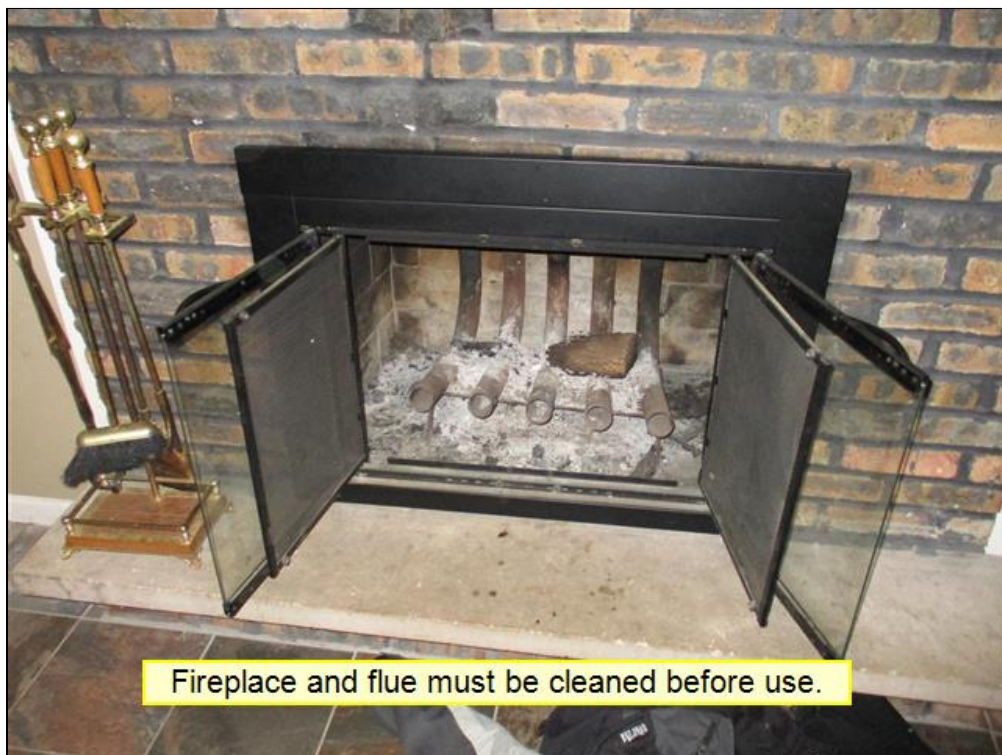
8.5 Item 1(Picture)

8.5 I conducted a level I inspection of the chimney and flues. My view of the chimney, flue, and shelf are limited. The National Fire Place Association recommends a level II inspection upon sale or transfer of a property. A level II inspection includes video scanning to examine flue liner condition, material, sizing, and clearances. Contact a chimney sweep to conduct a level II inspection of the fireplace and flue.

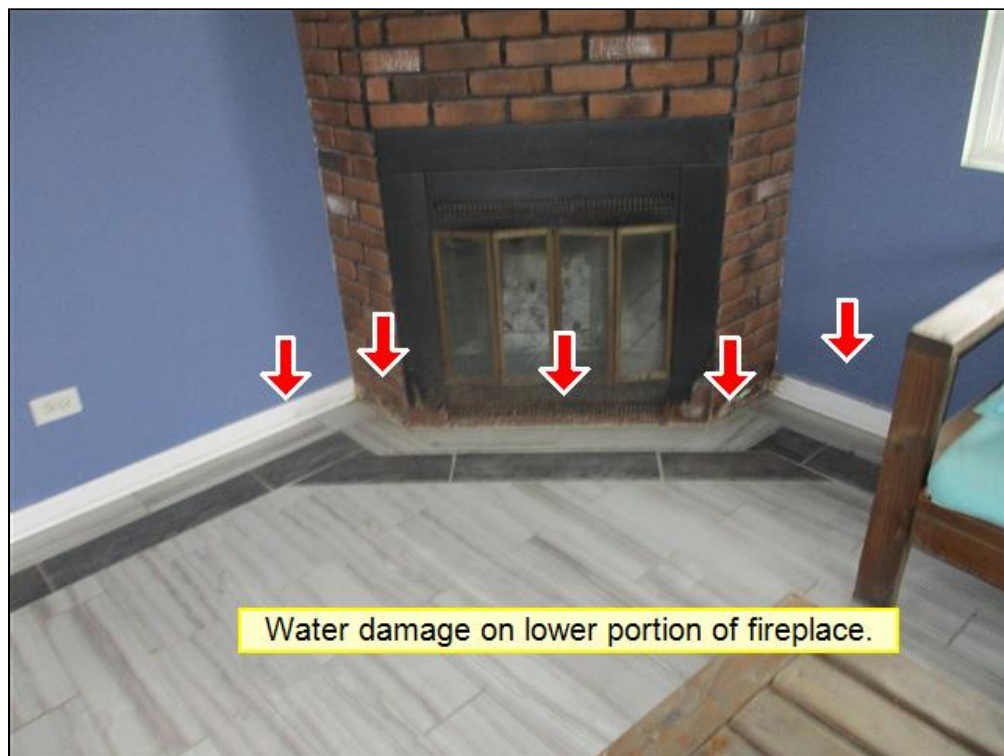
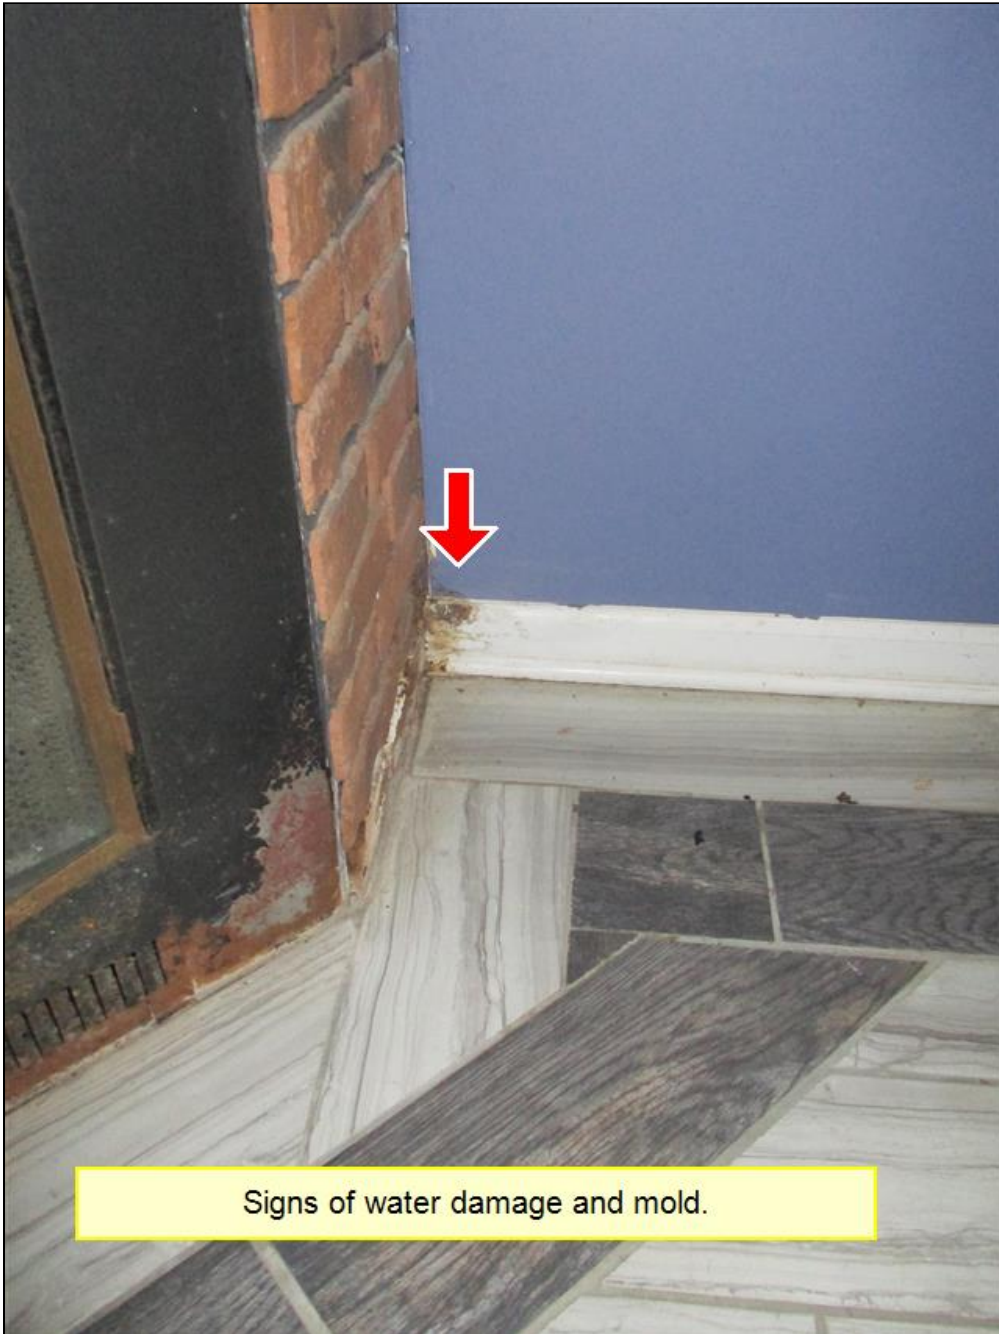
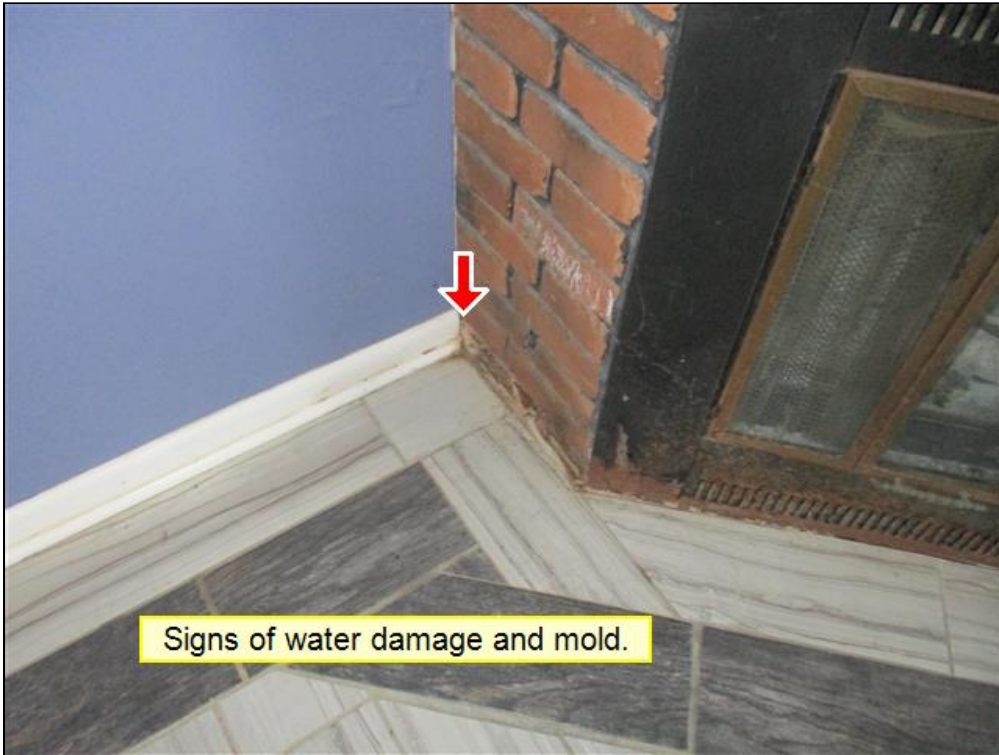
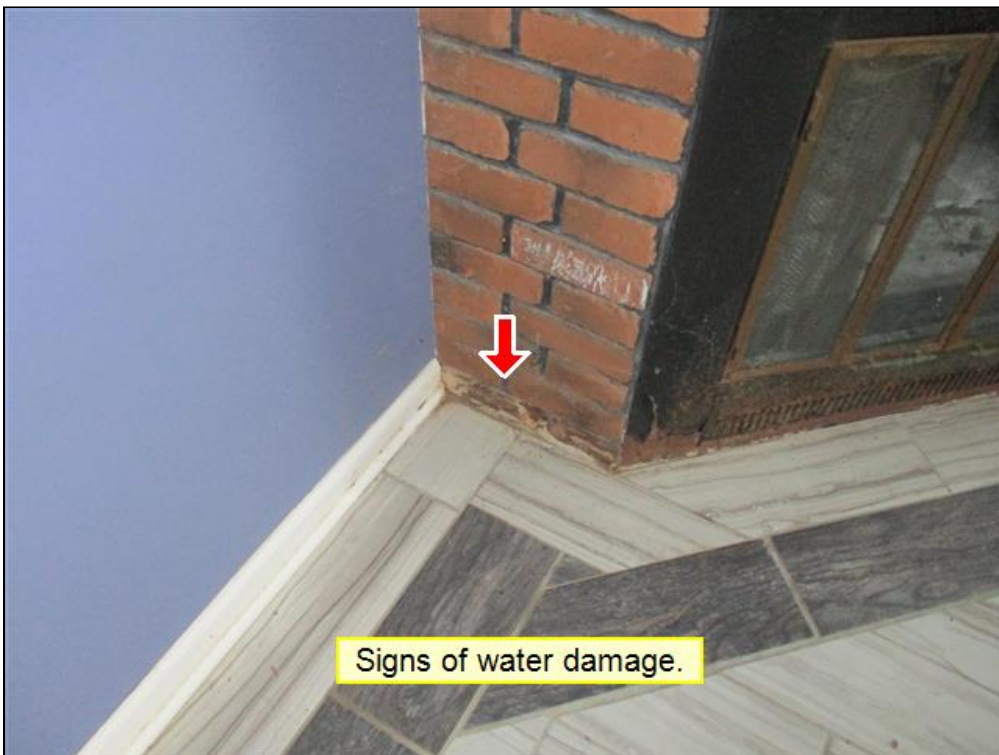
**8.6** (1) There is water damage present on the lower portion of the rear three seasons room fireplace and wall. This indicates that water is entering the fireplace or flue.

After the water source is eliminated, a mold mitigation company must be contracted to properly remove water damaged material.

Contact qualified contractors to complete this repair.
