Inspection Report

Sample Report

Assure Home Inspection

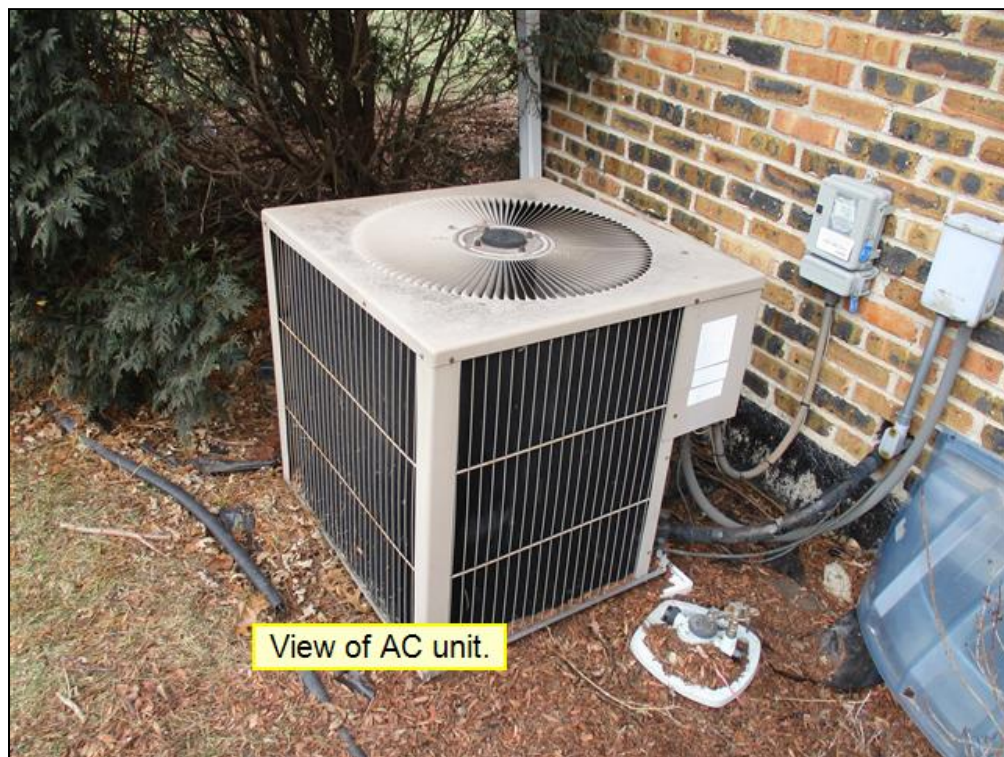
8.9 Item 1(Picture)

(2) The condenser outside (AC unit) is very old and may last a few years more, but maybe not. I have seen units fail shortly after a home inspection during the seasonal change from mild to hot weather. I cannot determine how long your AC will last before a replacement is necessary.

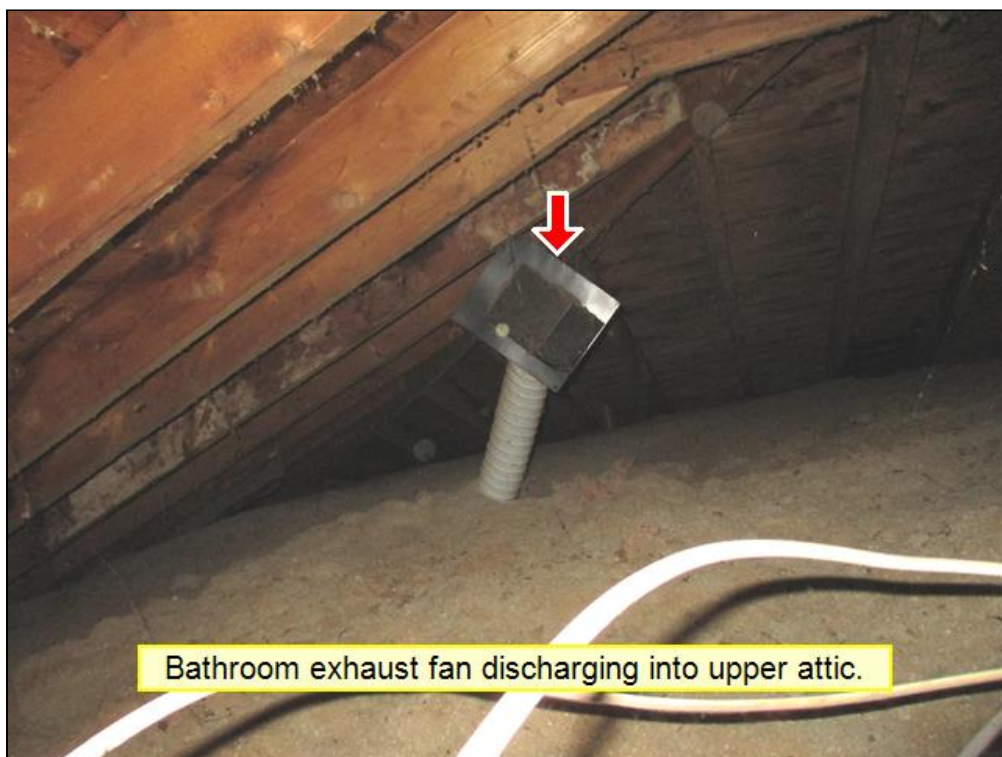
9.3 Item 1(Picture)

9.3 (1) There is one bathroom exhaust fan that is discharging into the attic. If not corrected, moisture related problems may develop. Contact a qualified person to direct the exhaust fan discharge to the exterior of the home.

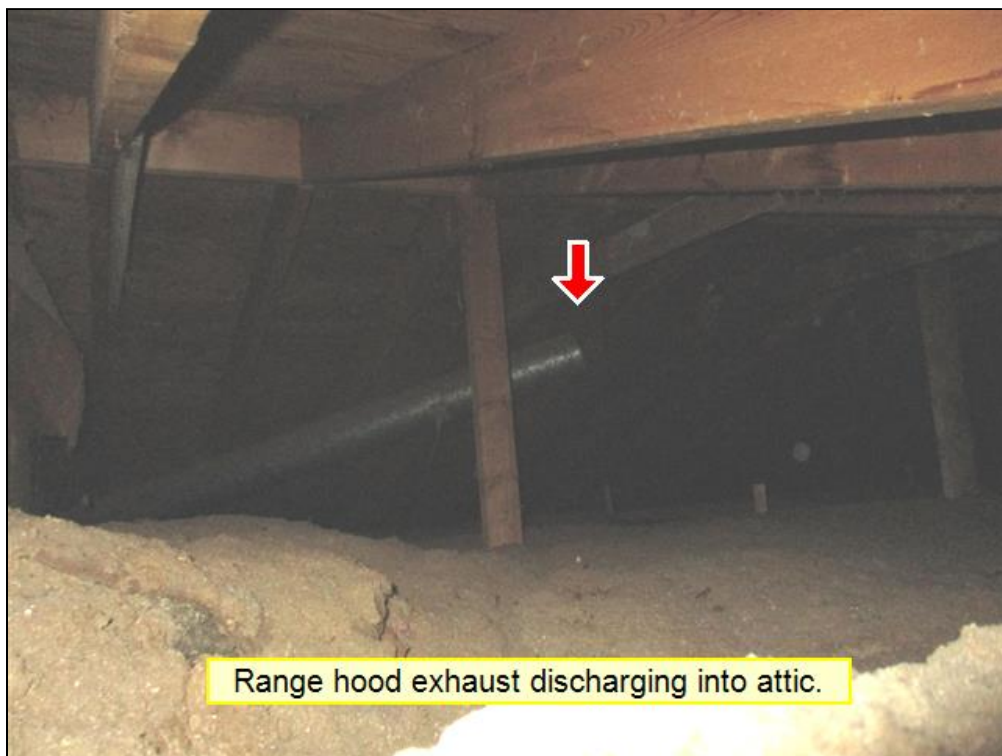
9.3 Item 2(Picture)

🏠 (2) There is one range hood exhaust fan that is discharging into the attic. If not corrected, moisture related problems may develop. Contact a qualified person to direct the exhaust fan discharge to the exterior of the home.

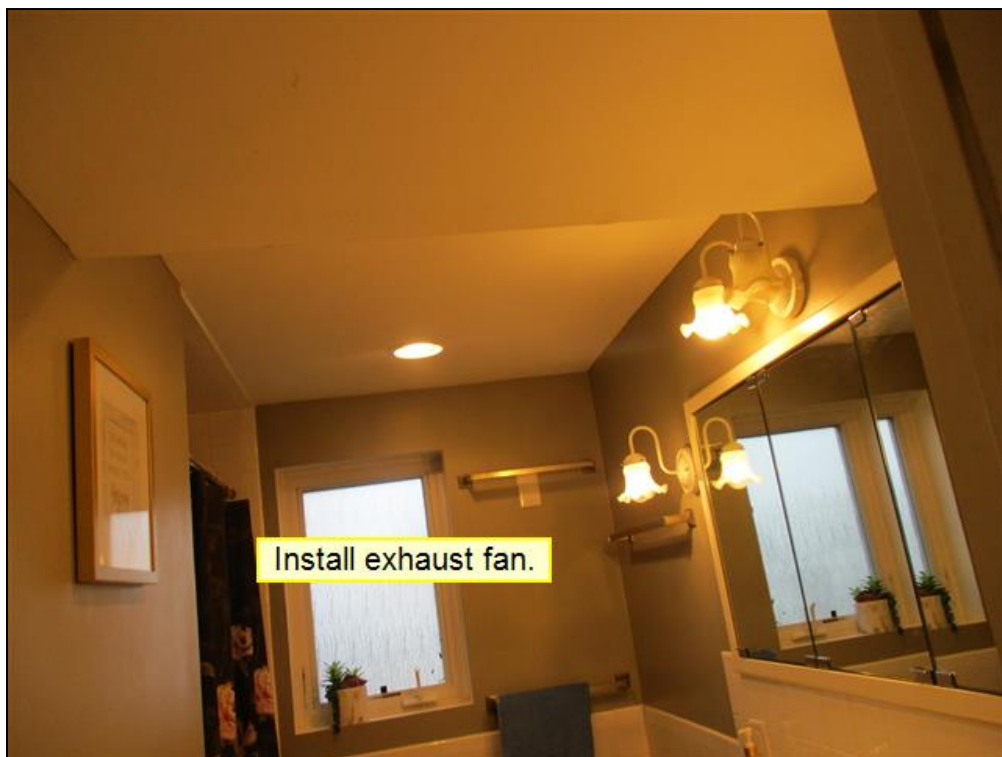
9.3 Item 3(Picture)

(3) The lower level bathroom is not equipped with an exhaust fan. Exhaust fans are required in all full bathrooms. Fans are important to prevent moisture related issues from developing. Contact a qualified contractor to install an exhaust fan.

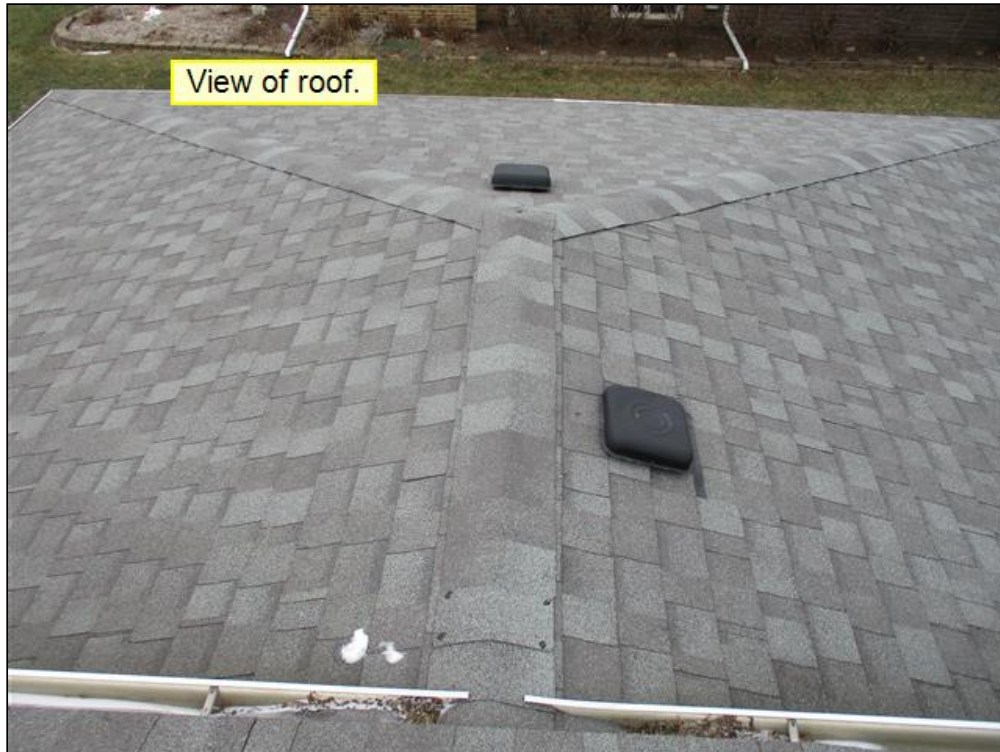
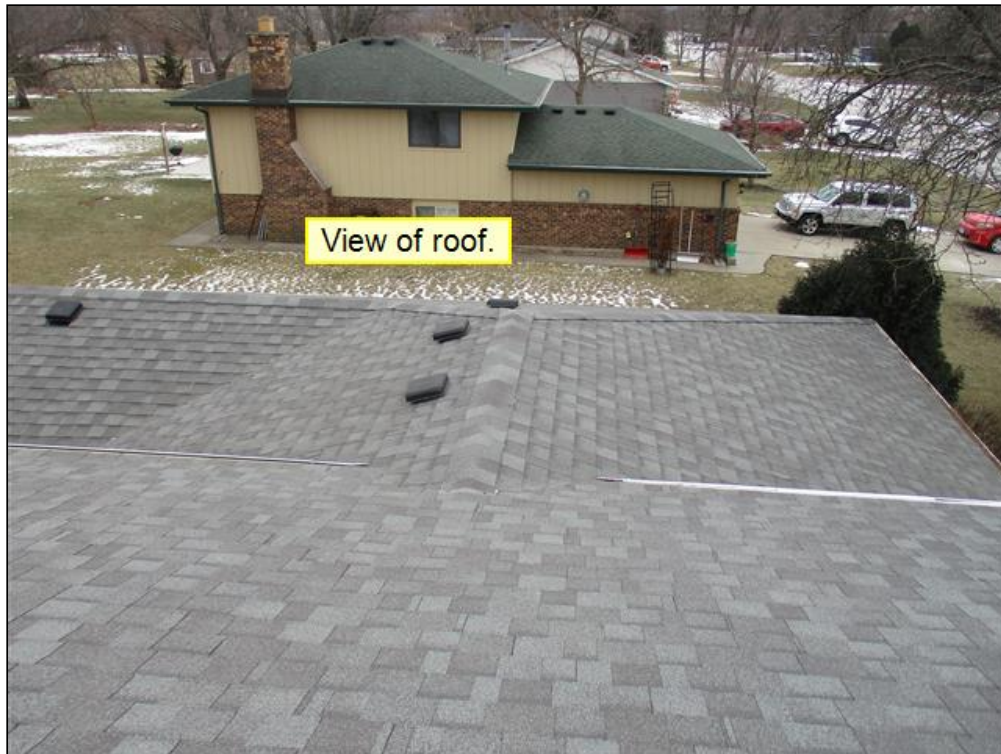
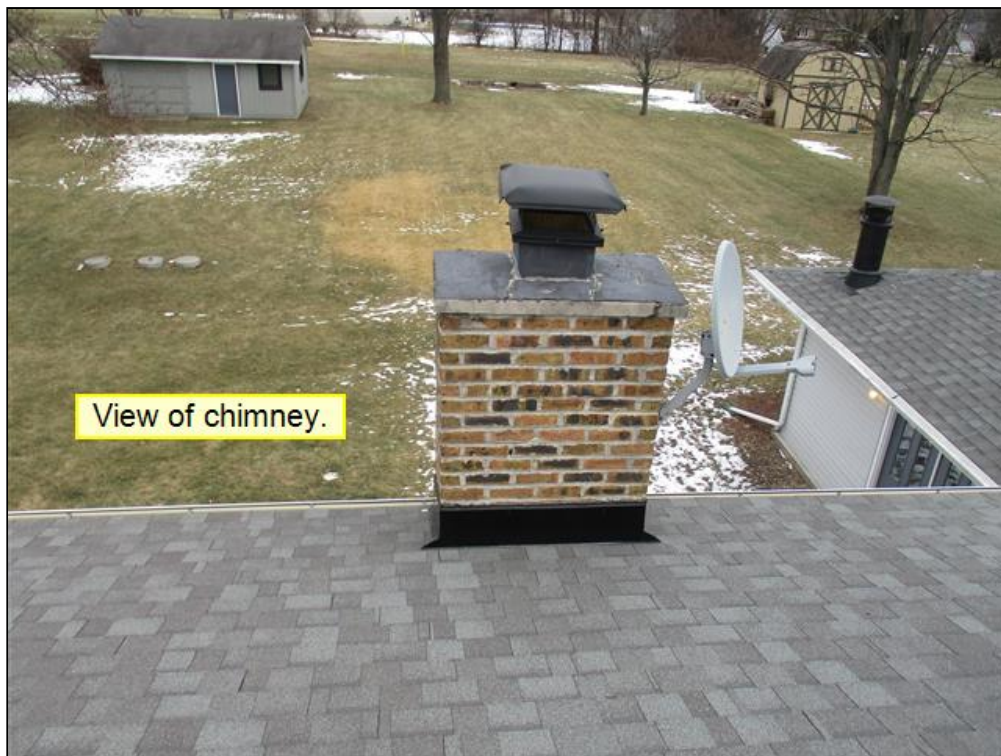
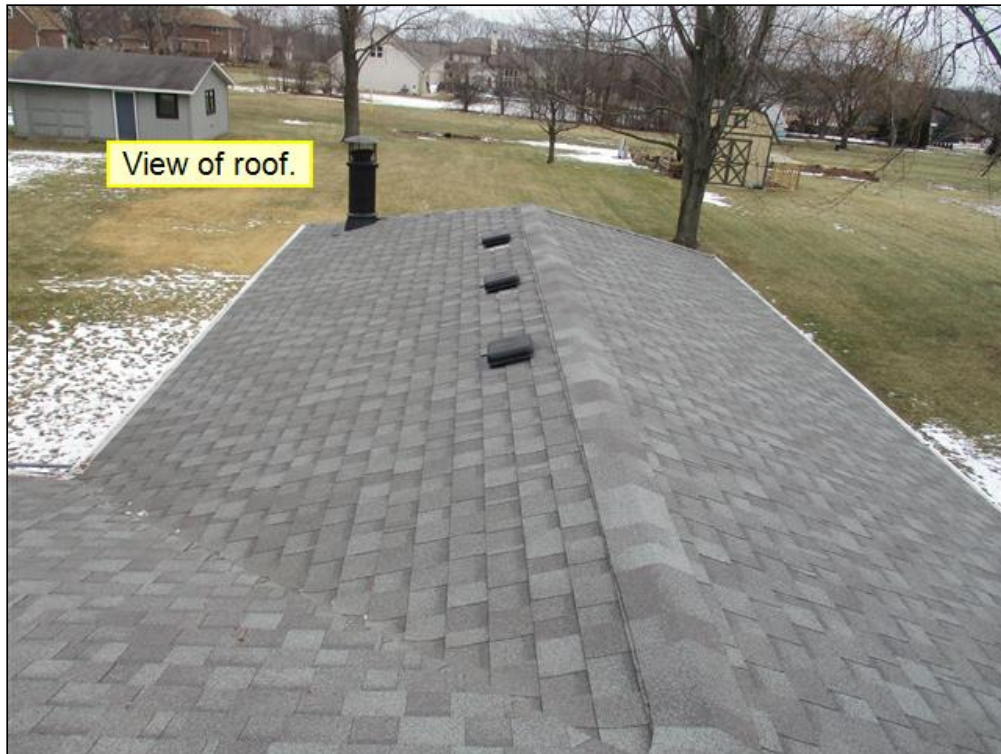
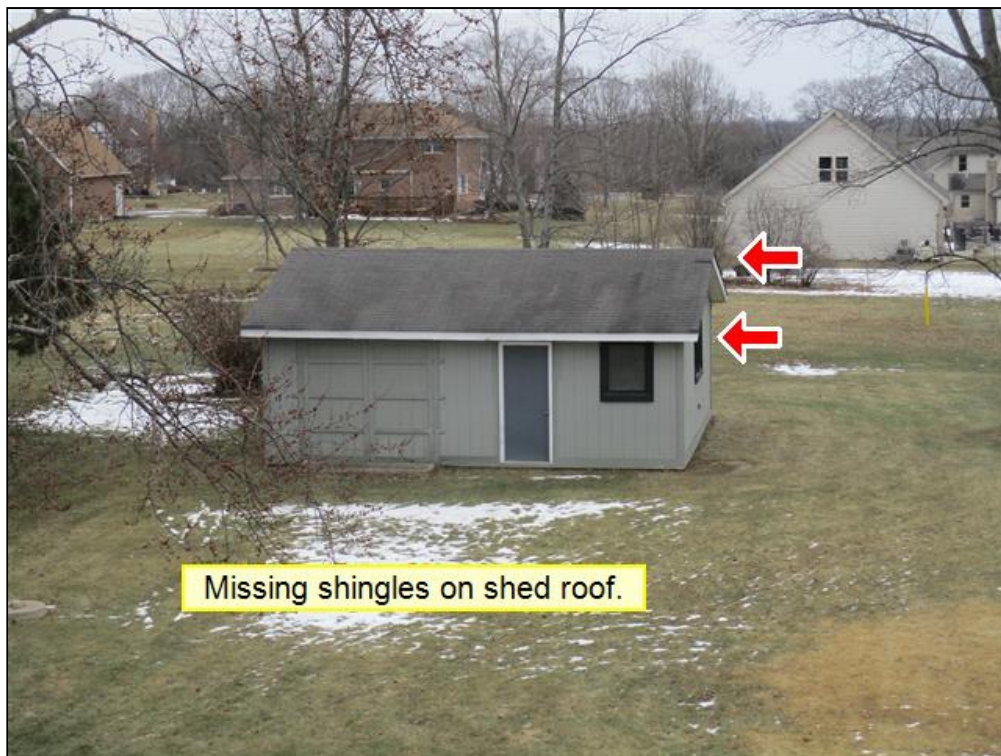
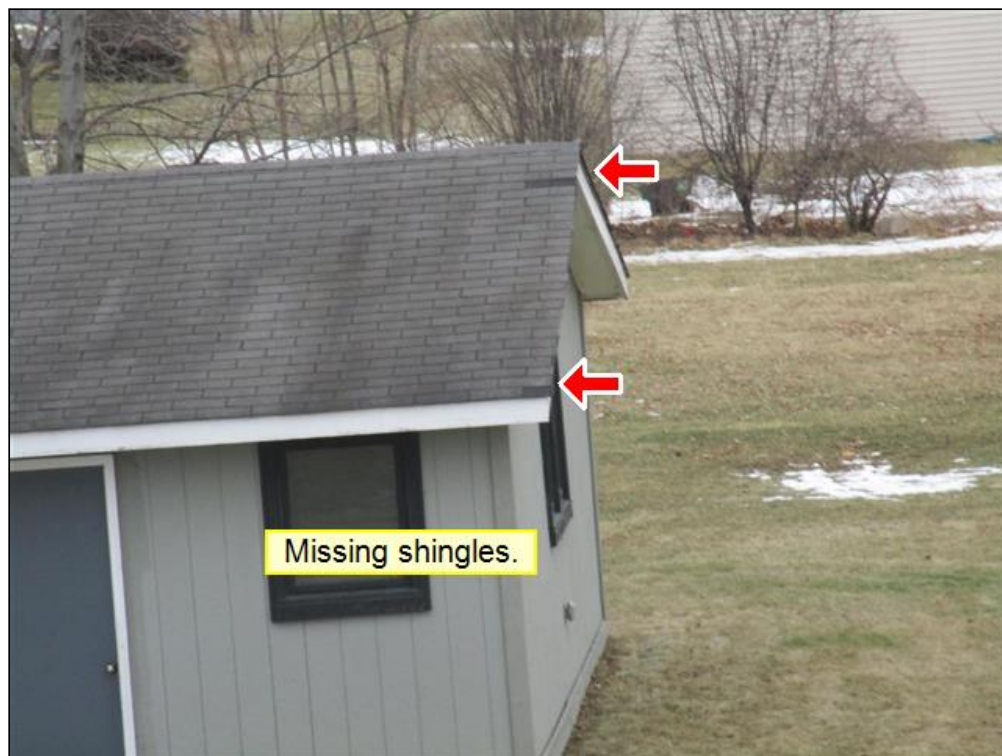
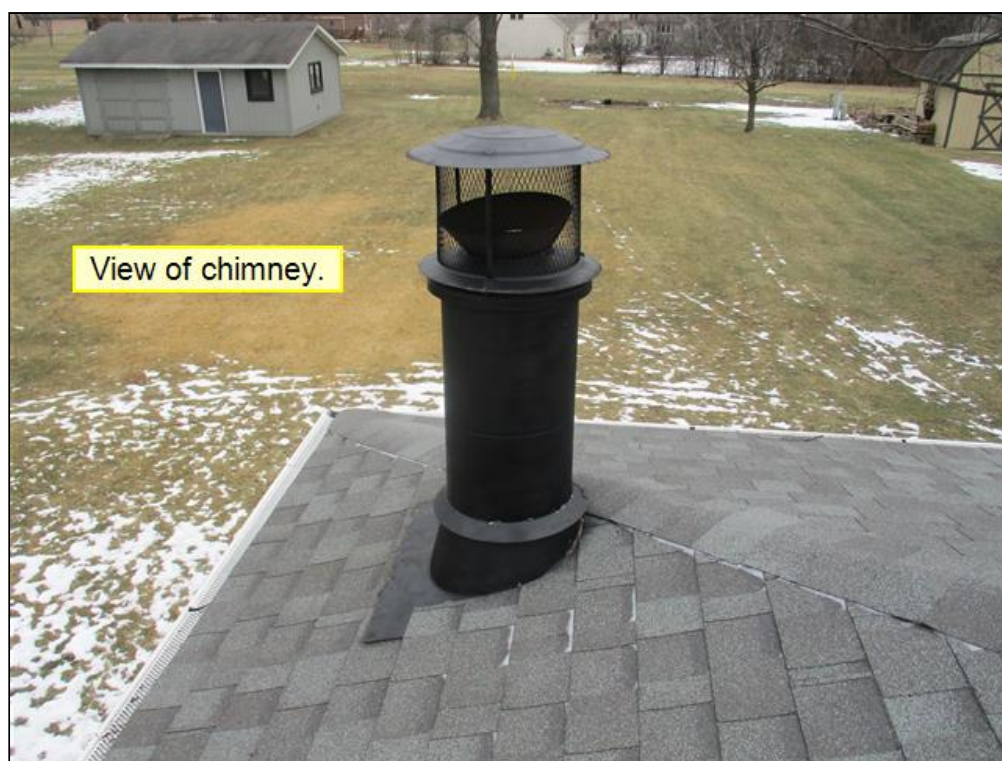
The detached shed roof was older, and had one missing shingle. Contact a roofing contractor to replace the missing shingle and any others that they find that need repair.

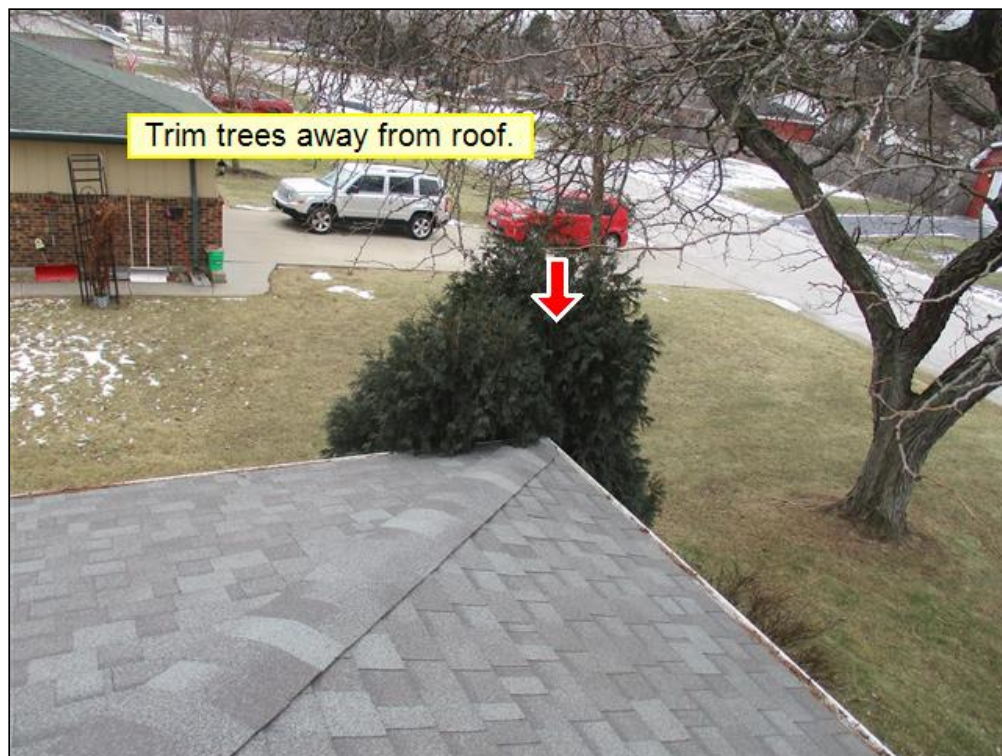
1.1 Item 8(Picture)

(2) There are trees in contact with the roof. This can cause damage to the roofing shingles and other components of the home. Contact a qualified person to trim tree branches away from the home.

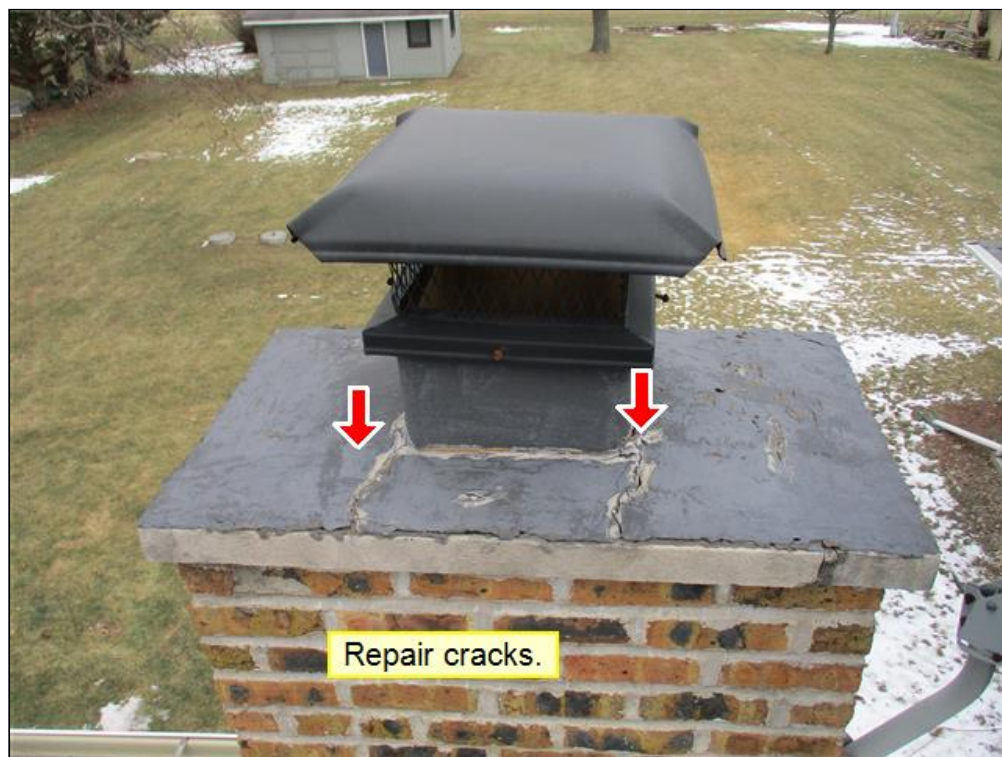
1.2 Item 1(Picture)

There are a few cracks in the brick chimney cap. I recommend caulking to prevent further damage.

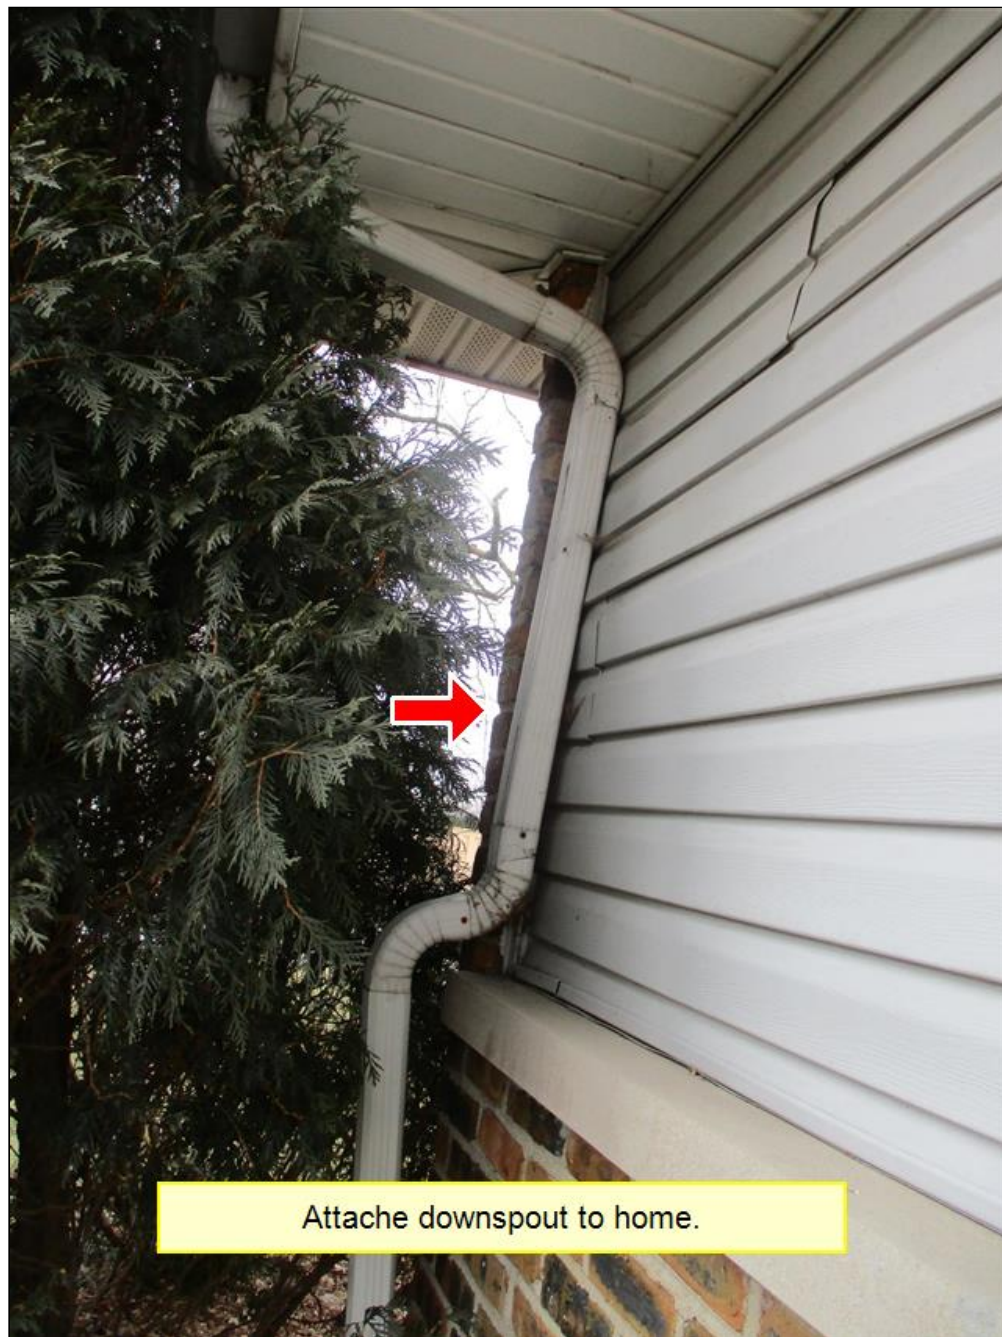
1.3 Item 1(Picture)

(1) There was one downspout that was not properly attached to the home. If not properly attached, further damage may occur. Contact a qualified contractor to properly attach the downspout to the home.

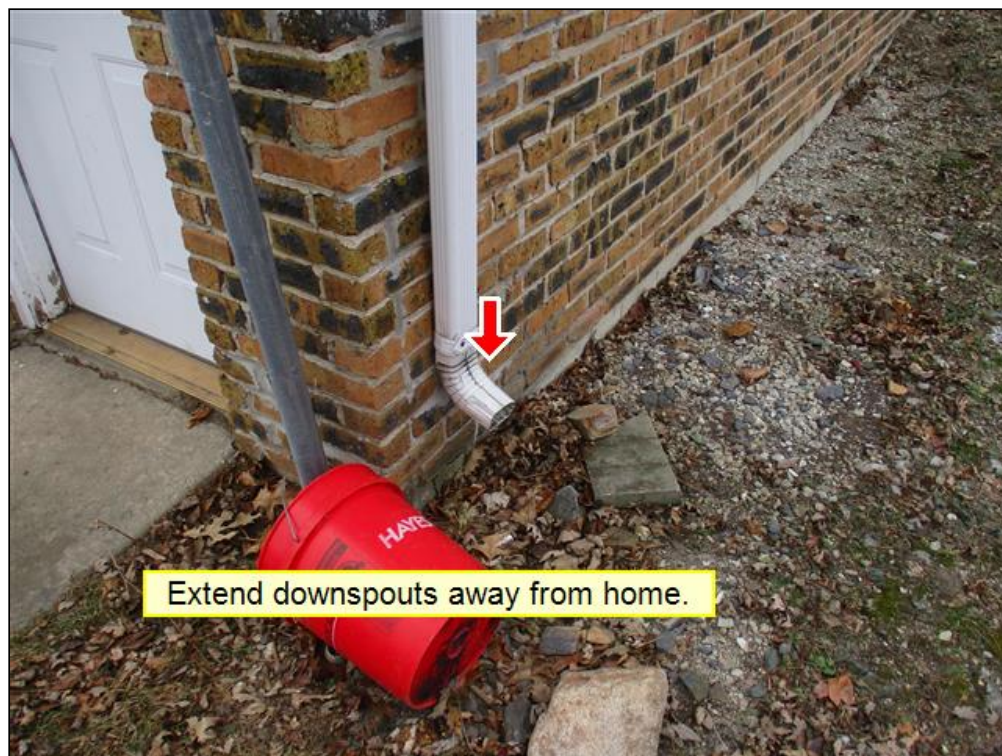
1.3 Item 2(Picture)

(2) The downspouts should be extended 6'-8' away from the home. This will prevent damage to the foundation, and water from entering the lower levels of the home. Contact a landscaping contractor to extend all downspouts away from home.

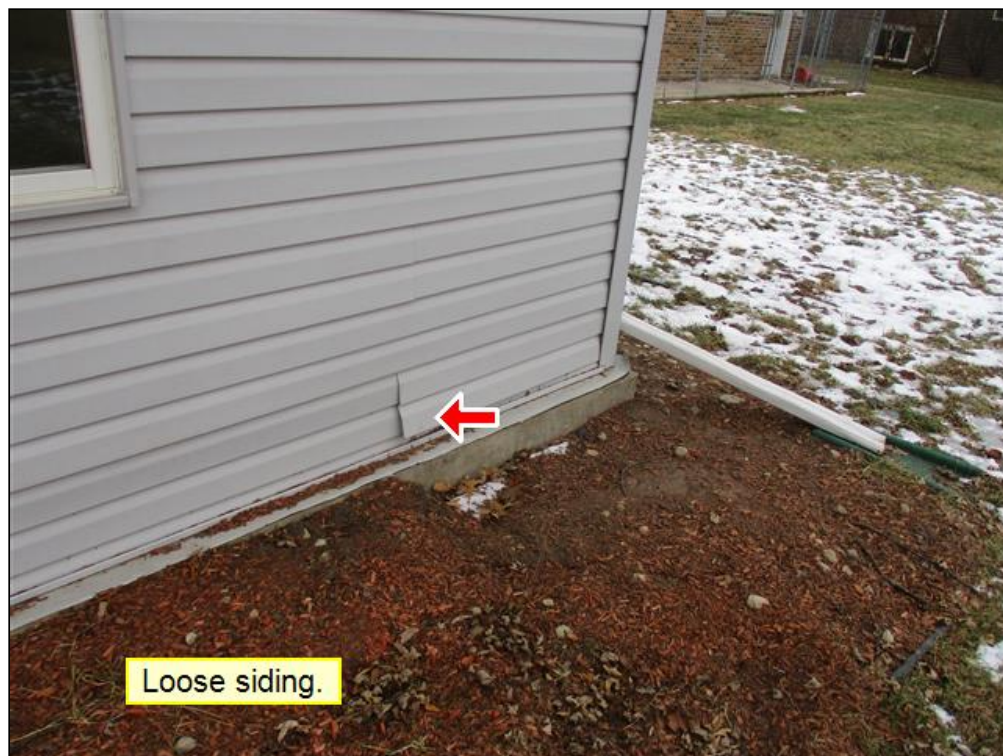
2.0 Item 1(Picture)

There is a section of loose siding on the rear of the home. If not properly secured, further damage may occur. Contact a qualified contractor to properly secure the siding.

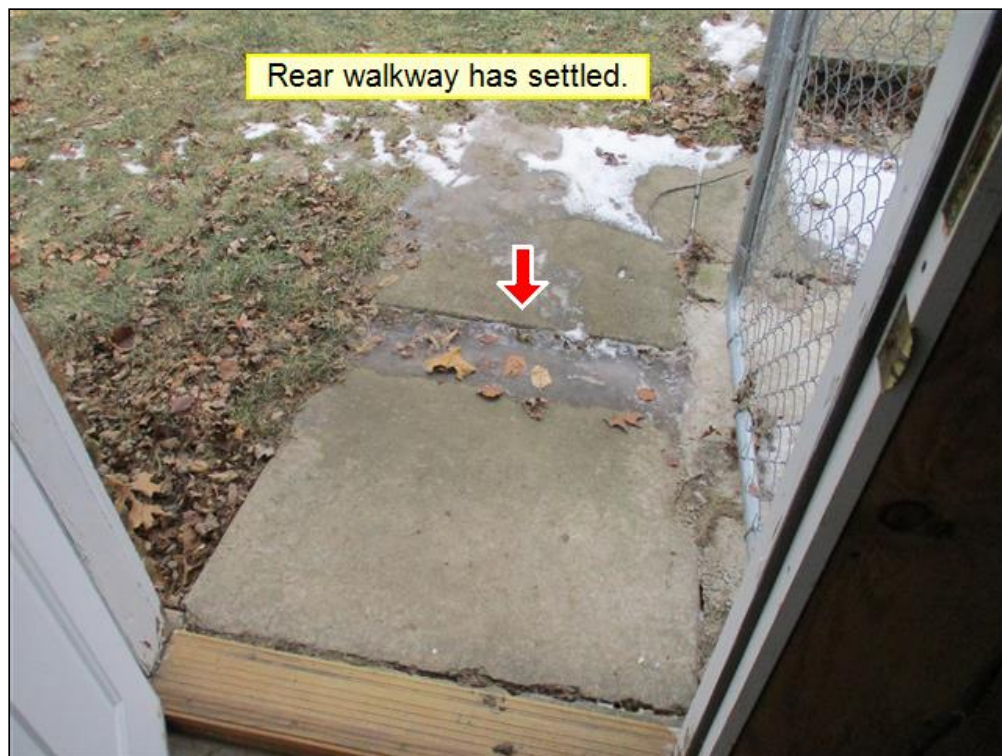
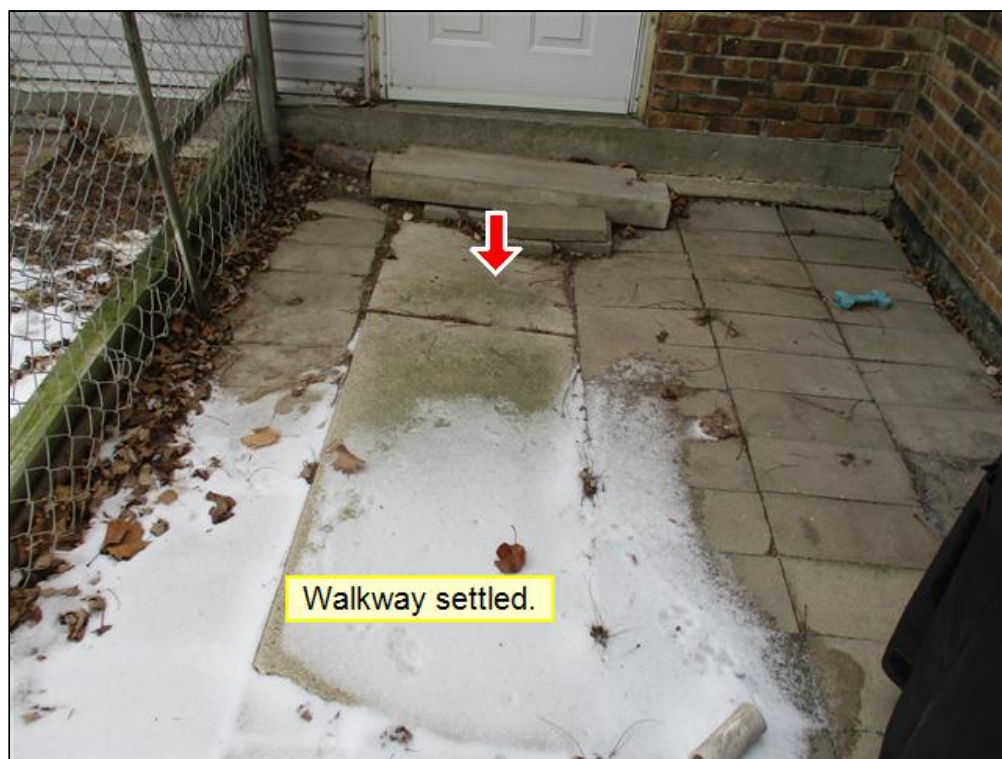
(1) There are sections of the rear walkway that have settled or lifted. This has caused a tripping hazard. If not repaired, injury to occupants may occur. Contact a concrete company to repair or replace the damaged sections of walkway.

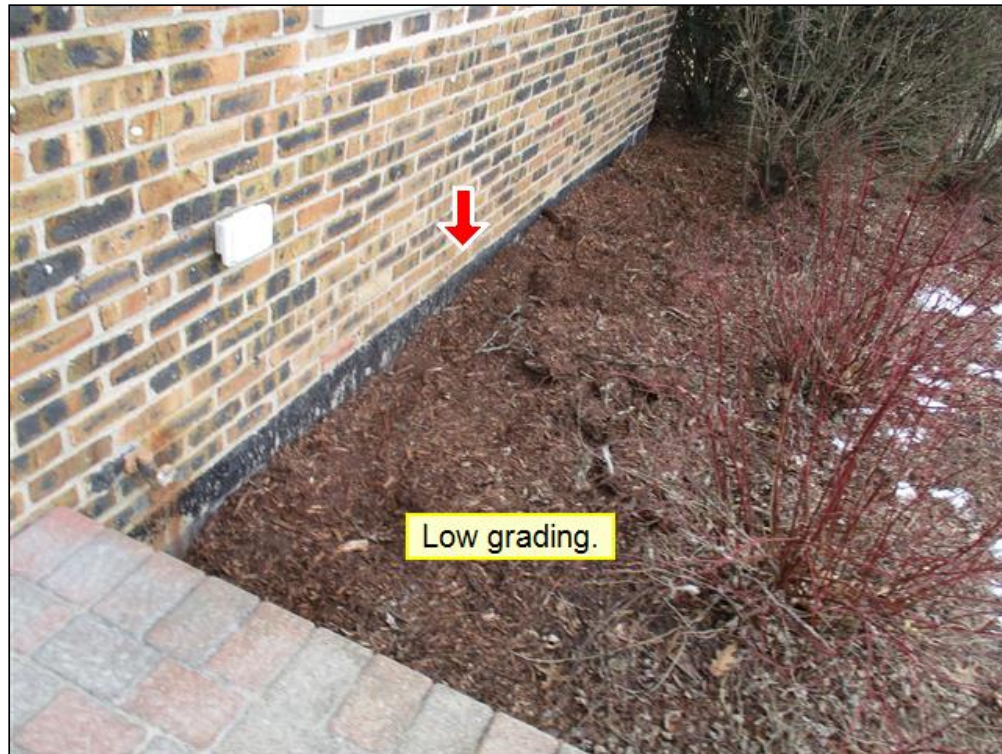
2.1 Item 3(Picture)

(2) The grading is low on the front and sides of the home. Low grading causes water to flow toward the home. The water can cause damage to the foundation or enter the crawl space. To correct the low grading, a landscaping company should be contacted to build up all low areas around the home.

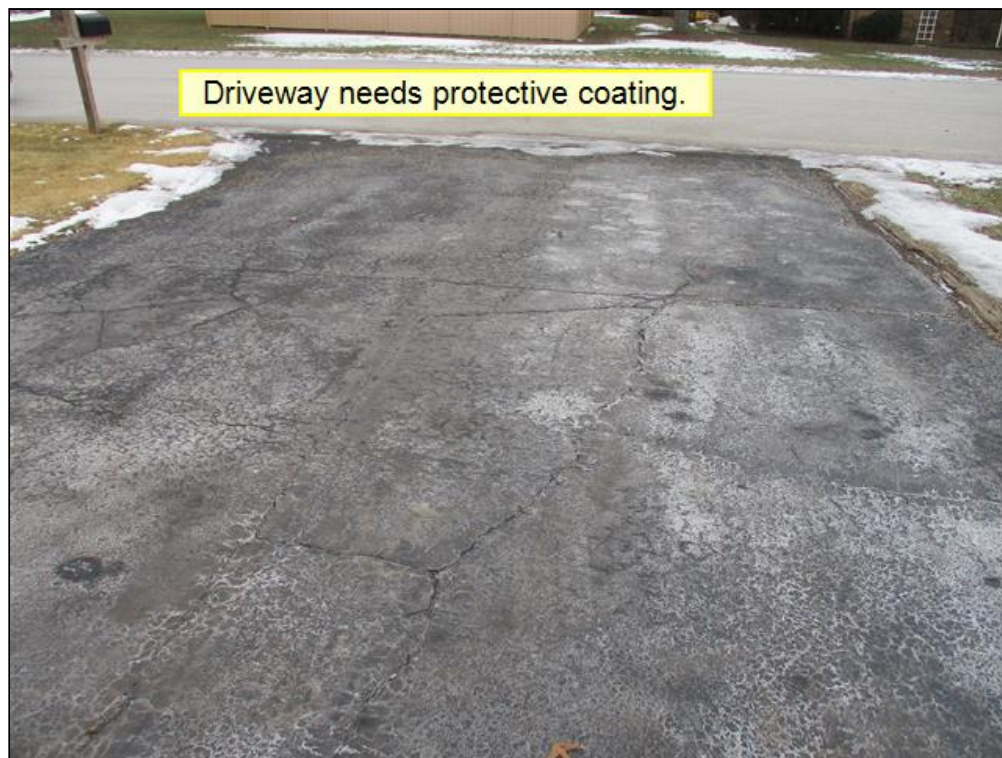
2.1 Item 4(Picture)

(3) The driveway is made of asphalt. Asphalt driveways should have a protective coating applied annually. I recommend applying a new protective coating to the driveway.

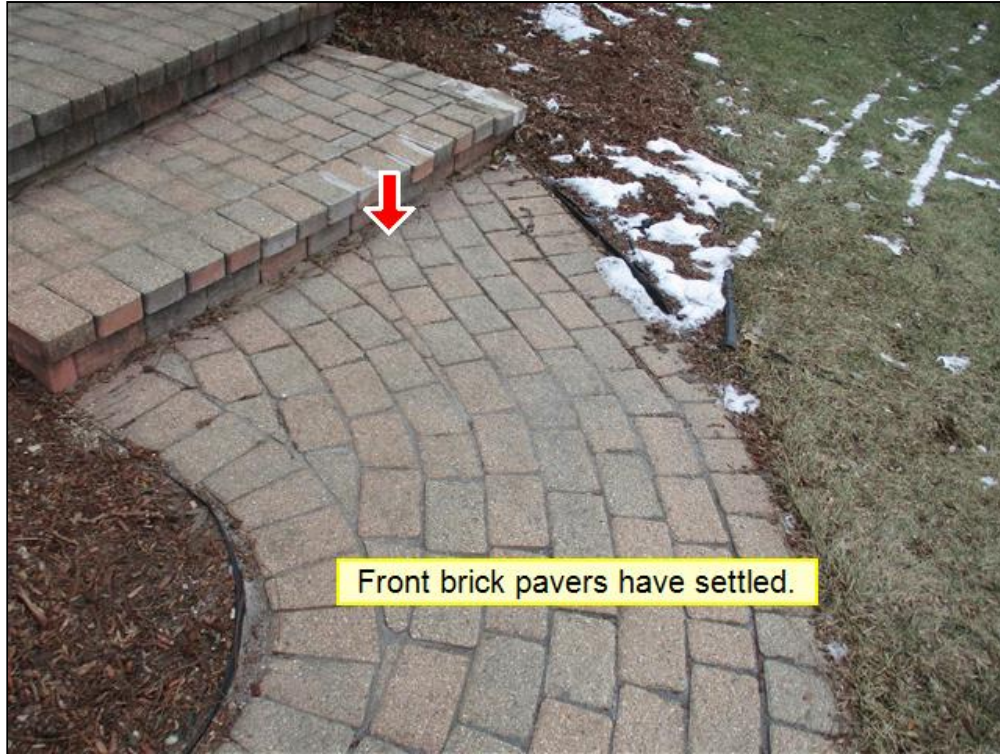
2.1 Item 5(Picture)

(4) The brick paver walkway needs repair. Brick pavers need periodic repair and maintenance to prevent damage. The algae must be removed from the joints, the brick power washed, new sand applied, and a new protective coating applied. Contact a landscaping company to perform this repair.

These pavers have also settled. They will need to be removed and reset.

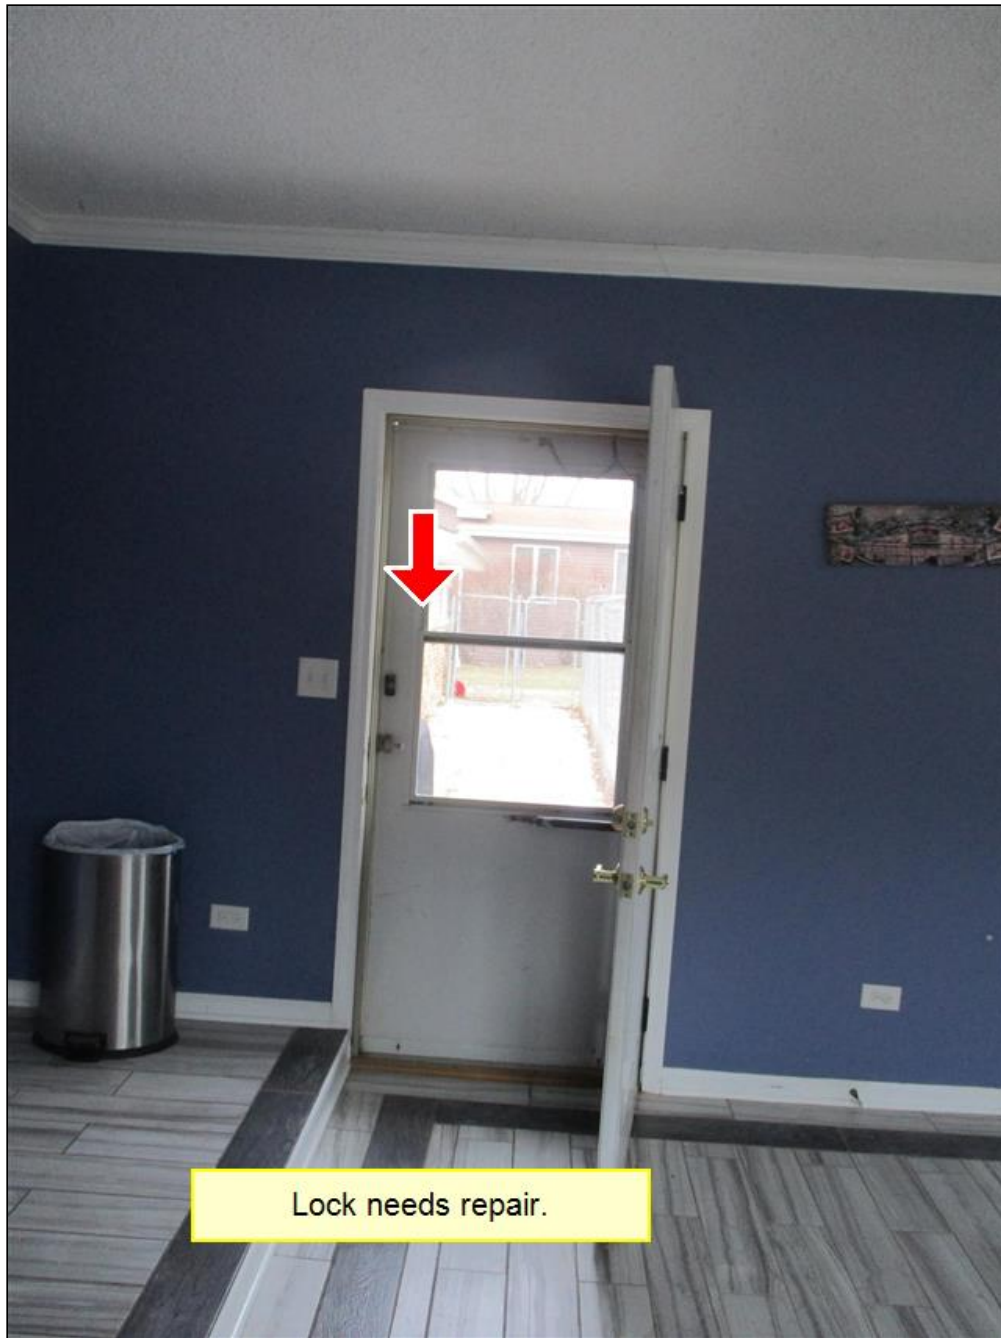
2.2 Item 1(Picture)

(1) The lock does not function on the rear storm door. Contact a qualified contractor to repair or replace the lock

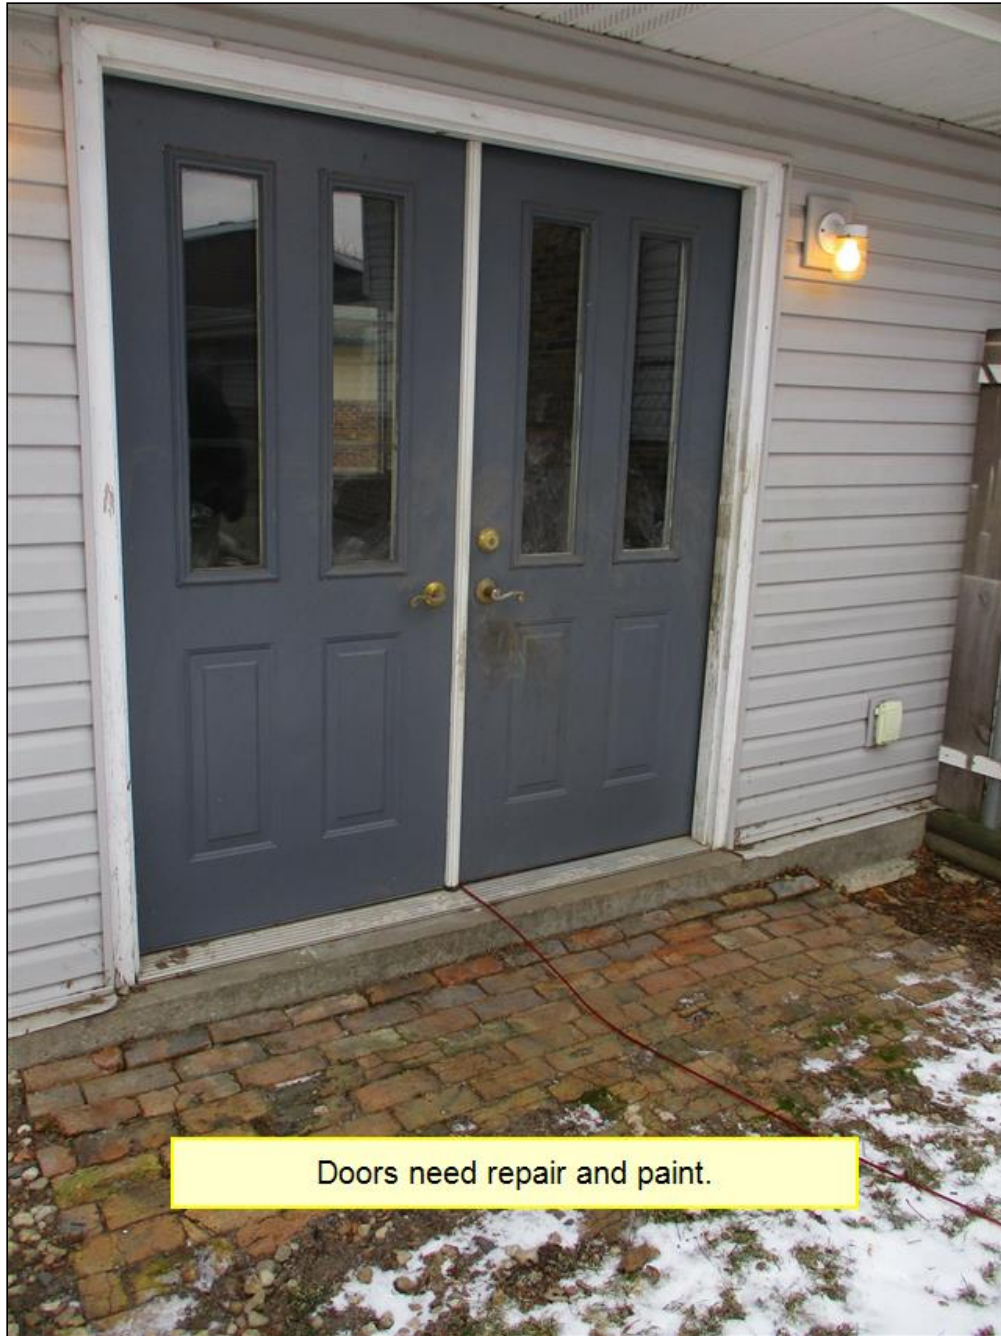
2.2 Item 2(Picture)

(2) The three seasons room double doors are severely worn. Contact a painting contractor to repair and paint.

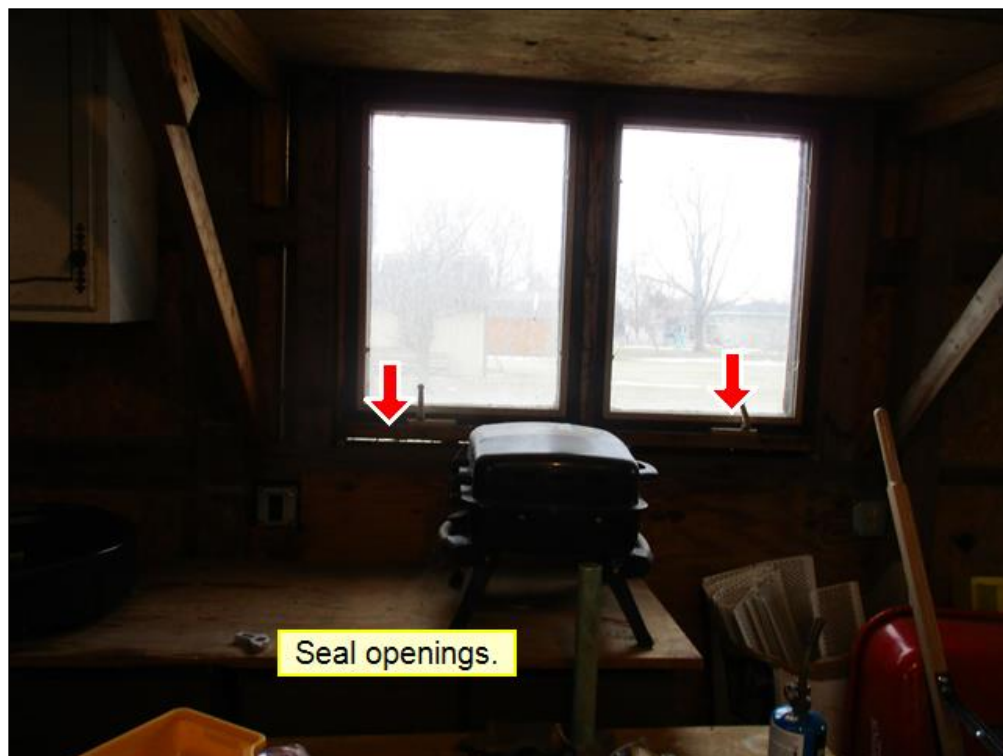
2.3 Item 1(Picture)

There are gaps under the shed windows. Contact a qualified contractor to seal all openings.
