Inspection Report

Sample Report

Assure Home Inspection

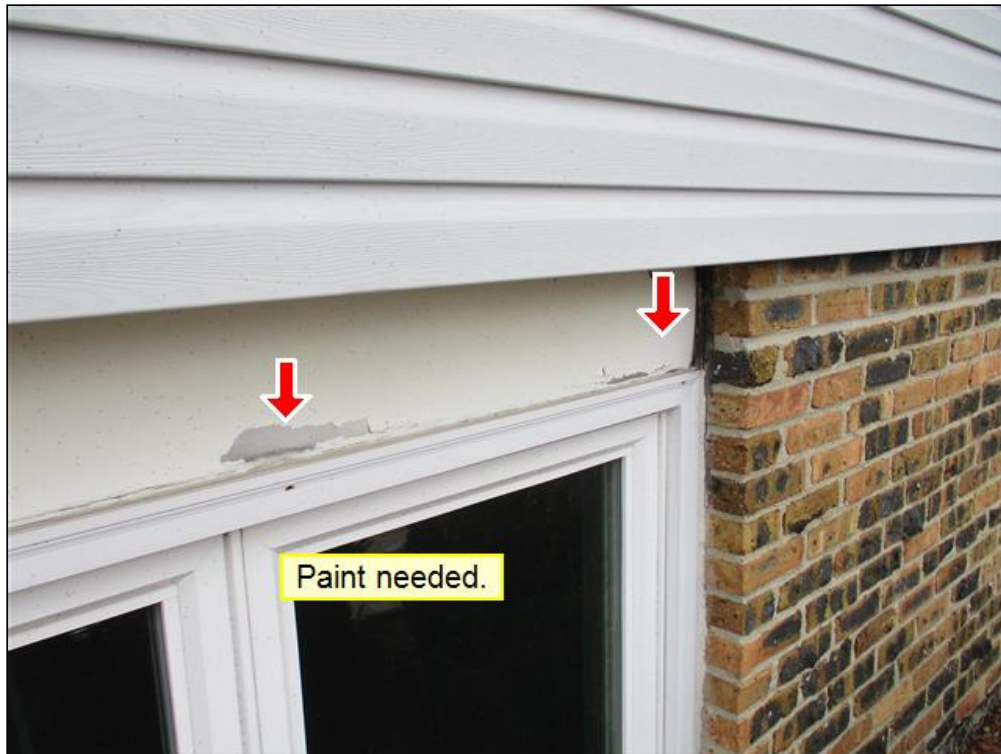
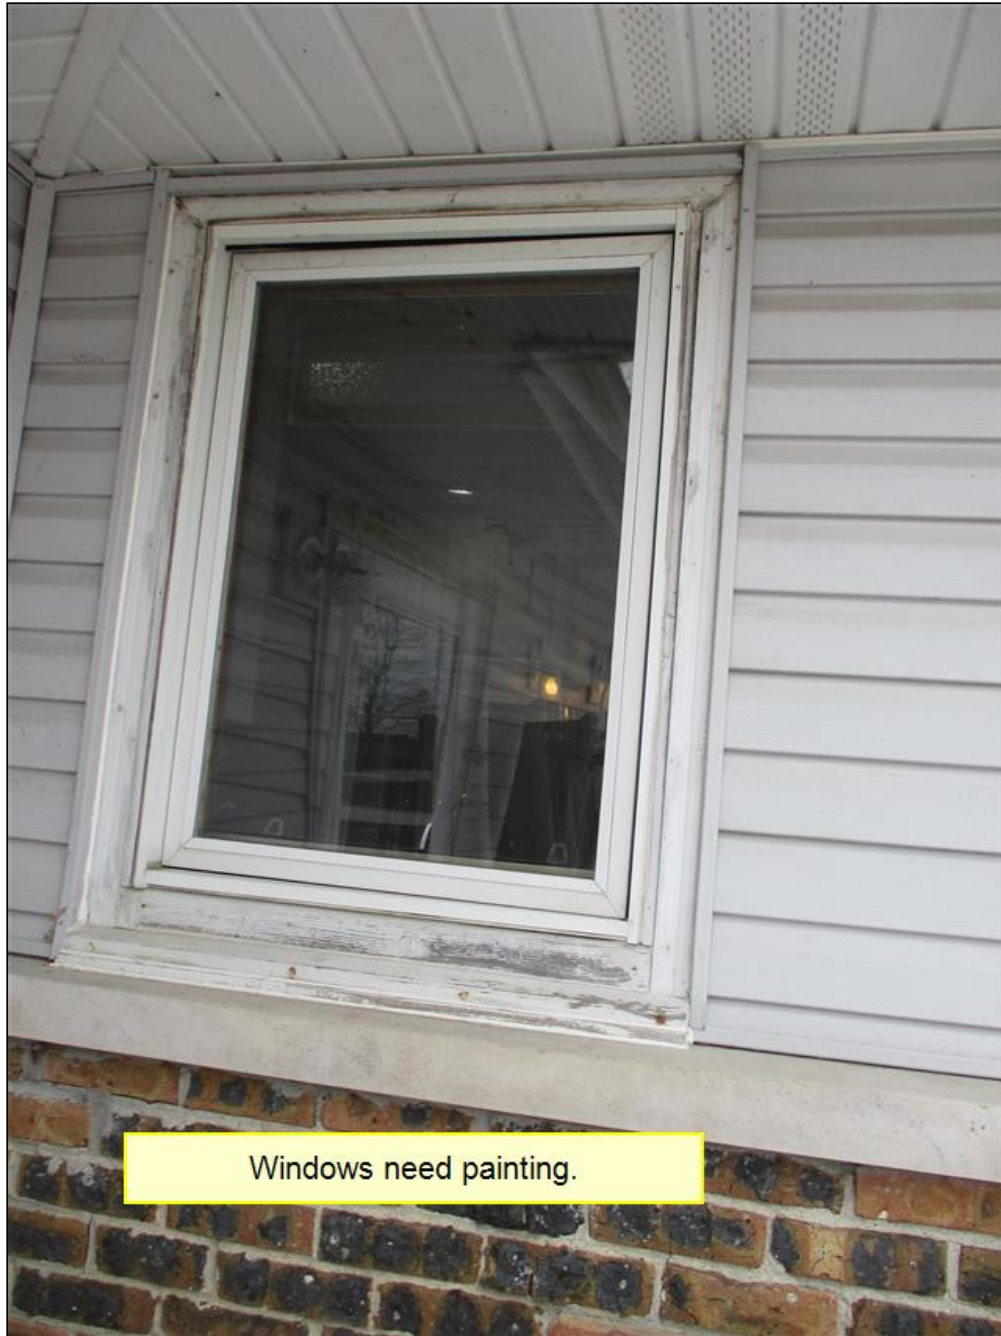
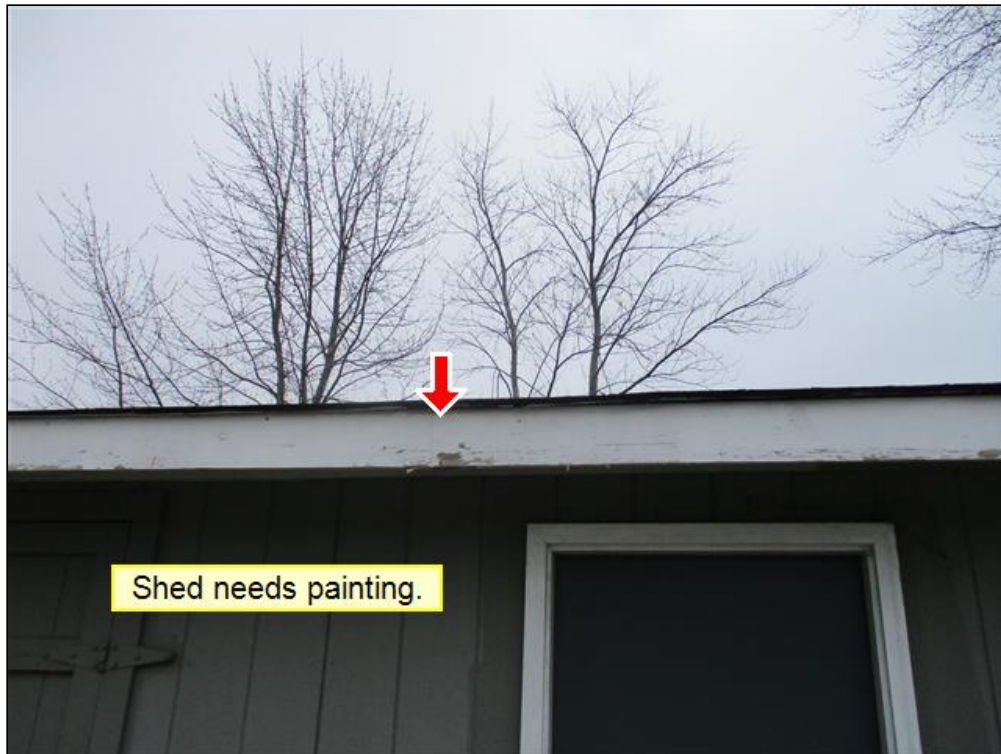
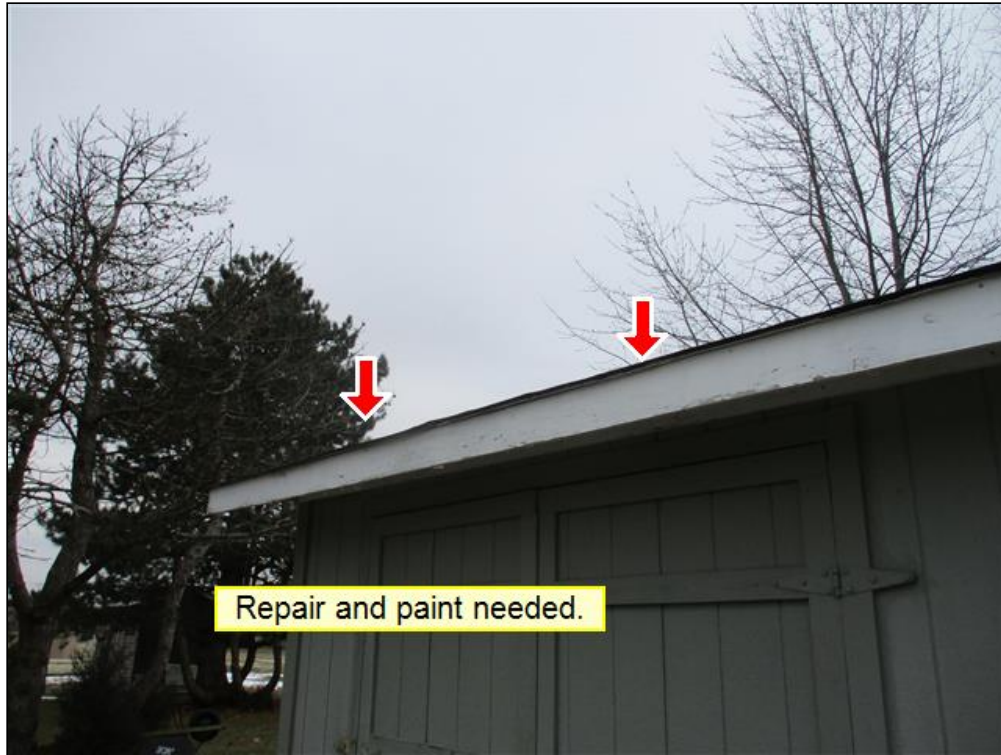
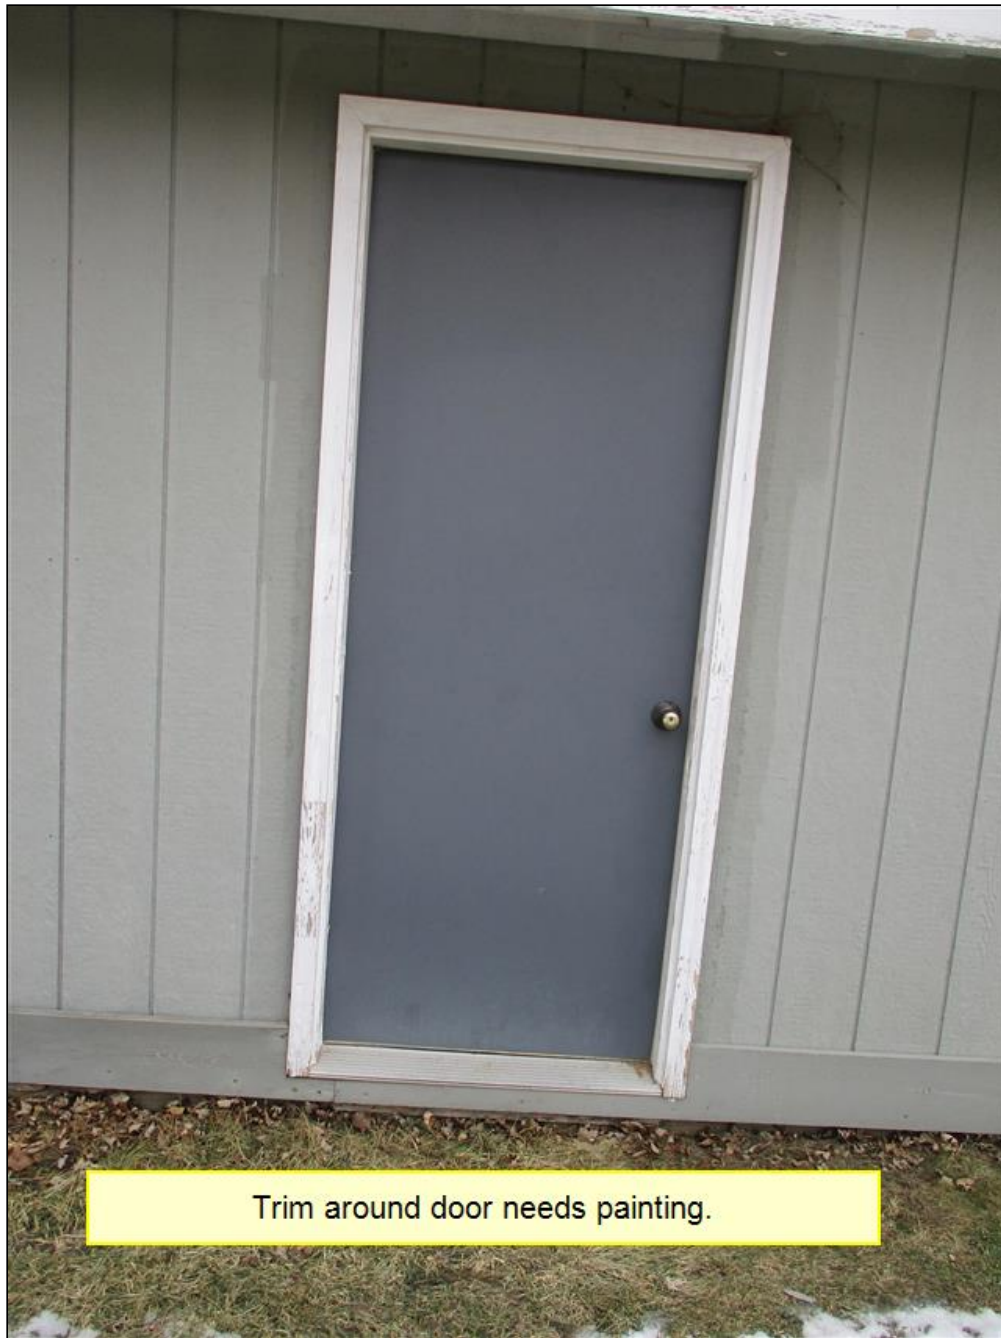
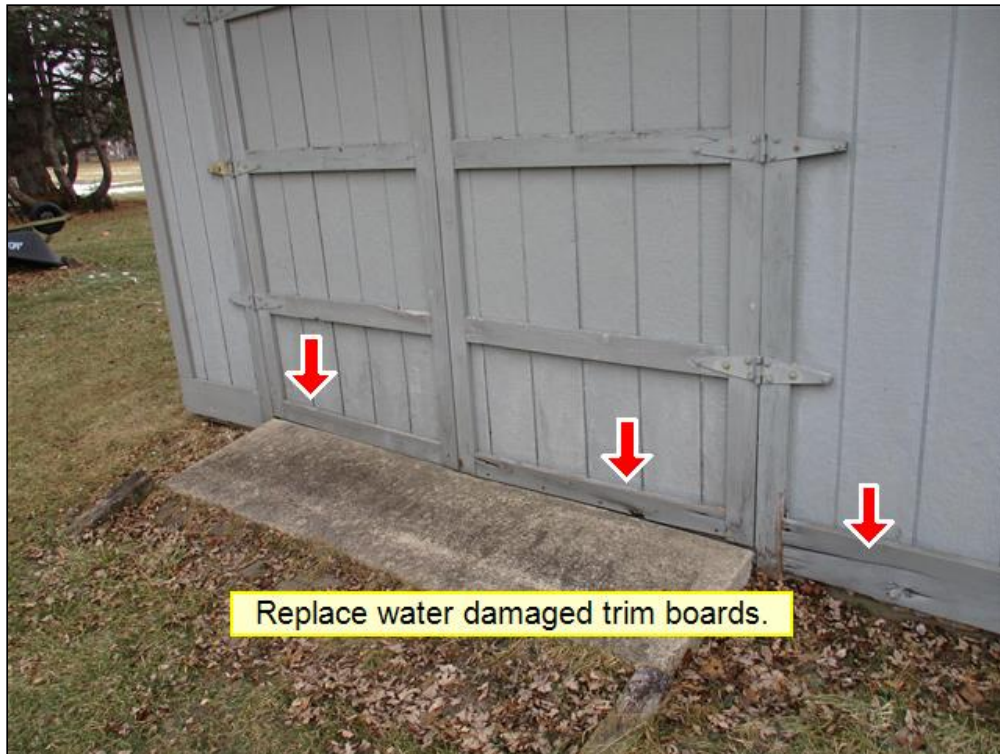
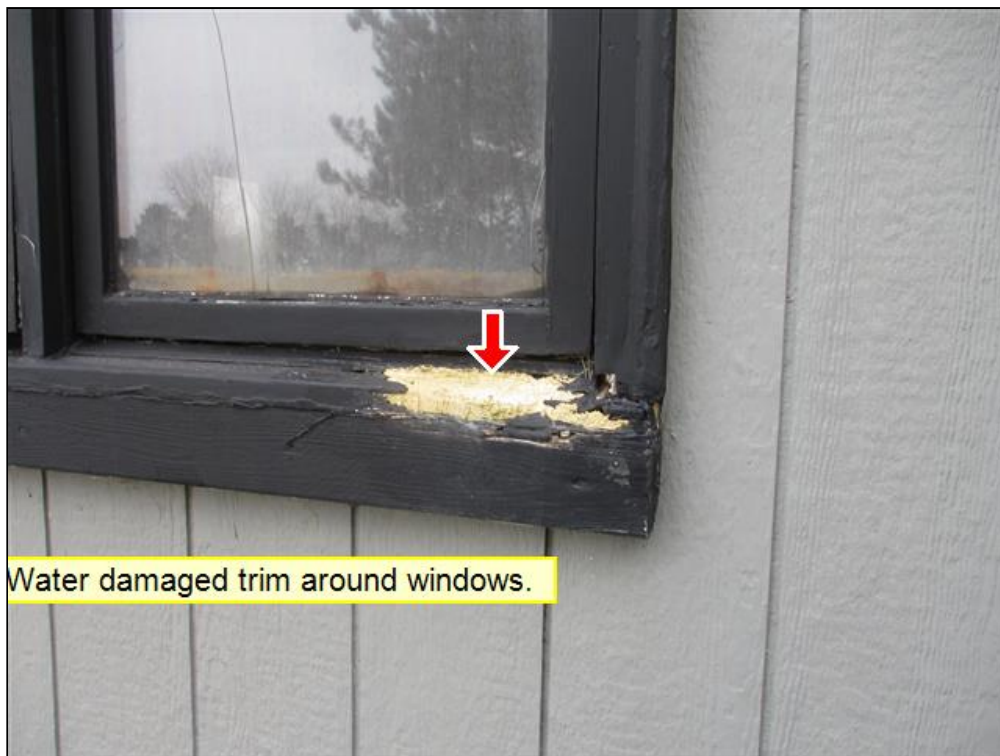
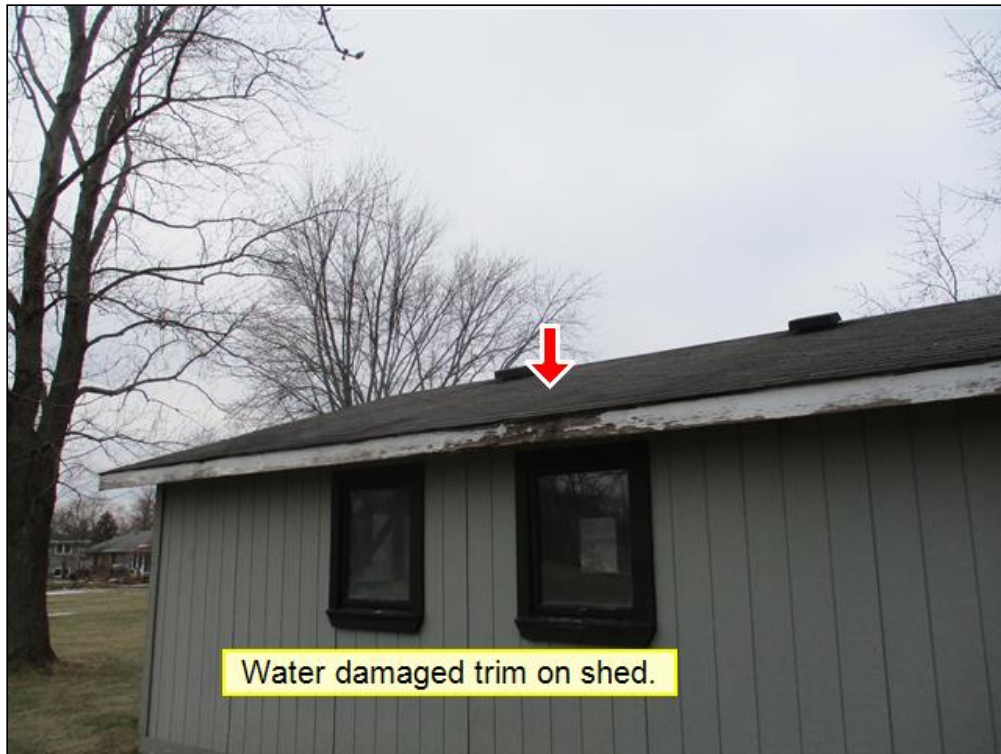
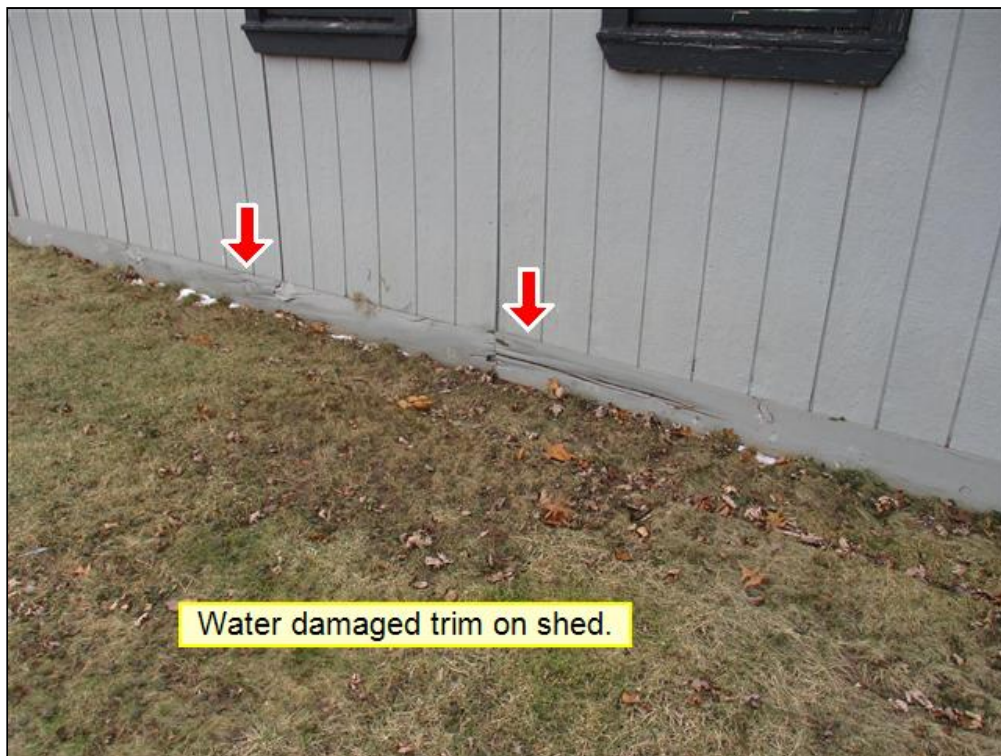
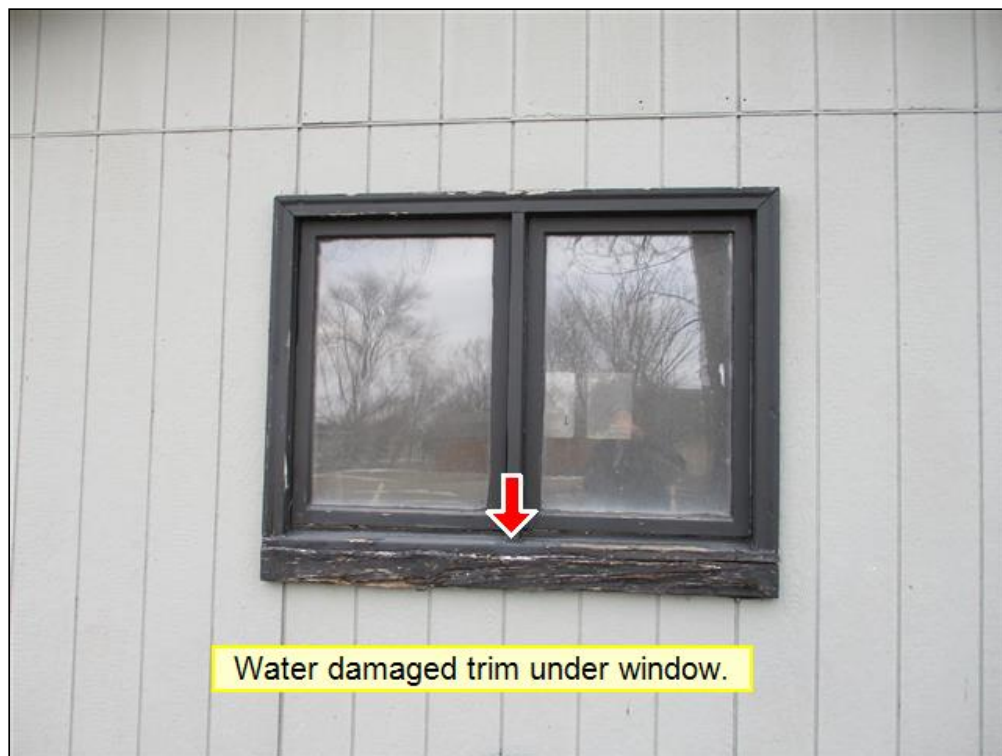
There is peeling paint and water damaged trim, fascia, and soffits, on the exterior home and shed. If not repaired and painted, further damage will occur.

Contact a qualified contractor to repair, replace water damaged wood, and paint.

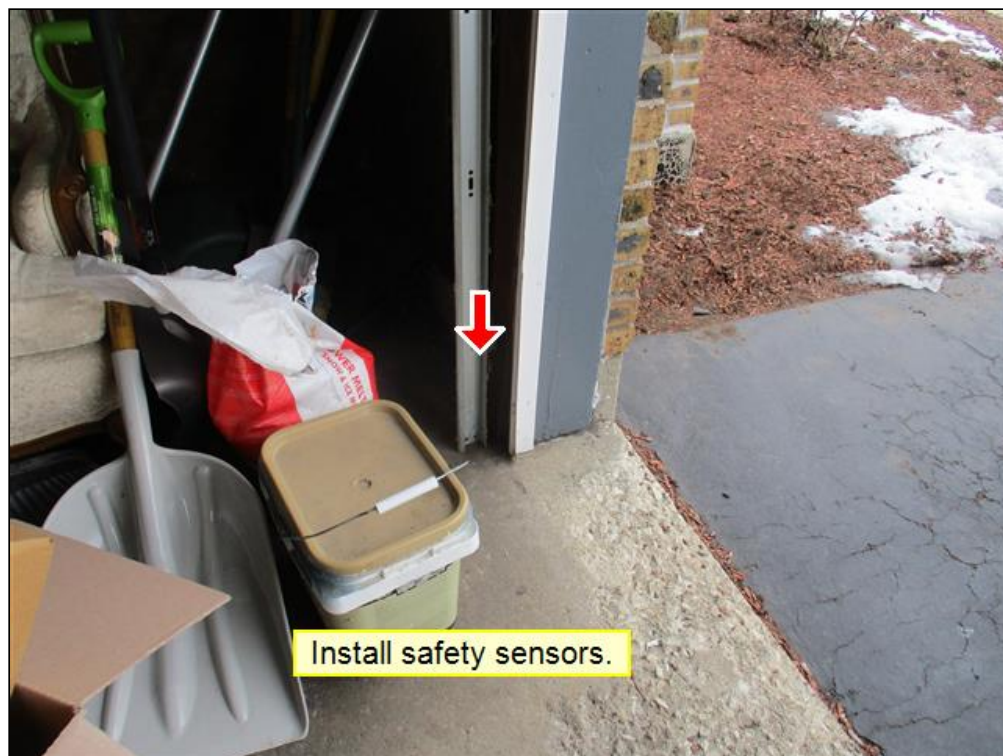
3.5 Item 1(Picture)

The garage door opener is not equipped with safety sensors that prevent injury to occupants or animals. The sensors should be located on the lower portion of the garage door, and are designed to reverse the direction of the door if someone is beneath. This is a safety code enforced by municipalities. Contact a qualified person to install safety sensors on the garage door.

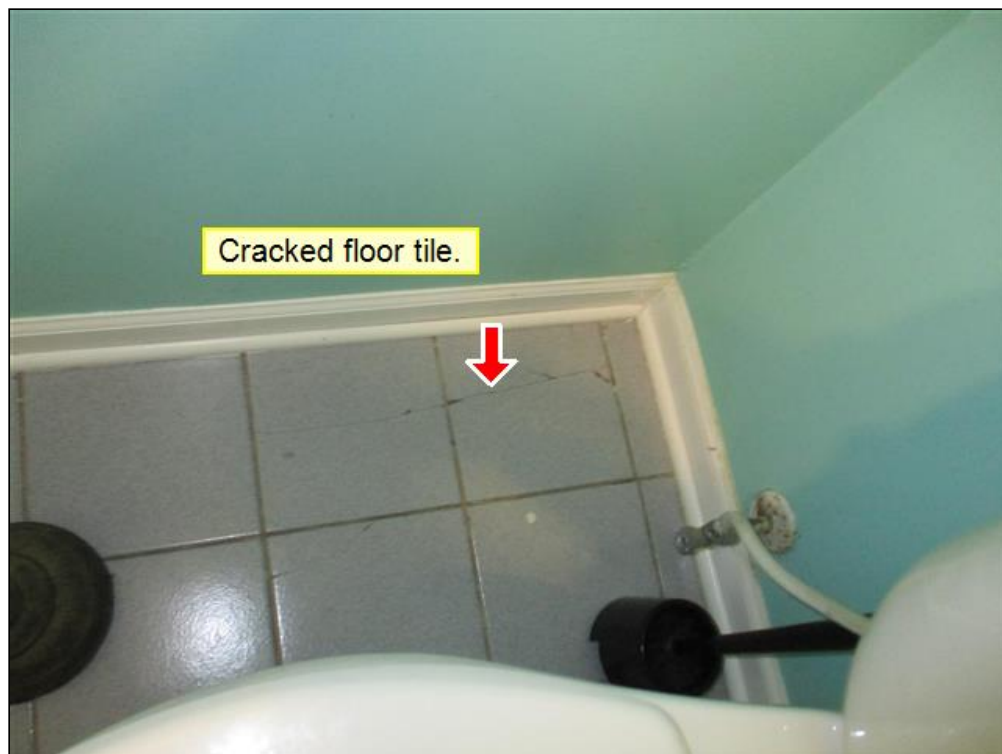
4.2 Item 1(Picture)

There are several upper bathroom floor tiles that are cracked, and several kitchen floor tiles with holes. Contact a flooring contractor to replace all damaged floor tile.

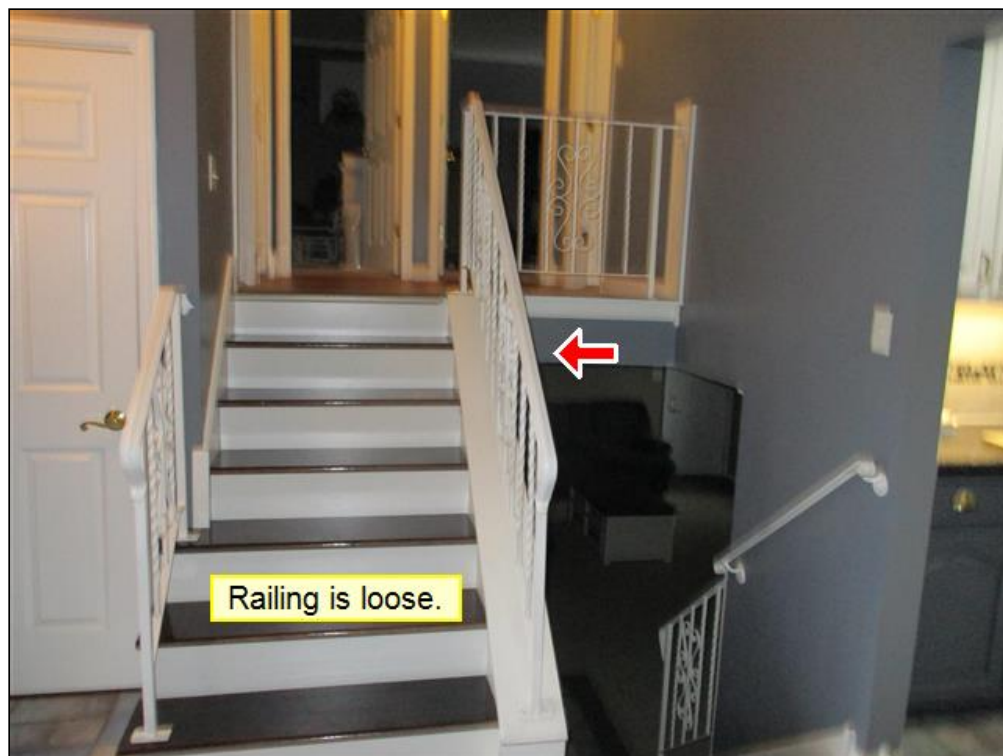
4.3 Item 1(Picture)

The upper level hand railing is slightly loose. If not properly secured, further damage will occur. Contact a qualified contractor to properly secure the railing.

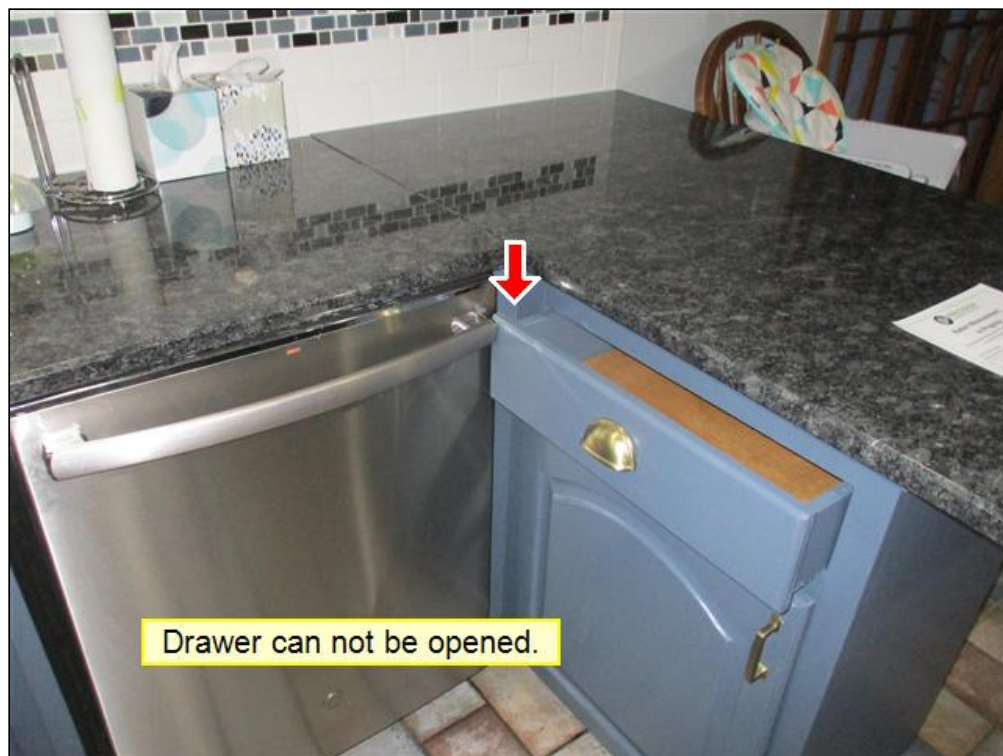
4.5 Item 1(Picture)

There is one kitchen cabinet drawer that does not open. The drawer contacts the dishwasher upper handle. To correct this issue, the dishwasher may need to be replaced with one that has a recessed handle.

Contact a qualified contractor to make repairs needed so door can be utilized.

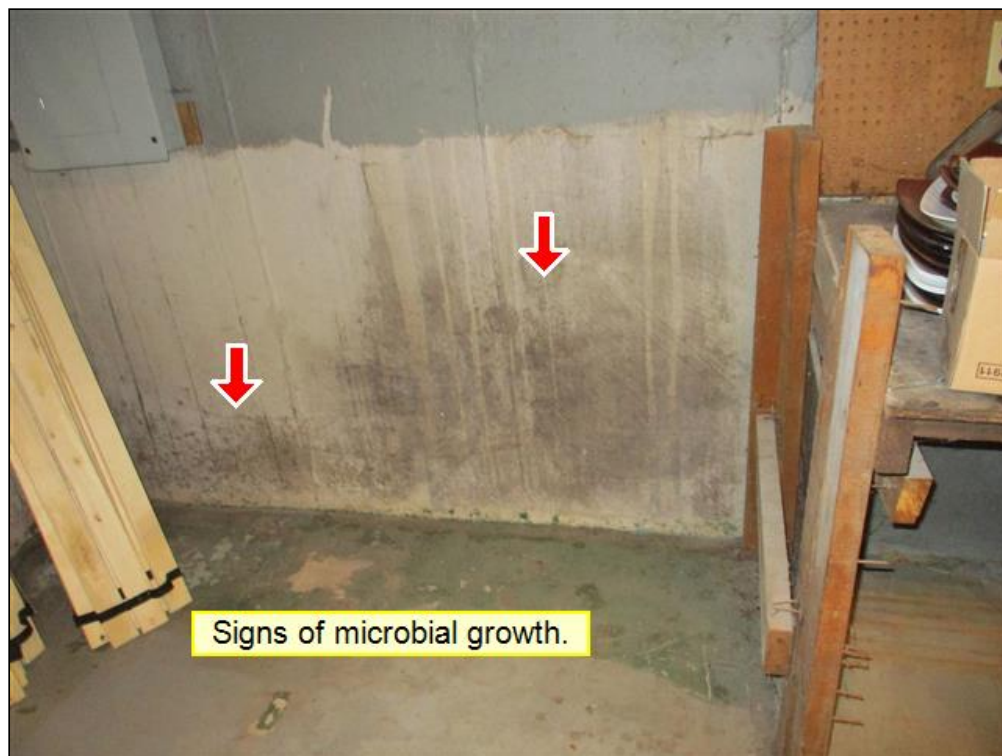
5.0 Item 4(Picture)

(3) There are strong signs of microbial growth on concrete walls in the basement. The microbial growth developed because of the damp atmosphere in the basement. Contact a mold professional to test or remove the growth.

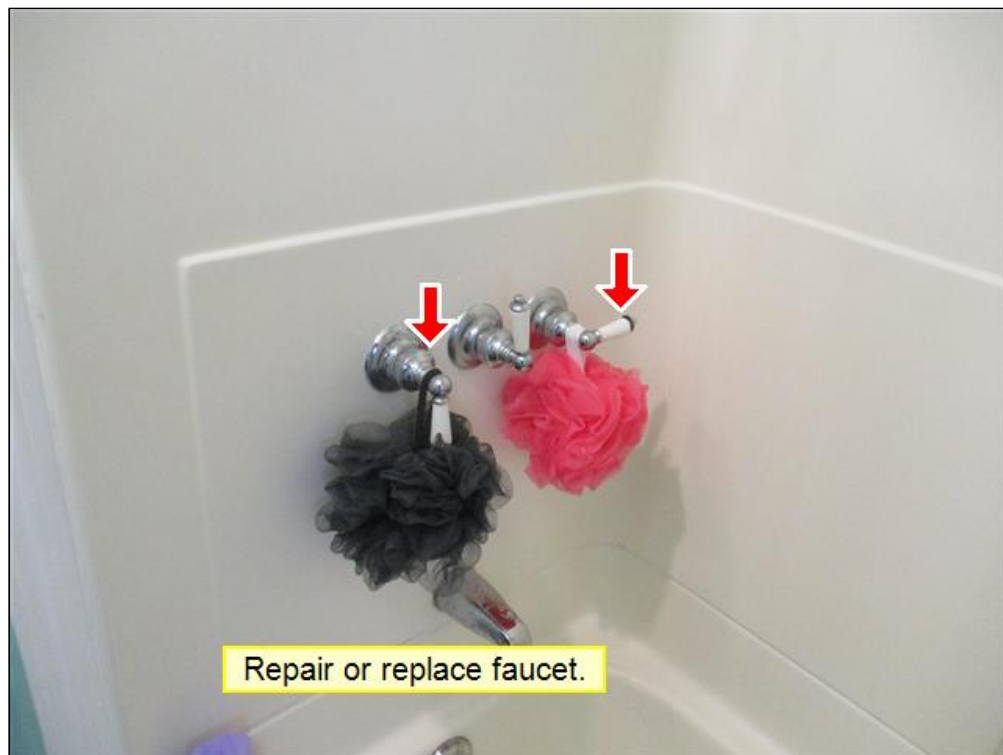
6.0 Item 7(Picture)

(5) The upper bathroom shower faucet is not properly installed. One of the faucet handles turns off when in the horizontal position and the other shuts the water off in the vertical position.

Contact a plumbing contractor to further evaluate and make repairs needed for proper operation.

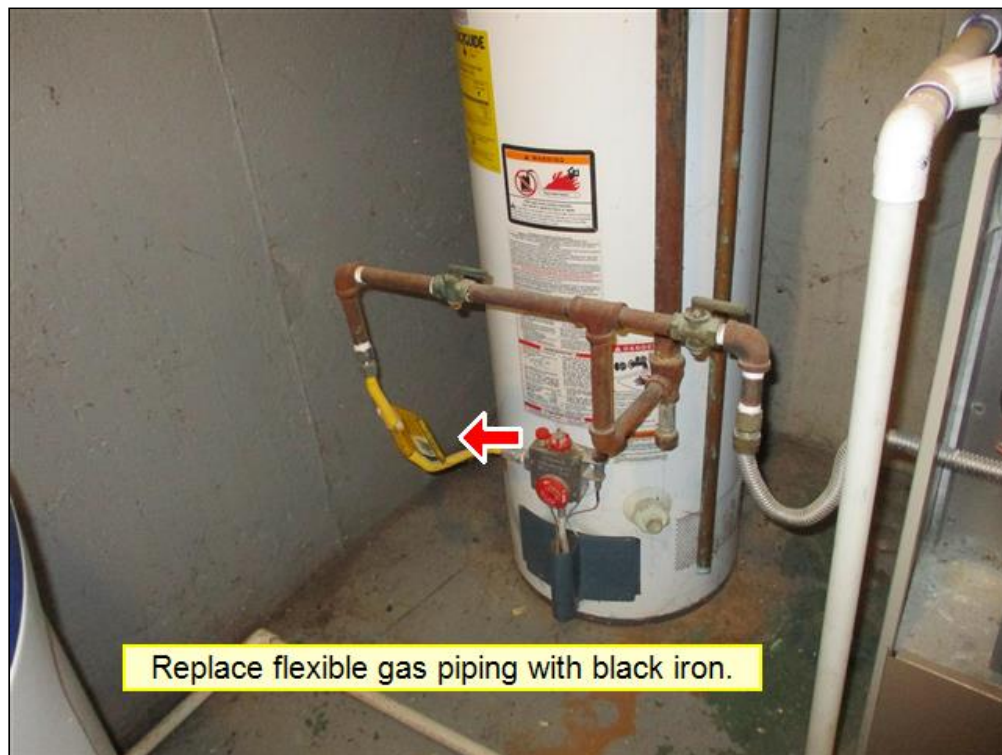
6.2 Item 1(Picture)

(2) There is no bonding wire present on the water heater. A bonding wire is required to prevent the electrolysis that can occur when dissimilar metals are joined together. The bonding wire is intended to allow that faint current between the water pipes to bypass the copper-to-steel fittings and thereby prevent corrosion caused by electrolysis. Contact a qualified person to install a bonding wire.
-

(3) The water heater gas piping is connected with flexible tubing. Modern standards require all gas piping to be made of black iron piping. This is a safety issue that must be corrected. Contact a plumbing contractor to install black iron piping.

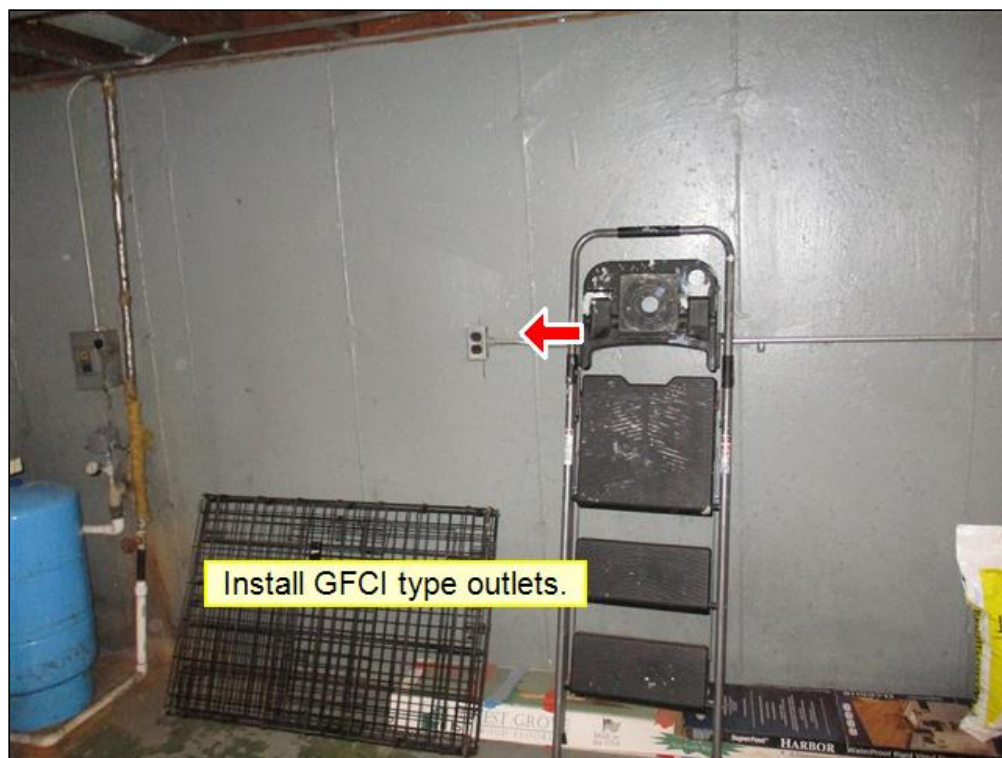
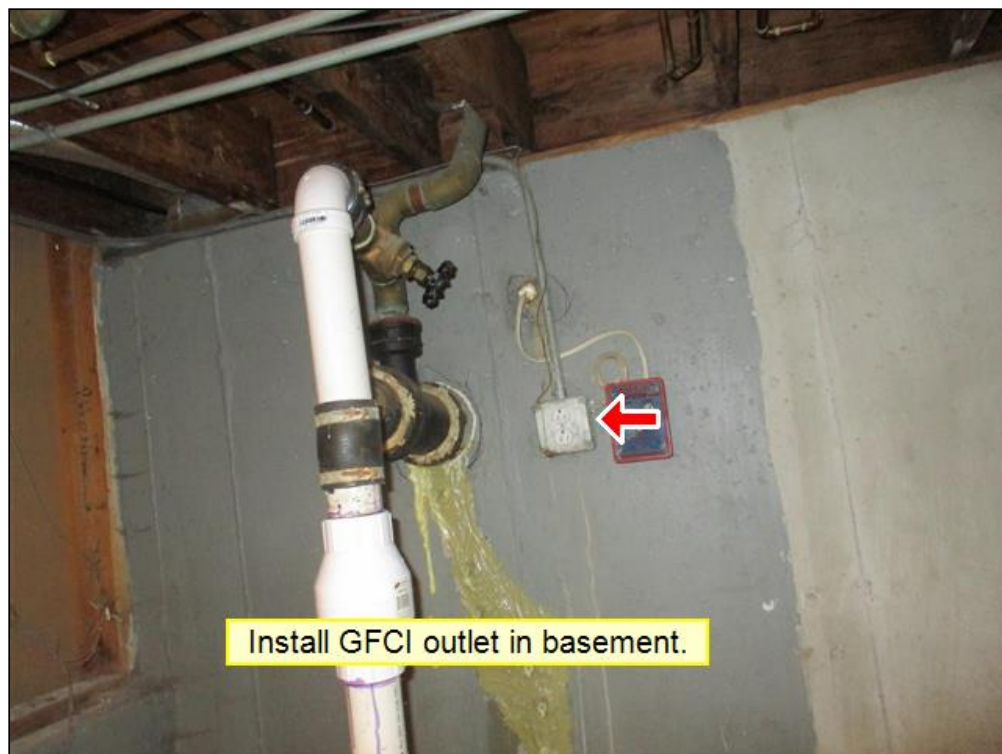
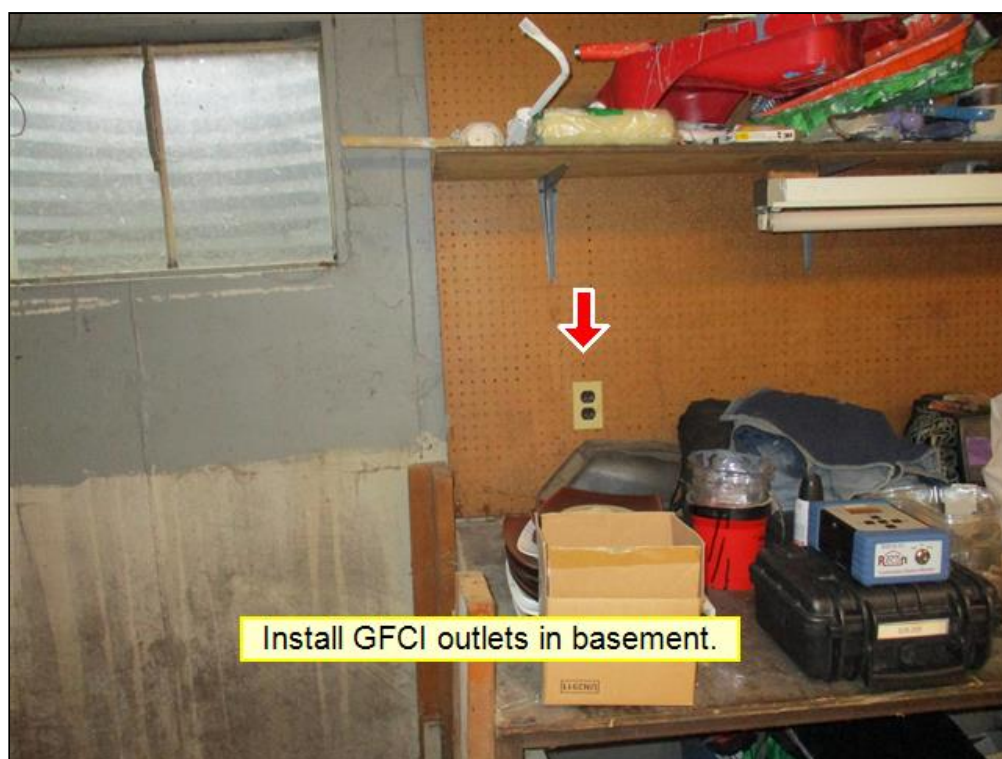
(3) The basement electrical outlets are not GFCI (ground fault circuit interrupted) protected. GFCI type electrical outlets protect the family against electrical hazards. When this home was built, it was not required to have GFCI electrical outlets in the basement. Modern standards not require GFCI outlets in unfinished basements. I recommend updating electrical outlets in garage to GFCI type outlets.

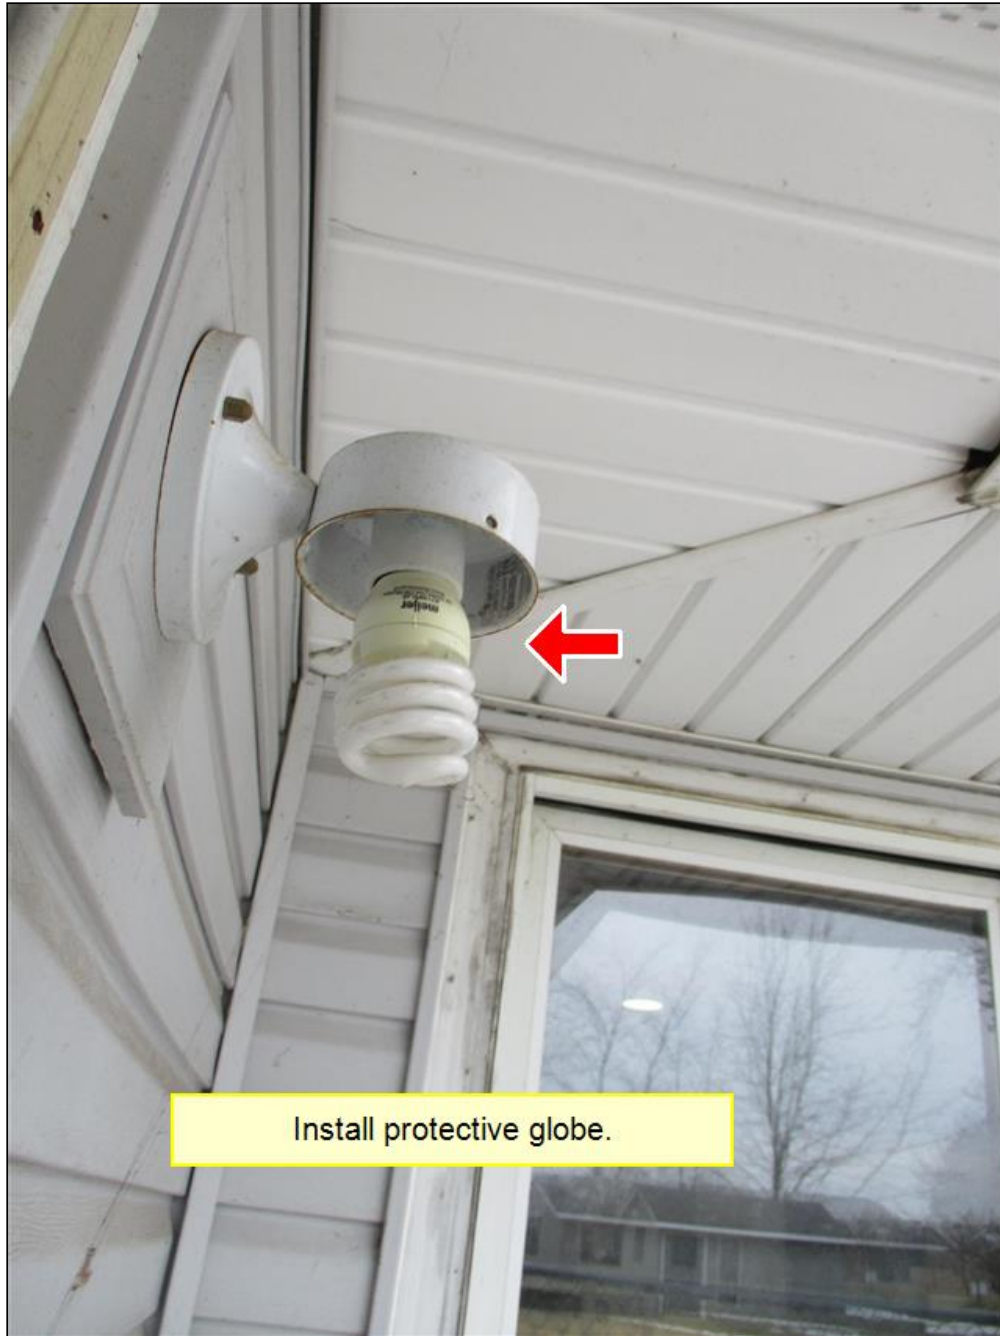
7.3 Item 7(Picture)

(3) One of the exterior rear light fixtures has a missing globe. These globes can be purchased at any hardware type store. Purchase and install a protective globe.

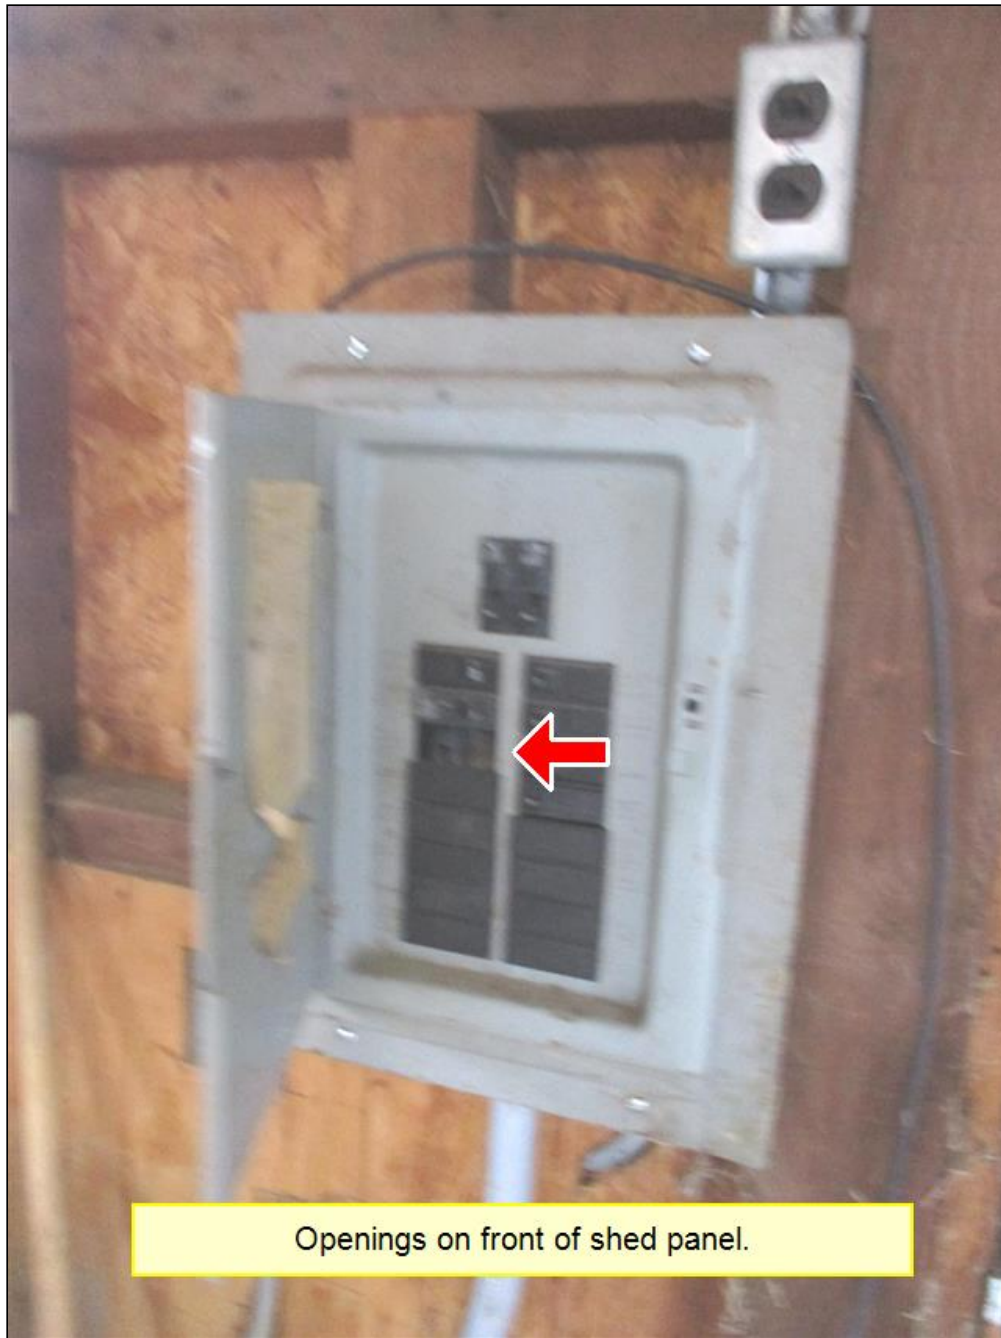
7.4 Item 1(Picture)

(1) There is an opening on the front of the detached shed electrical panel. Openings in the electrical panel are a safety hazard because the internal components are exposed to the occupants. If not corrected, injury could occur. This can be corrected by inserting a breaker, or inserting a cover plate. Both items can be purchased at any hardware store. Any type electrical work should be done by a qualified person.

The main electrical panel is located in the basement, there is a sub-panel in the garage, and one in the detached shed.

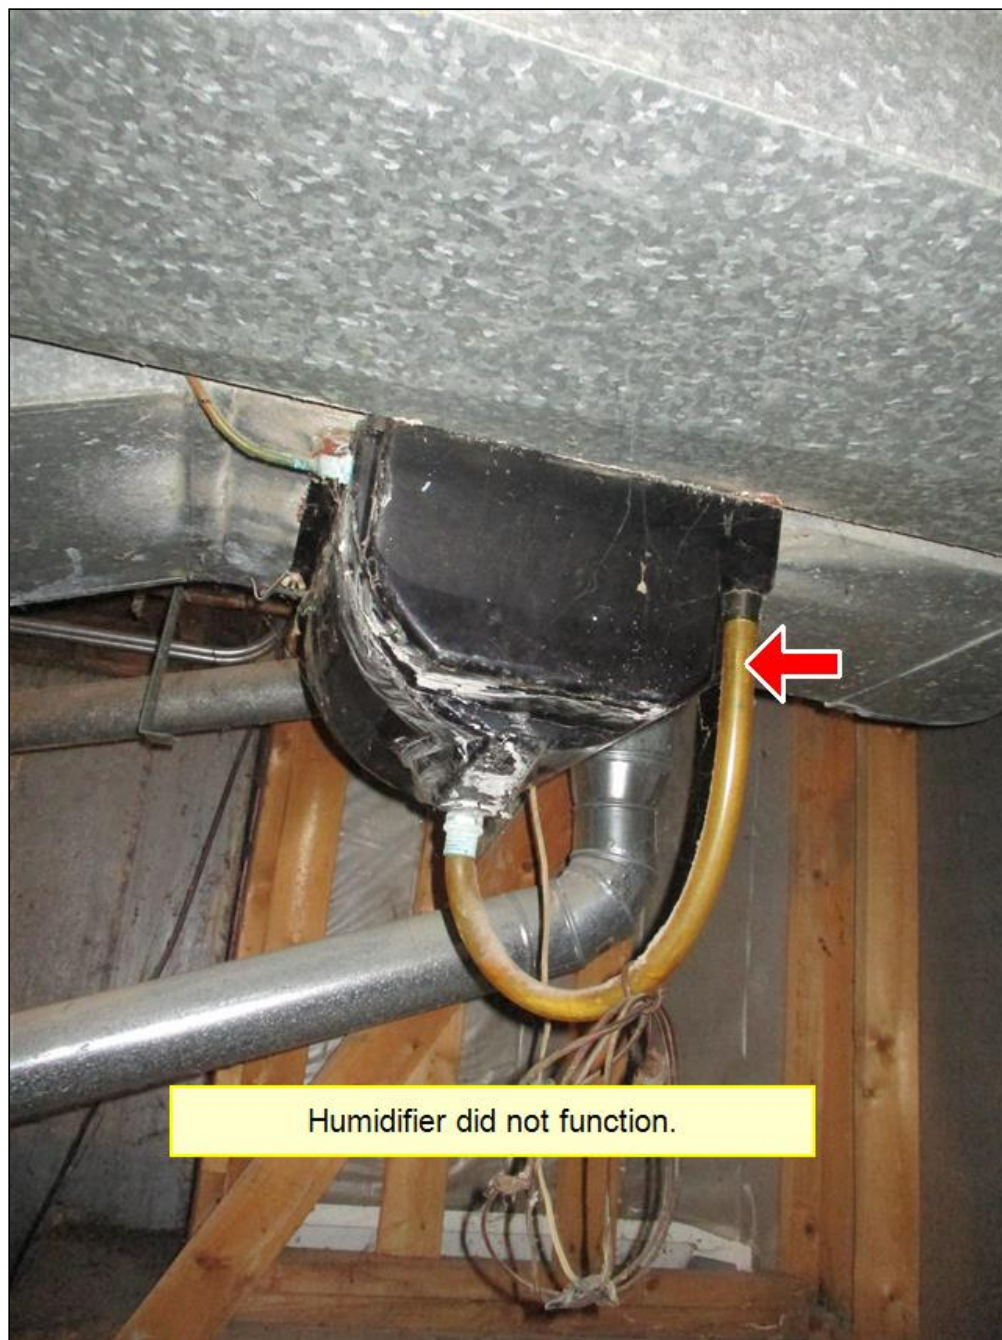
8.2 Item 2(Picture)

The humidifier was not working during the home inspection. Humidifiers are important to prevent wood flooring and trim from drying out and separating. They also have health benefits for occupants. I recommend contacting a heating contractor to repair humidifier in home.

There are two humidifiers that do not function.
