Inspection Report

Sample Report

Assure Home Inspection

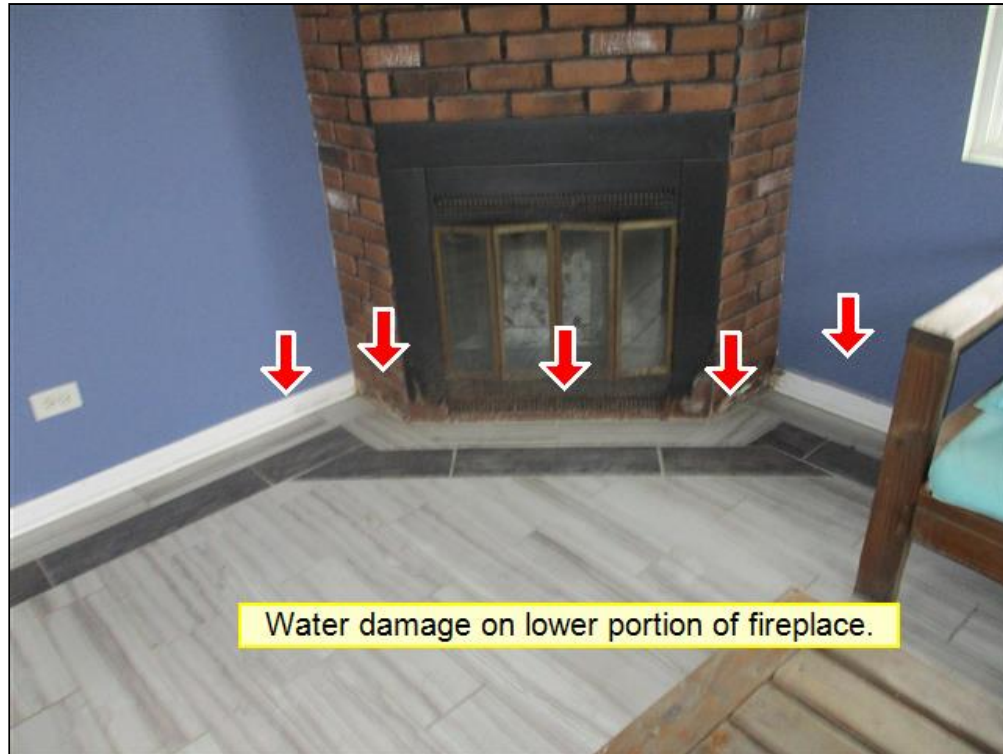
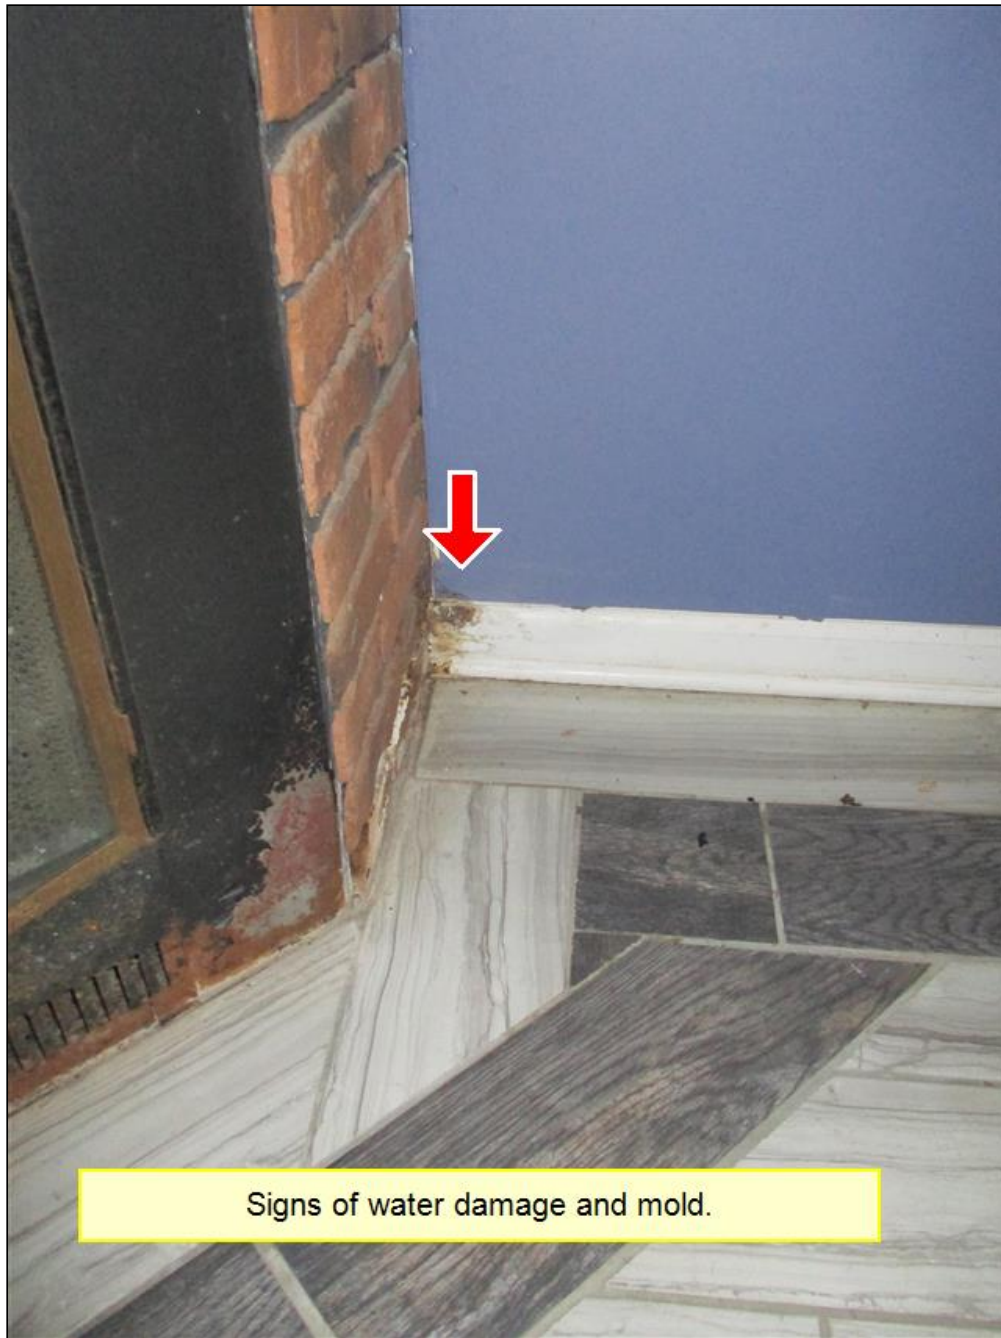
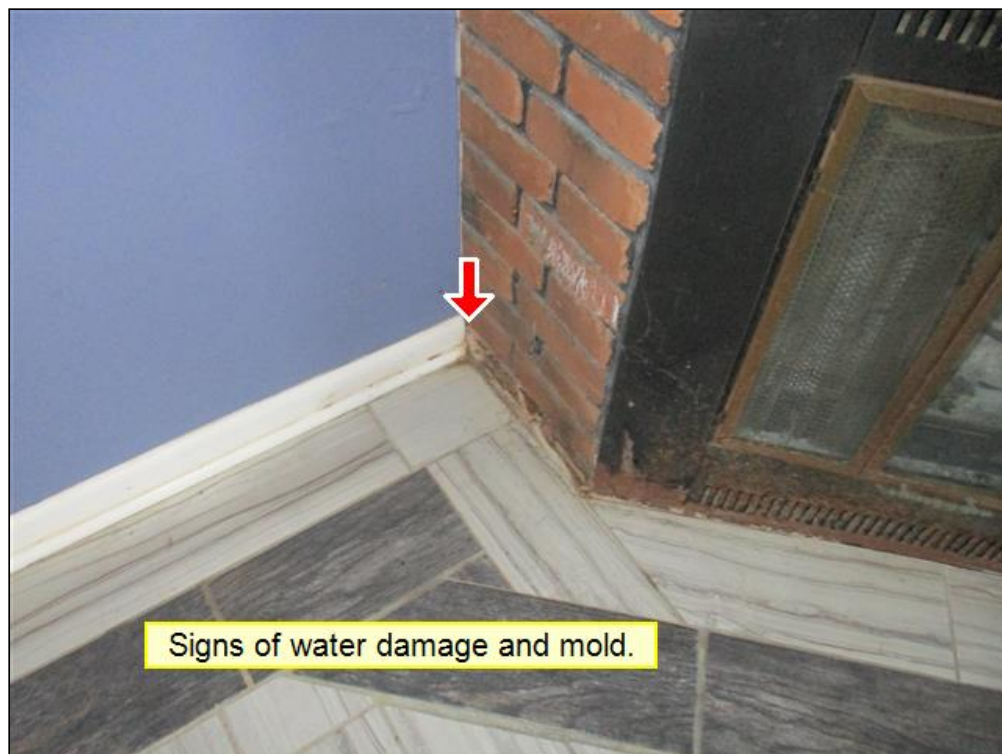
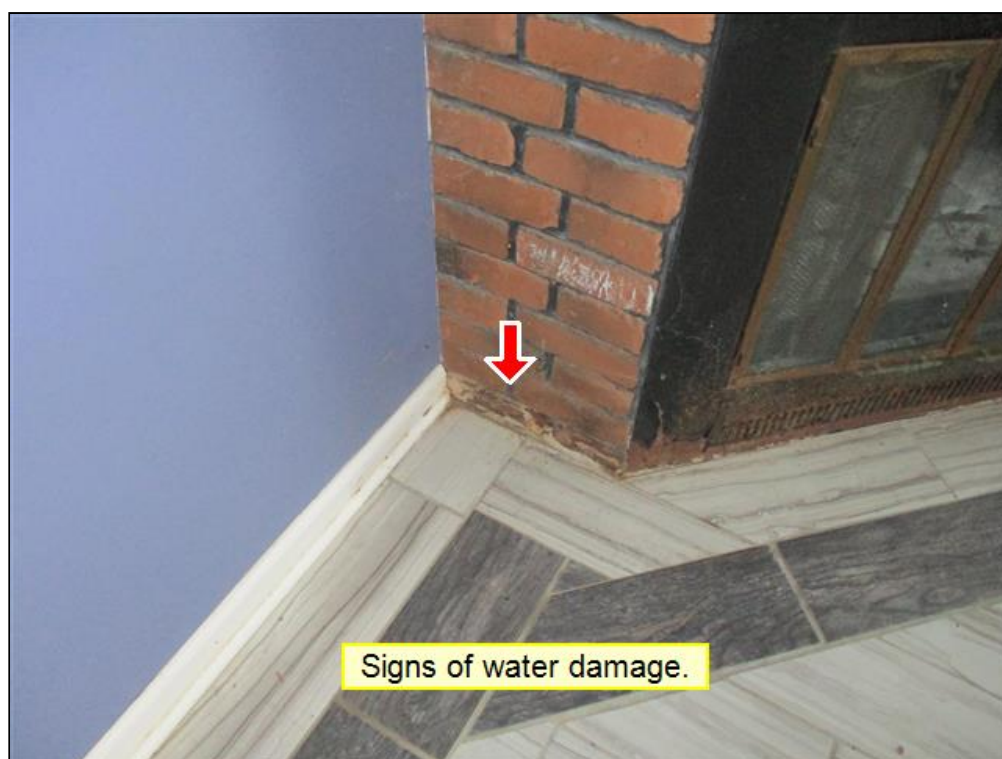
(1) There is water damage present on the lower portion of the rear three seasons room fireplace and wall. This indicates that water is entering the fireplace or flue.

After the water source is eliminated, a mold mitigation company must be contracted to properly remove water damaged material.

Contact qualified contractors to complete this repair.

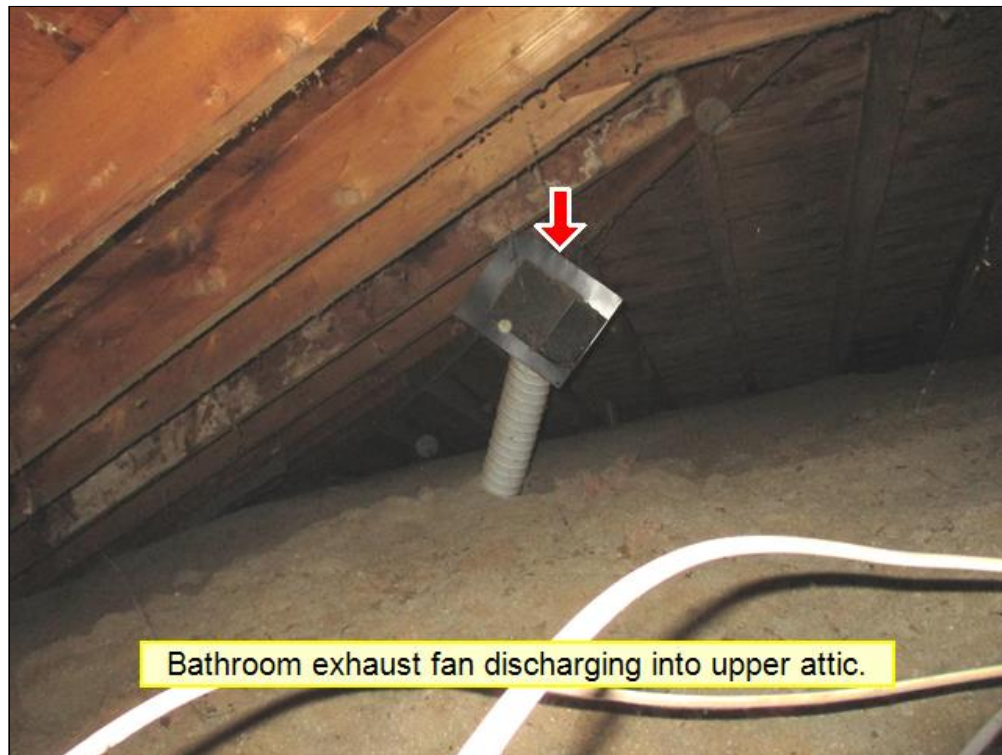
9.3 Item 1(Picture)

(1) There is one bathroom exhaust fan that is discharging into the attic. If not corrected, moisture related problems may develop. Contact a qualified person to direct the exhaust fan discharge to the exterior of the home.

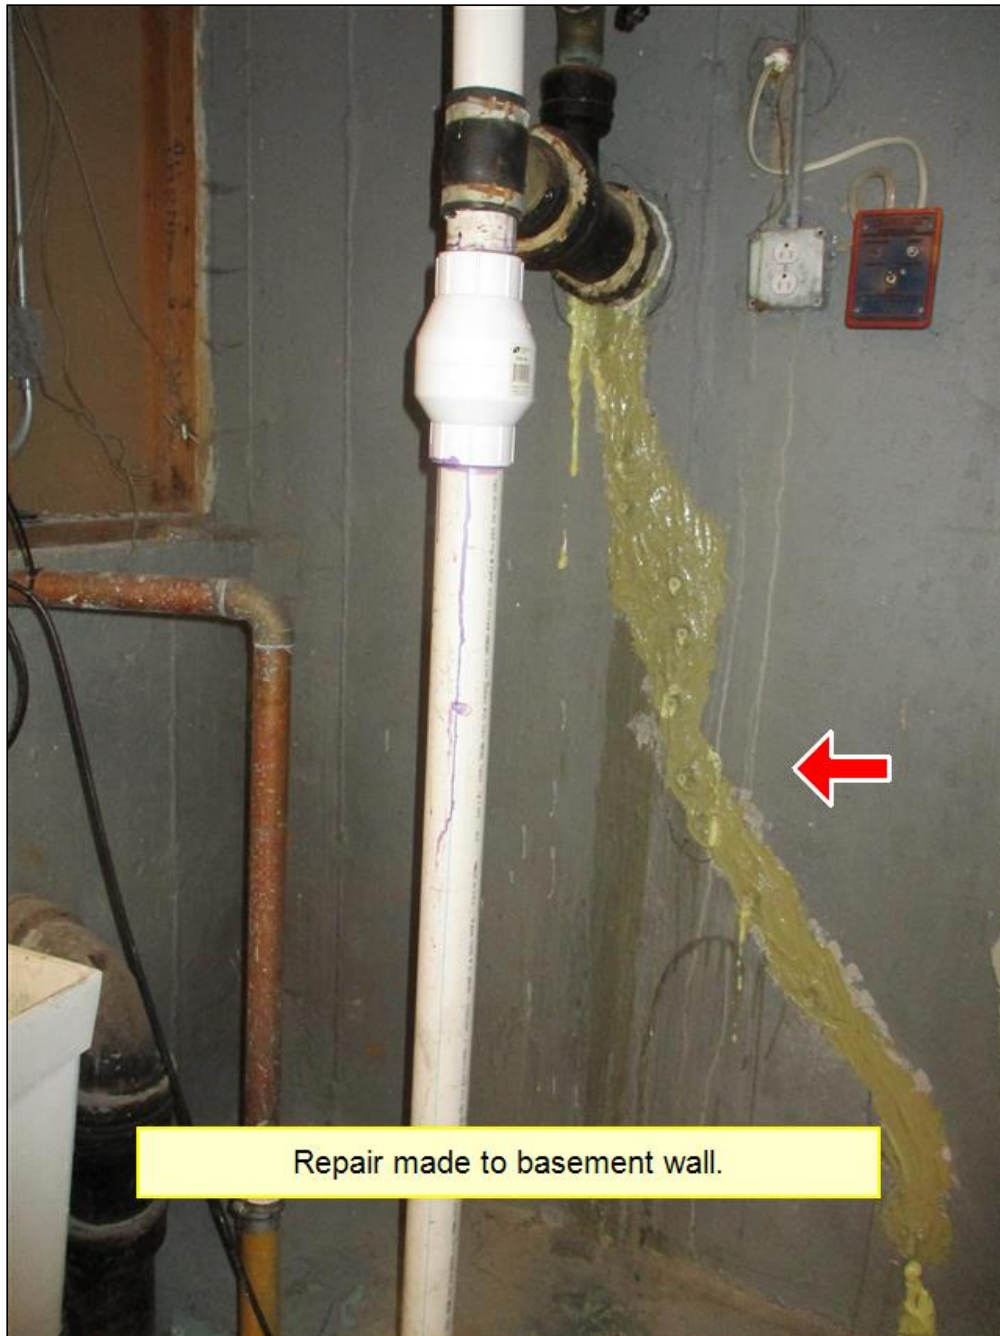
5.0 Item 2(Picture)

(1) There were repairs made on the basement concrete walls. These repairs are common and not a problem, but I recommend asking owner for any warranties that may be transferable.

Repair made to garage foundation wall.
